A case study about the experimental works on the production of repair mortars to be used in the restoration of Anemas Dungeons

Seden Acun Ozgunler

Key words: Anemas dungeons, repair mortars, historical buildings, experimental methods.

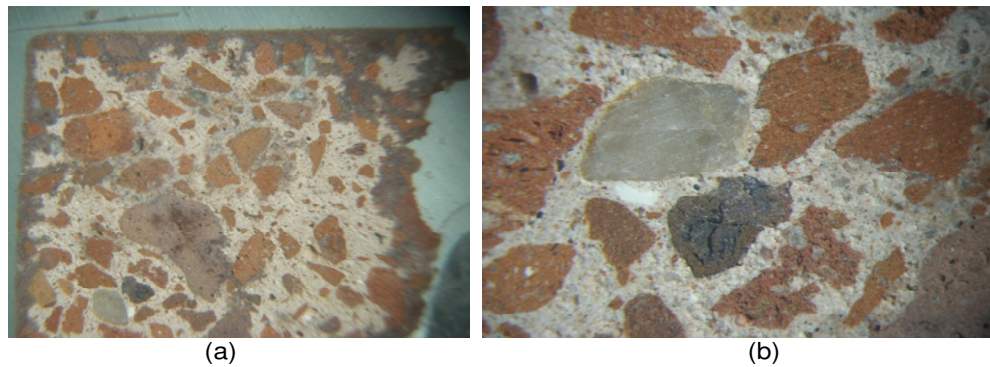
In order to examine the micro structure of the repair mortar produced in laboratory conditions, the thin section analyses were performed in the laboratory of Protection and Conservation of Immovable Cultural Assets Department in Istanbul University. The petrographical analysis was performed on original khorasan mortar samples and repair mortar samples produced in laboratory conditions. As a result of the petrographical analysis, the textures of repair mortar sample were found compatible with the original mortar sample as shown in Figures 4 to 6.

Figure 4. The stereo microscopic photos of the repair mortar sample from surface, (a) 2X magnification, (b) 4X magnification.

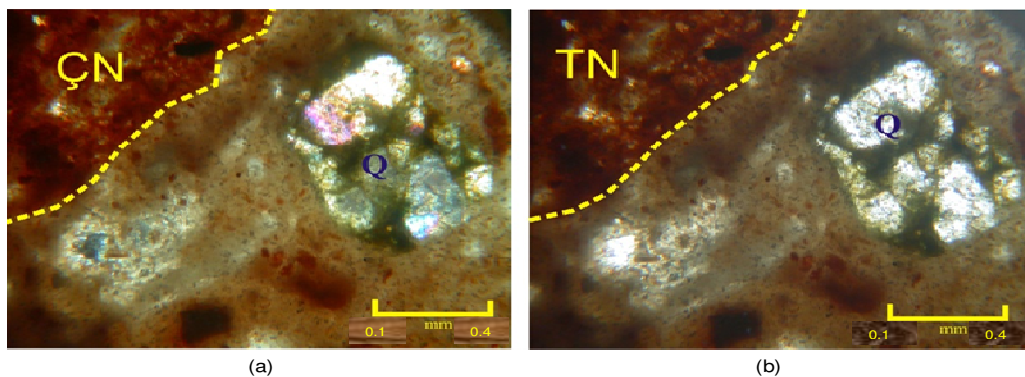
Figure 5. The thin section photos of the repair mortar sample produced in laboratory condition. (a) Double Nicole, (b) Single Nicole.

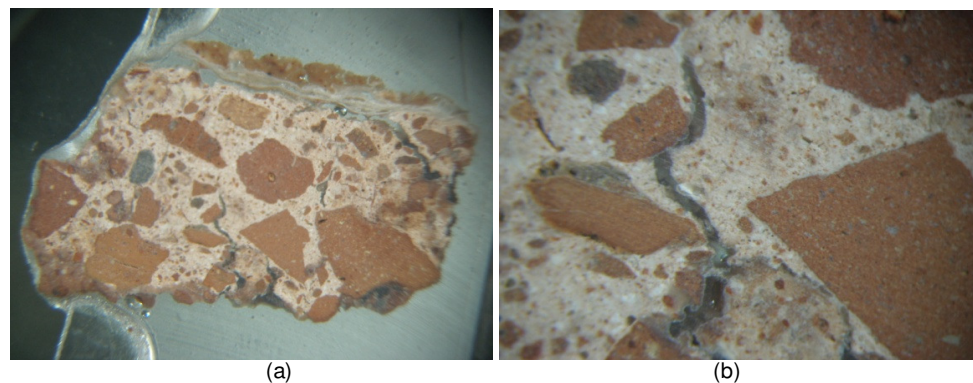
Figure 6. The stereo microscopic photos of the original mortar sample from surface, (a) 2X magnification, (b) 4X magnification.

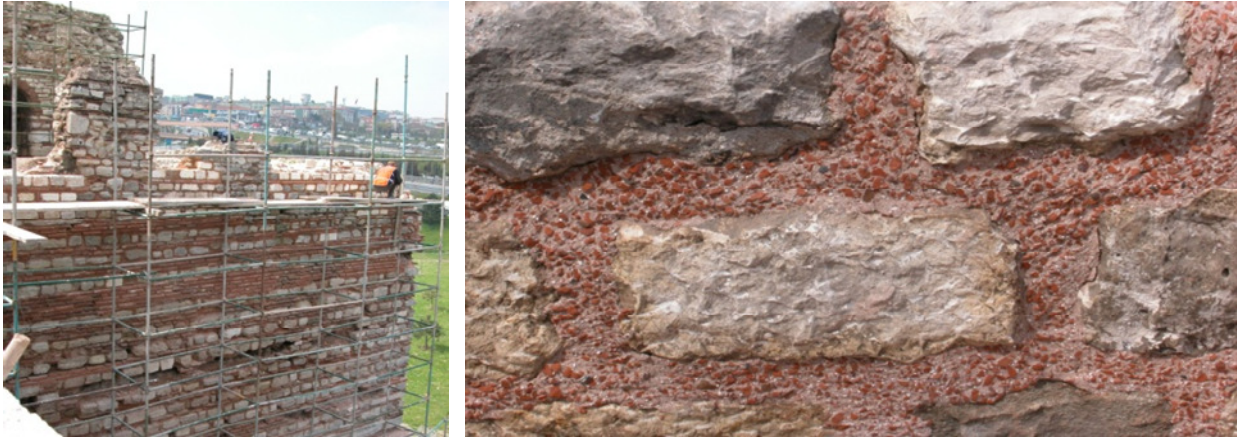
Figure 7. The photos of the repair mortar used during the restoration of Anemas Dungeons (2006).

After, an evaluation of laboratory results are promising, it was decided to produce the repair mortar *in situ* conditions. The repair mortar was produced according to the same mixture ratios and same type of materials determined in laboratory conditions. And then, it was applied on an appropriate wall of Anemas Dungeons (Figures 7 and 8). After one year, it was seen that the repair mortar was much more similar like the originals as color and texture. Even though the wet weather passed, the durability performance of the repair mortar was much better than the previous.

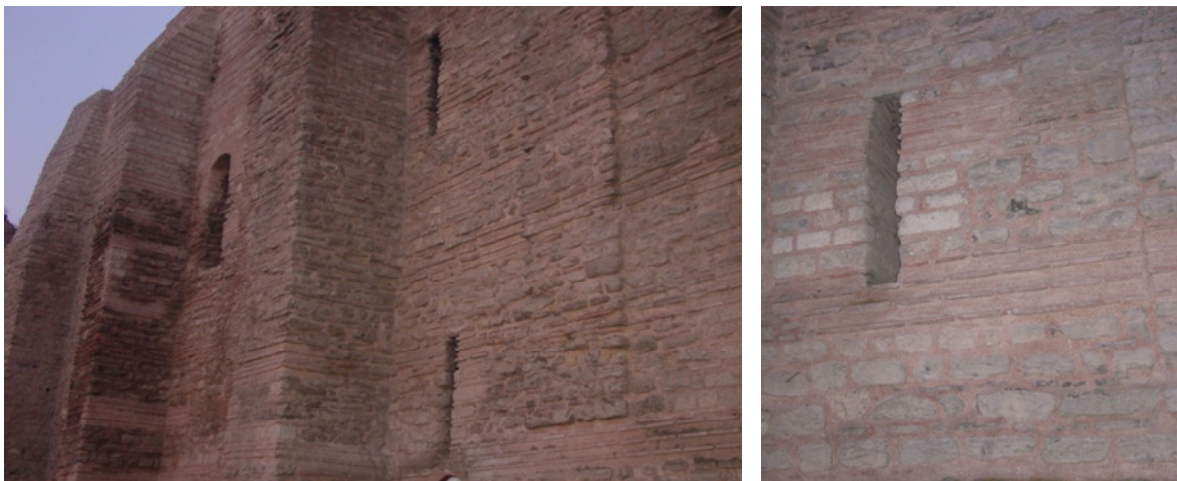
Figure 8. The photos of the repair mortar after one year, during the restoration of Anemas Dungeons.

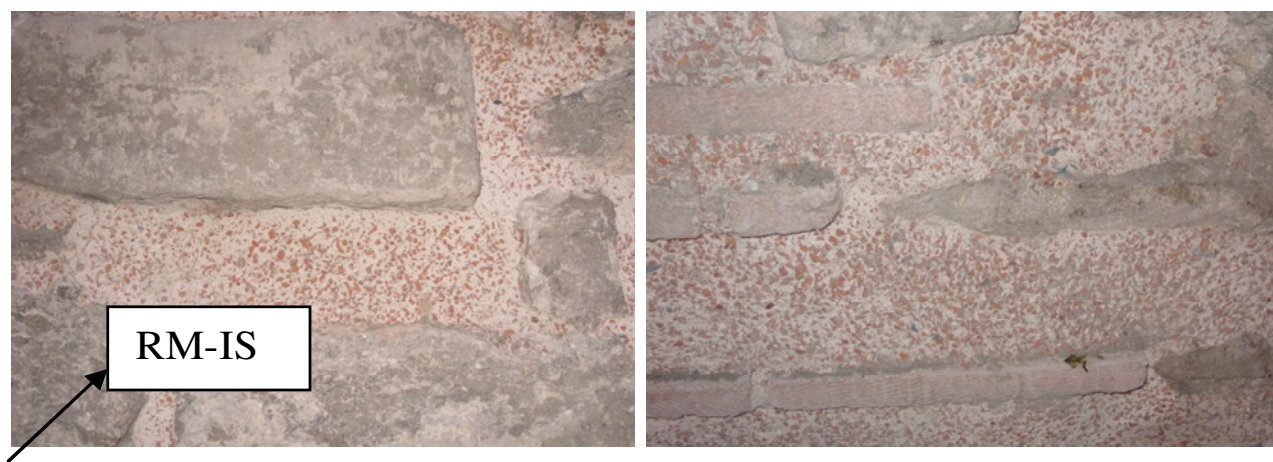
The tests conducted during the previous studies were repeated on the repair mortar samples taken from the structure (Figure 9). These were acid loss, ignition loss, sieve analysis, tests for physical properties and interior structure properties.

Figure 9. Location of the sample taken from the repair mortar which is previously used in the restoration of Anemas Dungeons.

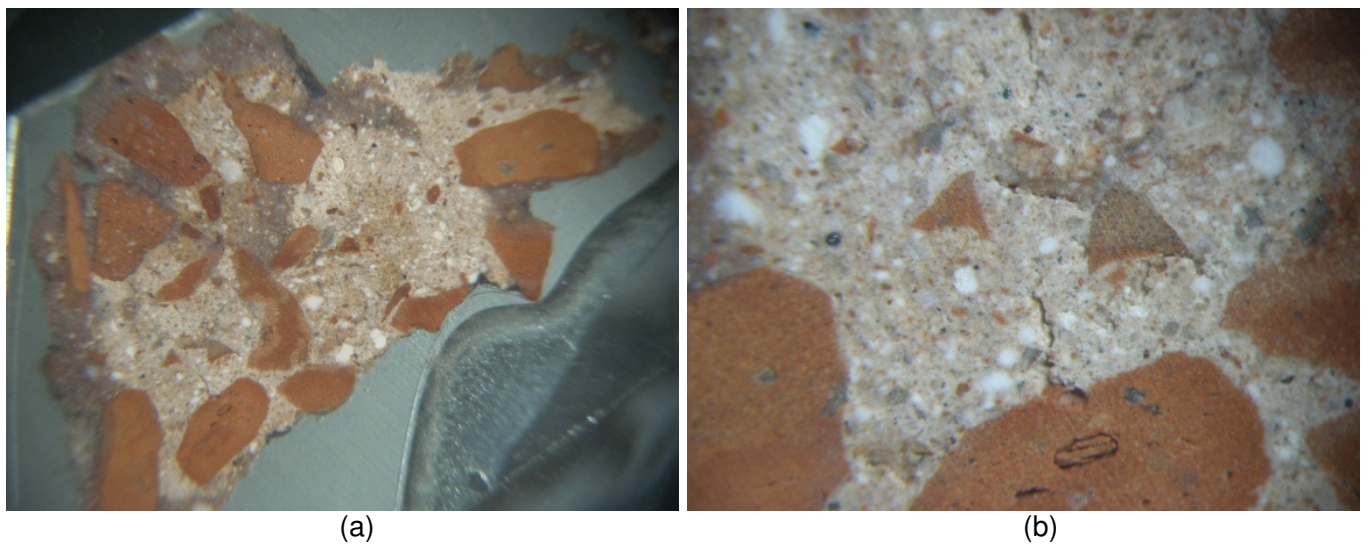
SEM-EDS analyses were performed as shown in Figure 11. SEM-EDS analysis was conducted on the repair mortar sample taken from the structure after 1 year. The results are shown in Figure 12 and Table 5. As Figure 12 is shown, it is been determined that aggregates and matrixes bonded properly, there are interfaces between and in these sections there are structures composed of reticular texture. This texture shows the composition of calcium silicate hydrate. These reactions increase the mortar's durability against atmospheric conditions.

Figure 11. The thin section photos of the repair mortar produced *in situ*, (a - b). 2x and 4x magnifications.

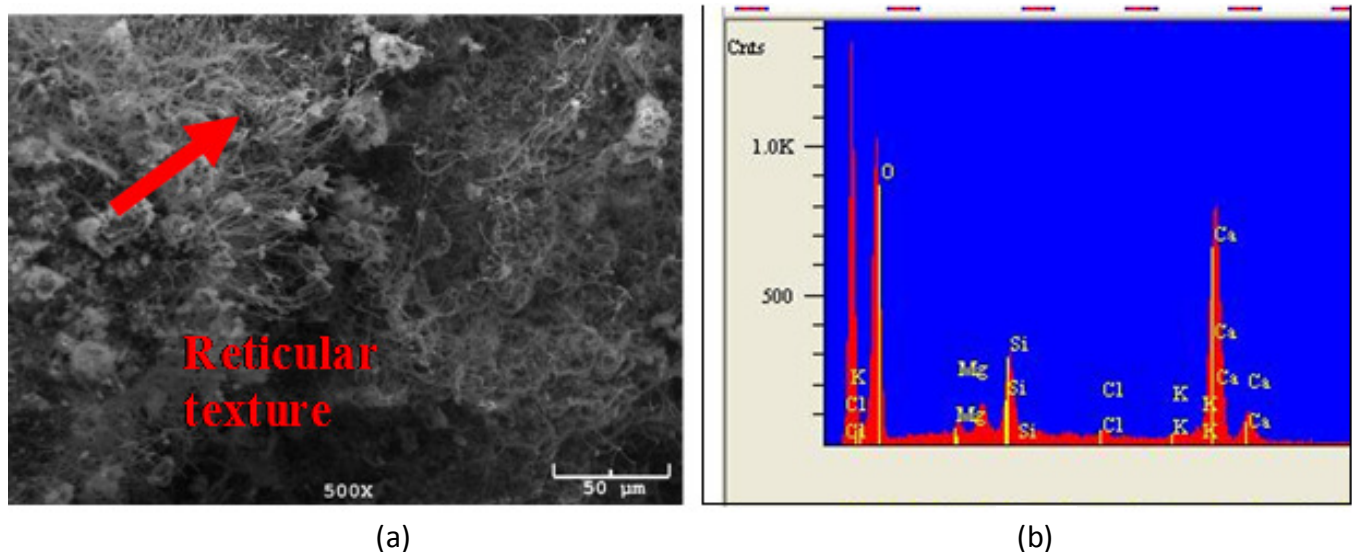
Figure 12. (a) SEM image (500x), (b) EDS graphic of the interior structure of the repair mortar used during the restoration.
