Full Length Research Paper

Investigation of premature fracture of a tail pulley in the field

An unexpected (premature) failure happened in Tail Pulley during operation in field. Consequently, a complete analysis in terms of fracture and fatigue performed. The analysis aimed to determine the failure root-cause by the analysis of the project and materials. The analysis covered the tensions undergone by the pulleys under operation and the material's mechanical strengths. The results showed the project conforms the classical mechanics calculations. The failure, on the other hand, characterized as ductile fracture – Fatigue - with crack propagating along 45° referencing the cylinder longitudinal axis. The crack initiated at a flaw found at the weldment region, which resulted a shorter lifetime (collapsing). The sharpen flaw generated a shortcut in the failure process and jumped it straight to the phase of fracture - Stage II fatigue – called crack propagation.

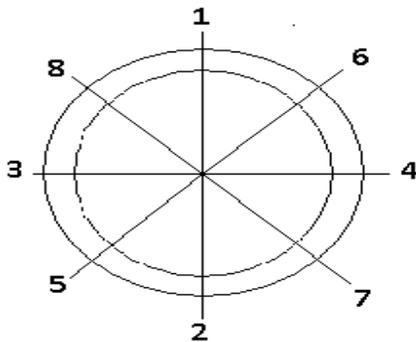
Figure 2. Pulley failed surface mapping.

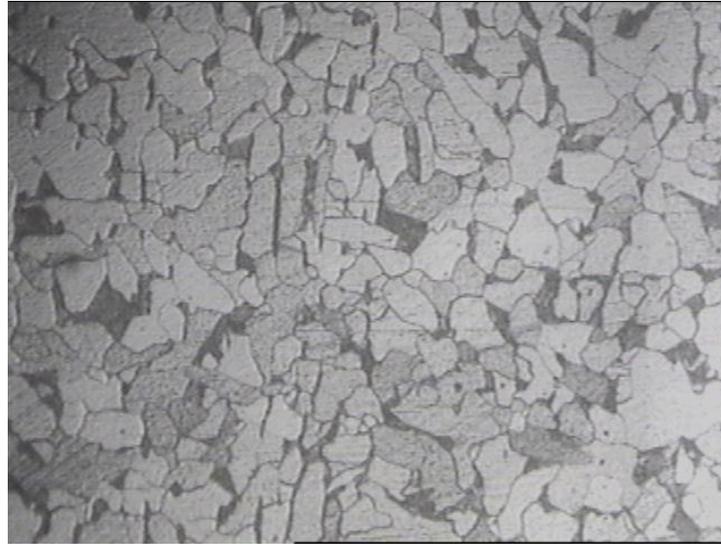
analysis revealed that the materials conforms the standard ASTM A-36. The elements Ni, Cr, Mo, Cu, V, N and Al, as known, are considered residuals into the material, and do not jeopardize its metallurgical or mechanical functions in the application. Figure 3 presents the microstructure of the material A-36 used in the cylinder. Figure 4 presents the same material but now of the discs.

Both, cylinder and disc, present the specified and expected microstructure ferrite and perlite and in accordance with ASTM A36 (Ashby and Cebon, 1993; Metso specification, 1998; Roberts et al., 1988). Any segregation, unexpected microstructure nor cracking were found. The expected hardness at the discs and cylinder are within the specification tolerance. The discs hardness was 135 HB while the cylinder 133 HB, both conform the material hardness specification.

Figure 3. Cylinder - microstructure ferrite and perlite [250X] (Hardness 133 HB) (Specification 119-159 HB).

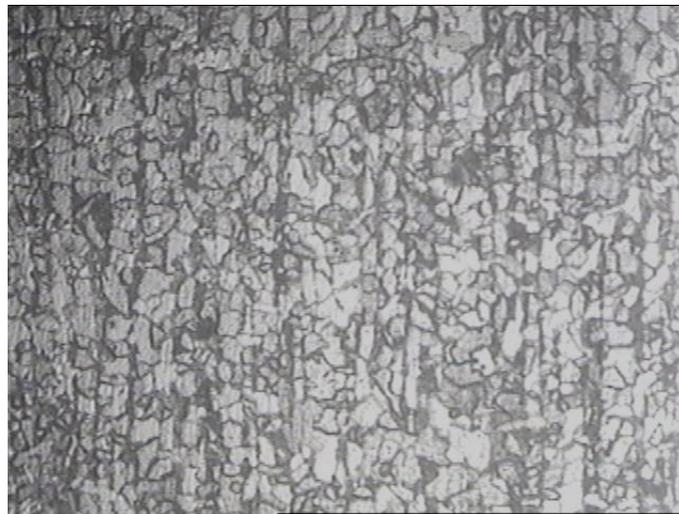
Figure 4. Disc-microstructure ferrite perlite [250X] (Hardness 135 HB) (Specification 119-159 HB).

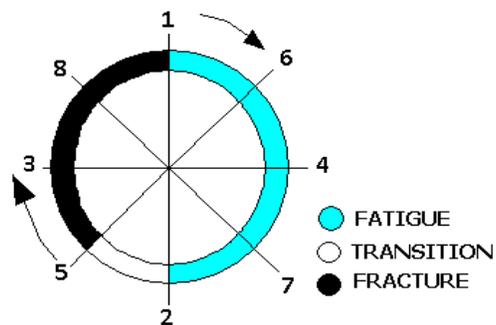
Figure 5 presents an overview of the mapping of the fractured surface of the pulley, while Figure 6 the two broken parts of the pulley rearranged for a better visualization. Figure 7 just ahead shows only one of the shorter pulley failed piece also for a better comprehension.

Figure 5. Failure mapping, based on Figure 1.

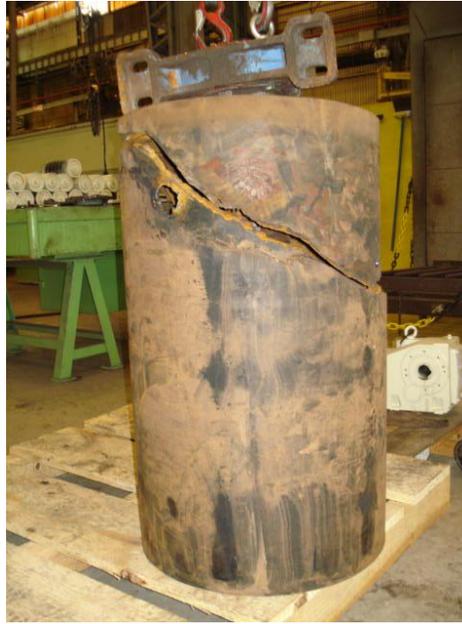
Figure 6. Pulley overview.

From the Figures 6 to 8 seen that the fracture is macroscopically characterized - by naked eye- as ductile fracture due the crack path (crack propagation, phase II) around 45° (Dieter, 2008). The graph in the Figure 7 maps the height of the fractured cylinder measured from the cylinder face, versus its angular position, separating the different zones along the circular area. As seen the maximum height of the cylinder was 292 mm to an

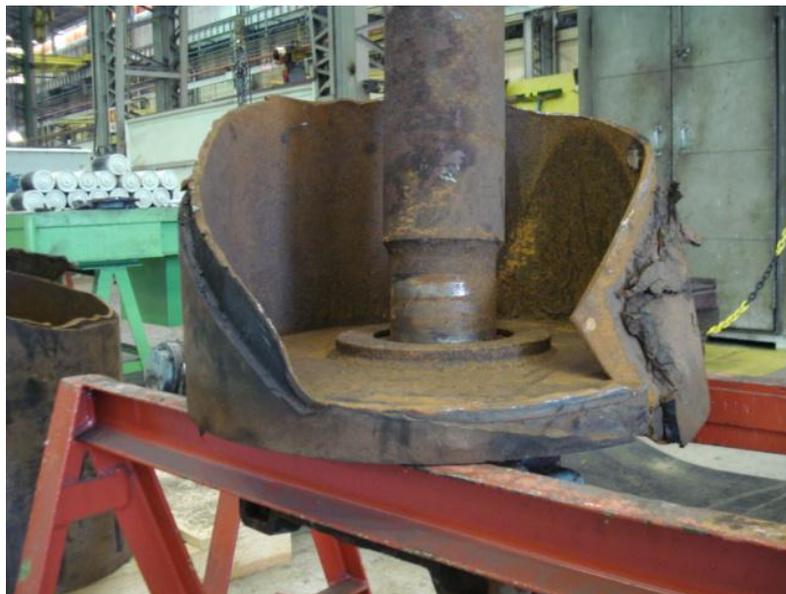
Figure 7. One side of the pulley.

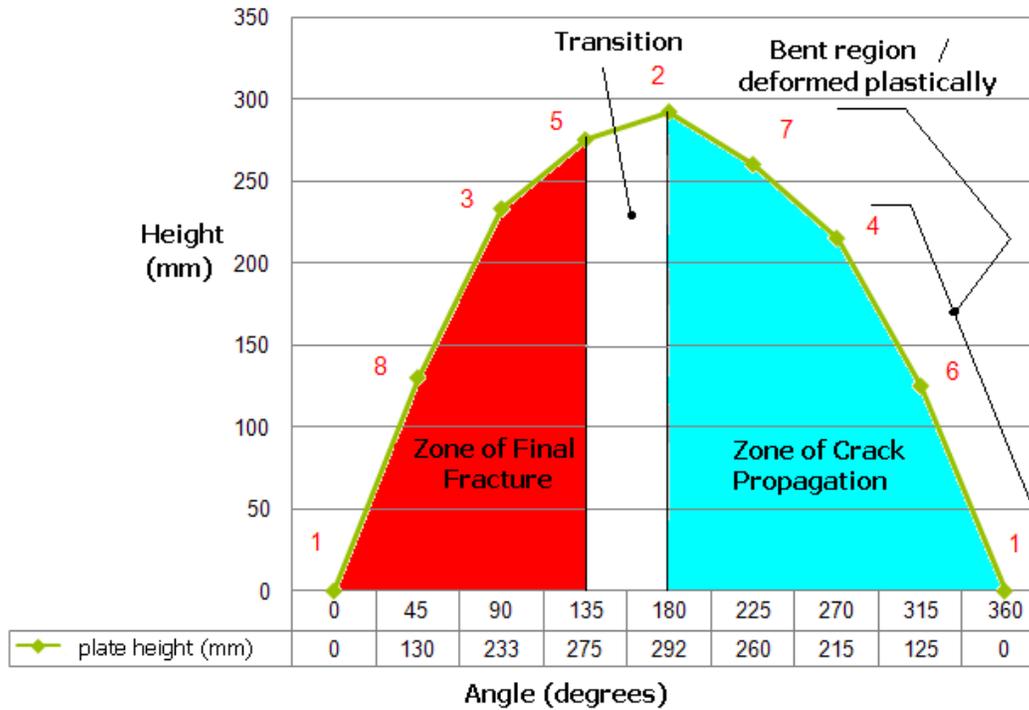
angular position of 180° (Figure 8).

Figure 8. Cylinder plate height.

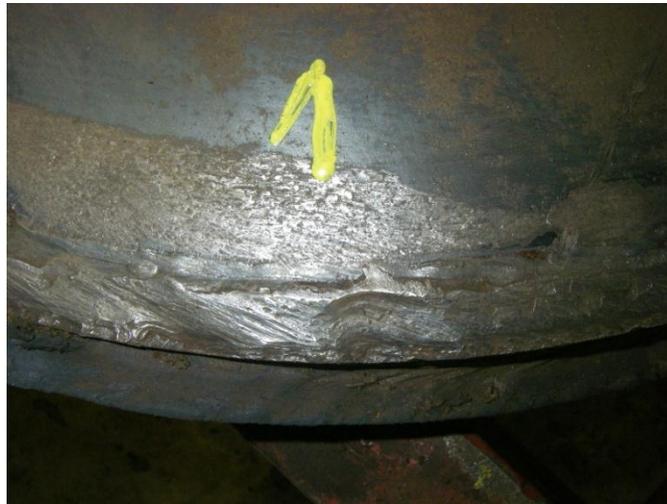
Figure 9. Zone of crack propagation, point 1, failure initiation and crack propagation.

2011). Figures 9 to 11 aims to reveal the aspects of each of the mapping zones identified in the chart of the Figures 5 and 8.

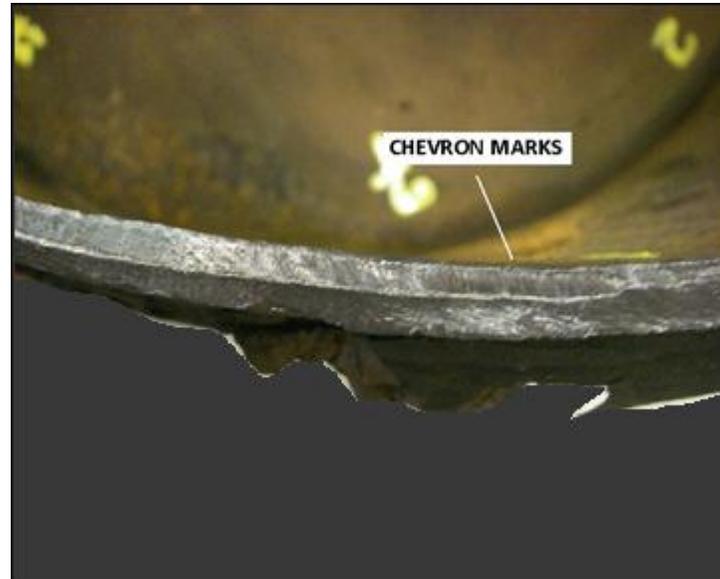
Figure 10. Zone of crack propagation, point 7.

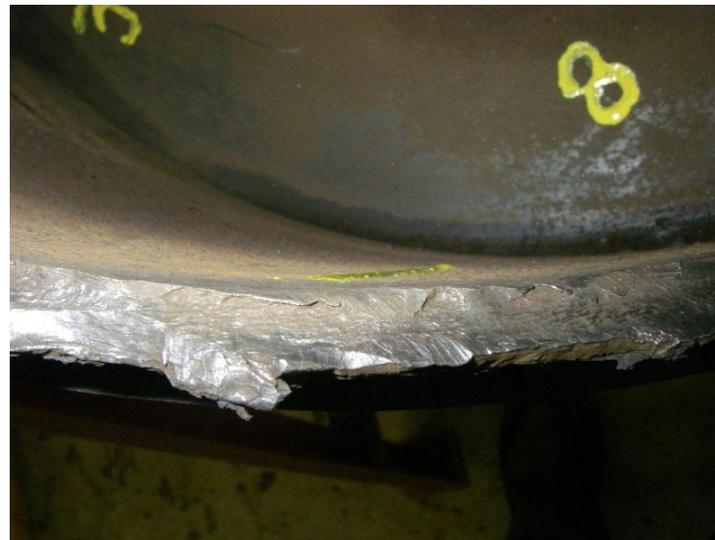
Figure 11. Zone of final fracture, point 8.

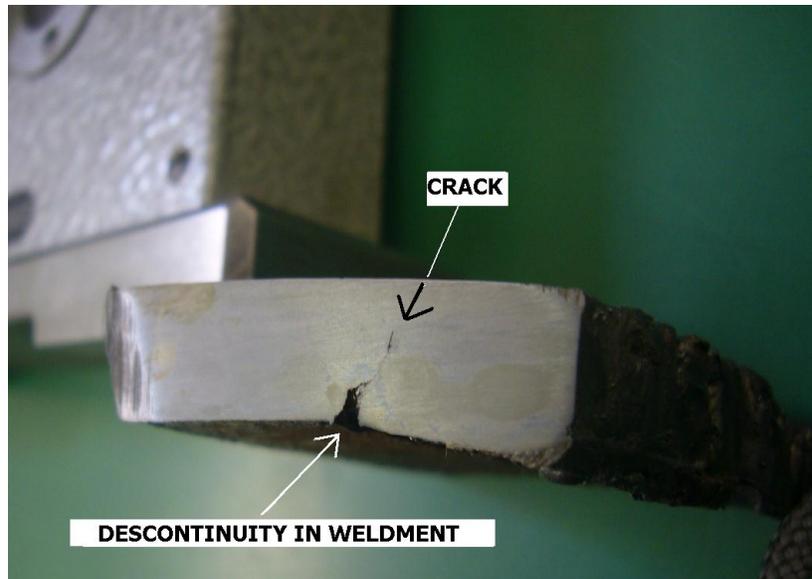
After a detailed investigation at the failure initiation region and taking a small sample from the cylinder to analyze, one discontinuity found in the zone of crack propagation and particularly close to the crack starting point, at the cylinder longitudinal weldment, more

precisely at the interface between disc and cylinder (Figures 12 and 13).

Figure 12. Discontinuity in weldment ($a = 2.5$ mm).

9. The discontinuity presented in the weldment region was the root cause to the fatigue;

It is highly recommendable for pulleys but also for all mechanical parts under cyclic loading to have a detailed manufacturing procedure. This procedure must cover all the processes parameters and follow its monitoring and registration along the manufacturing steps. At this manner a more traceable and reliable product is

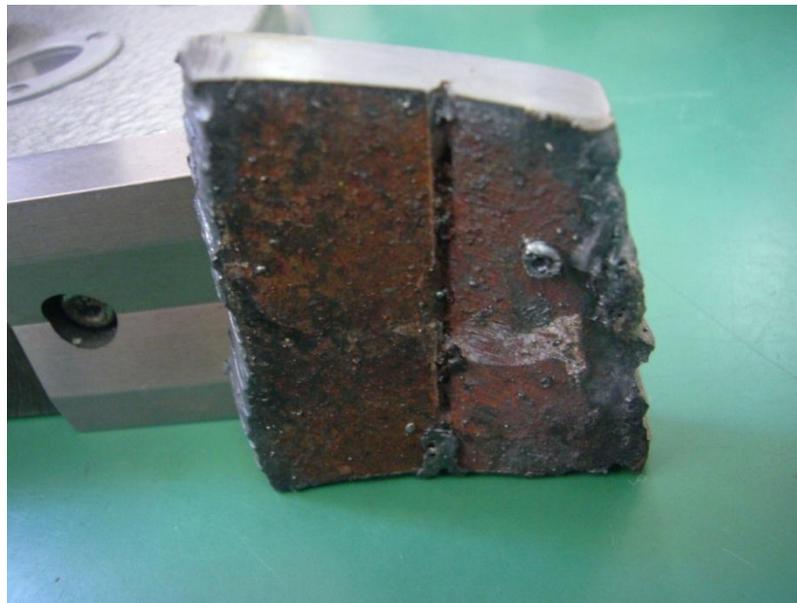
(Figure 13), $a = 2.5$ mm, $c = 100$ mm against $t = 6.35$ mm (cylinder thickness), it does not lead to the final fracture, particularly for brittle fracture. The compilation of high material fracture toughness value (K_{Ic}), big crack size and low stress on the cylinder, based on Equation 1 and Table 1, shows the impossibility of brittle fracture. Therefore, the yielding starts a process of slipping planes at the discontinuity, pre-requisite for the Stage I of structural fatigue, called Crack Initiation.

Figure 13. Discontinuity in weldment ($a = 2.5$ mm; $2c = 100$ mm).

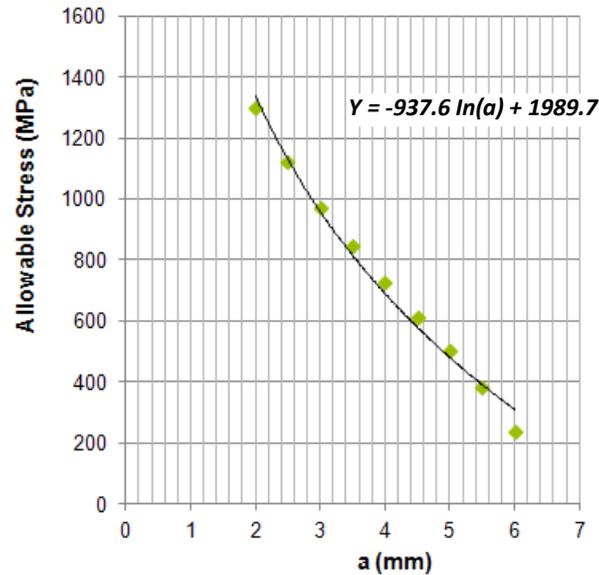
Figure 14 reveals that the crack dimension despite of being large when compared with the cylinder thickness

Figure 14. Allowable stress versus crack size.

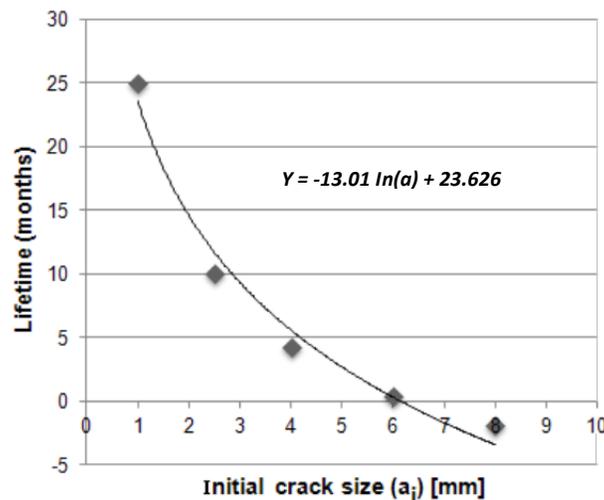
speeds up the failure process. The same figure makes clear that flaw (considered stress raisers) with dimension equal of 3.0 mm theoretically results in a lifetime of 10 months. For flaws equal or bigger than 6.0 mm these will not support the application. It means, when loaded into the conveyor the component fails whether just starts being cyclically loaded.

The customer traceability record demonstrates the pulley real lifetime under application in the field as 09 months, pretty close to the theory applied in the analysis.

Figure 15. Pulley lifetime versus crack size.
