Journal of Geography and Regional Planning

Volume 7 Number 5 July 2014

**Socio-economic effect of gully erosion on land use in
Gombe Metropolis, Gombe State, Nigeria** 97
Aliyu Danladi1* and H. H. Ray2

An analysis of some soil properties along gully erosion sites under different land use areas of Gombe Metropolis, Gombe State, Nigeria

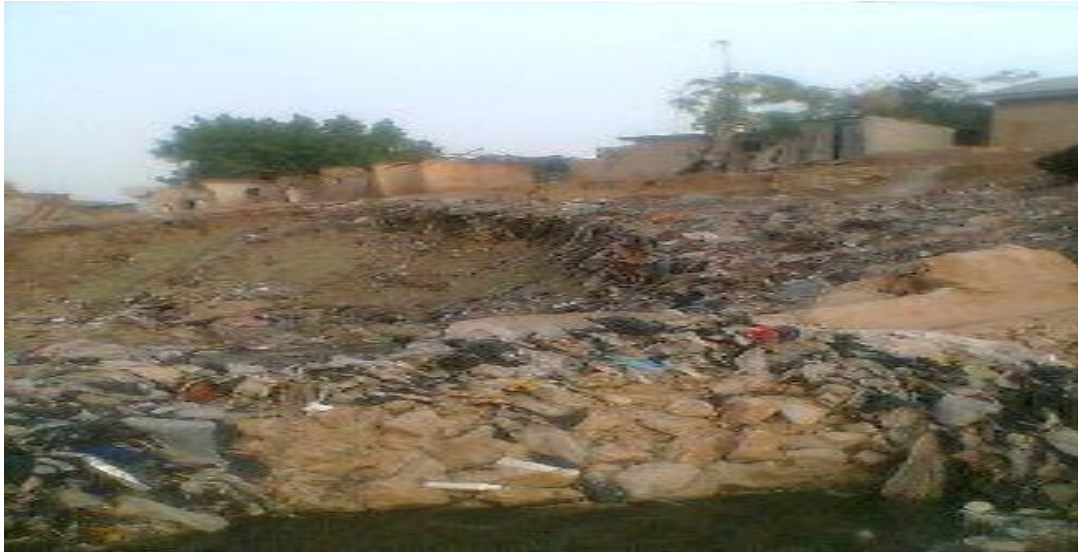
Plate 1. View part of houses destroyed at Herwagana by gully erosion
Source. Fieldwork, 2011.

destroyed by gullies are directly affected within the residential land use, but a total of four persons were affected by gullies in the agricultural land use and none identified to be directly affected in the other two land use areas (commercial and educational). Cracking and falling of buildings and other physical structures into gully sites are common features in the erosion prone areas within the study area. Shown in Plate 1.

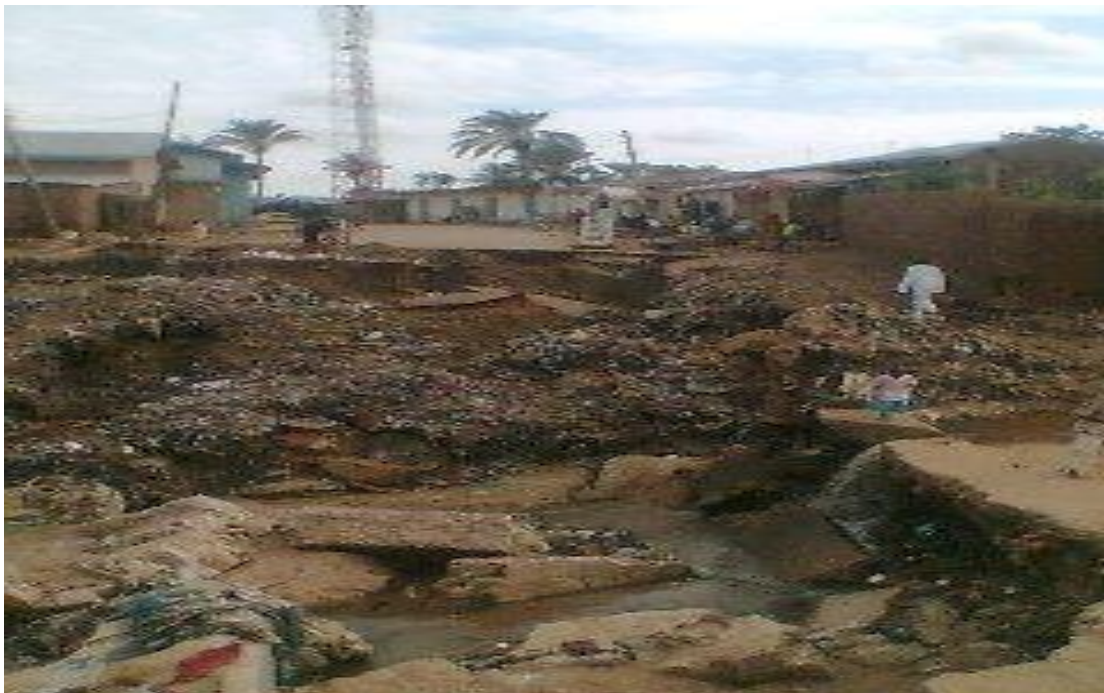
Plate 2. Bello Sabo Kudi road/ bridge destroyed by flooding in 2004.
Source. Field work, 2011
