Assessment of technical conformity of bench terraces for soil erosion control in Rwanda

The purpose of this paper was to evaluate technical conformity of bench terraces in the Eastern Province of Rwanda. A sample of 180 actual bench terraces from 12 sites located in this Province was tested against technical standards and models provided for by the Ministry of Agriculture of Rwanda and Food and Agriculture Organization of the United Nations. The results showed that many sites have been constructed with no consideration of these technical guidelines. Terraces were built on land slopes lower or higher than standards while terrace riser slopes above 90% and height above 2.9 m were frequent. Findings indicated weak correlation coefficient ($r=0.314$), although very significant, between field-measured and Agriculture Organization model-computed vertical intervals, and very weak but significant correlation coefficient ($r = 0.194$) between terrace measured and model-derived widths. In such circumstances, land terracing might have increased risks of landslide and erosion with no sustainable benefit for soil erosion control and crop production.

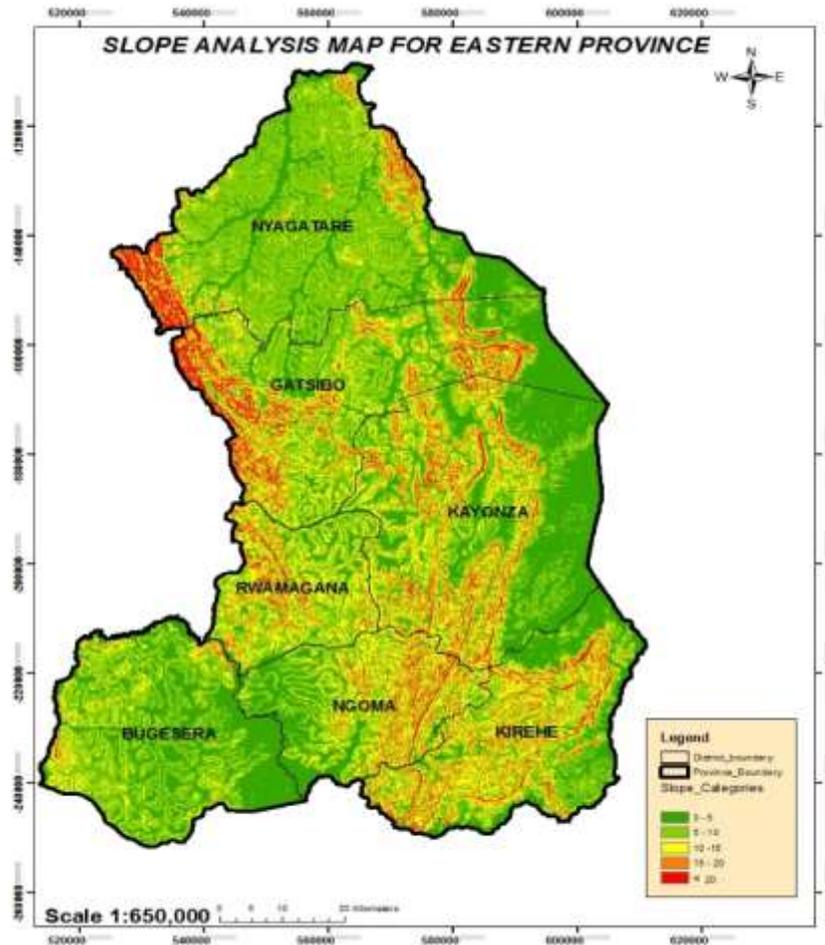
Figure 1. Slope analysis map of the Eastern Province.

The research was carried out in Eastern Province of Rwanda. The land surface of Rwanda is 26388 km² and the country has a population of about 11.78 million (National Institute of Statistics Rwanda (NISR), 2012). The least densely populated districts are found in the Eastern Province. The country is very hilly with steep slope lands and devastating soil erosion exacerbated by over stripping, deforestation, and inadequate use of land improvement techniques (National Institute of Statistics Rwanda (NISR), 2012). The soils of the eastern Province are naturally fragile. They result from the physical and chemical alteration of schistose, quartzite, gneiss, granite, which forms the surface geology of the country. The general geomorphology is a plateau characterized by localized steep slopes (Figure 1) which causes erosion and landslide (Ministry of Lands, Environment, Forests, Water and Mines 2004).

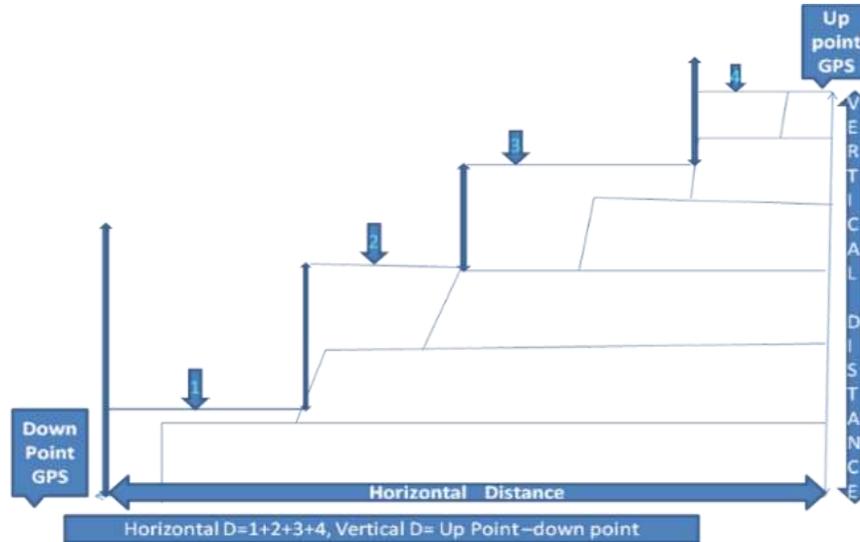
Figure 2. Site slope measurement

(i) Slope of land was measured as the ratio of the horizontal distance of the land (Figure 2), and the vertical distance as follows:

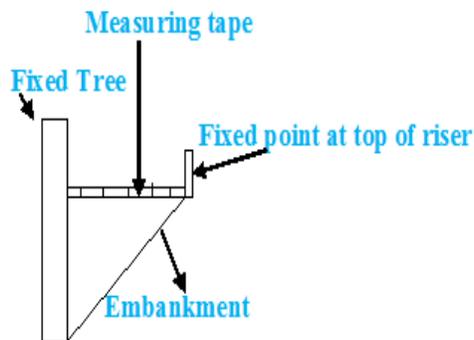
(iii) The slope of risers: The slope of risers were measured on 15 terraces of the up as the samples, the medium terraces and the lower terraces means 5 terraces for each level and the mean was made for each site and calculated. Figure 3 shows the procedure used in measuring of slope of risers.

Figure 3. Measurement of embankment slope.

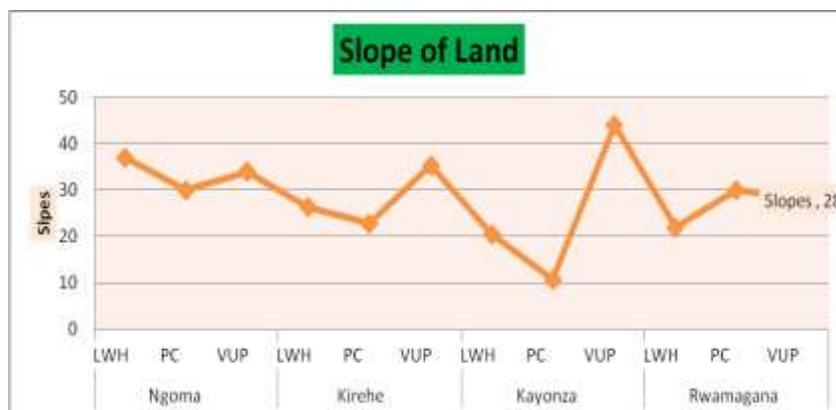
Figure 4. Mean slope of the study sites as monitored for each implementer by District

Land slope determination is the imperative criteria in selecting soil conservation and management practices for soil erosion control. In that regard, Figure 4 illustrates the study site mean slopes for each implementer (LWH, VUP and PC) by district. The results refer to the measured mean slope of terraced sites in eastern Rwanda by implementer for each one of the four Districts.

terraces. The study results in this paper as presented in Figure 4 indicated that bench terraces were chosen regardless of the land slopes for some sites. Land slope steepness is above or below recommended levels for terraces. That is notably true for terraces located in Kayonza district where some were constructed on 44% slope gradient while others were established on 11% slope gradient. The success of terraces above 40% slope

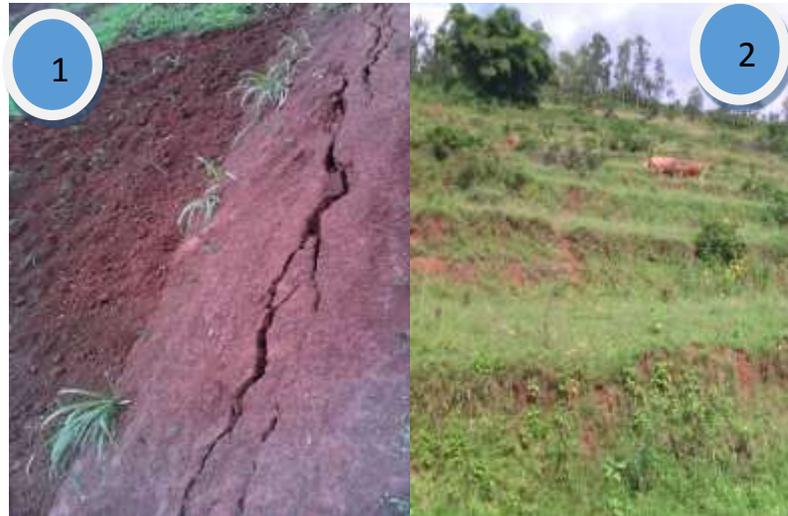
Plate 1. (1) The embankment started cracking few weeks after terracing, (2) abandoned terraces are actually used as pasture land
Source: Field Data (2015)

Concerning the riser slopes and heights, the results field-measured or calculated from field collected data showed that about 85% of investigated terraces have not complied with the established norms. In general, the inclination of riser slope between 30 and 60% results in stability and sustainability of terrace embankments while steeper risers should be planted with grasses to give them same stability (FAO, 2013). The assessment results indicated that, for most of sites constructed by private companies and VUP program, terrace risers are beyond recommendations established by LWH and FAO. Embankment slopes of 77 and 90%, instead of 60 to 70% as recommended by LWH and 30 to 60% recommended by FAO, were surveyed in some sites of Rwamagana and Kayonza. Thus, steeper riser is runoff-prone or subject to land slide. It is also an indicator of poor quality embankments which in the future can lead to sudden embankment collapse and destruction. The embankment gets more fragile as the riser height increases (Sheng, 2002). Tied closely with slope gradient is the gentle slopes receiving storm runoff from above which may have a much higher erosion hazard than very steep slopes near a ridge top. Brian (1990) stated that the experience shows the overall height of a riser should not exceed 1.8 to 2 m; above which the maintenance work will become difficult (Azene, 2011).

It is obligatory to shape and plant grasses as soon as possible after cutting a terrace. Field observations have shown that some sites were well protected (for instance those constructed by LWH), while many terraces constructed by VUP and CP are not well protected at all. The sites constructed by LWH are well maintained, some of them are projected by fruits trees and agro-forestry trees. Although tall grasses may produce considerable forage for cattle, they require frequent cutting and attention. The rhizome-type of local grass has proved very successful in protecting risers. Stones, when available, can also be used to protect and support the risers (FAO, 2013; Sheng, 2002). Risers require regular care and maintenance. If a small break is neglected, large-scale damage will result (Sheng, 2002).

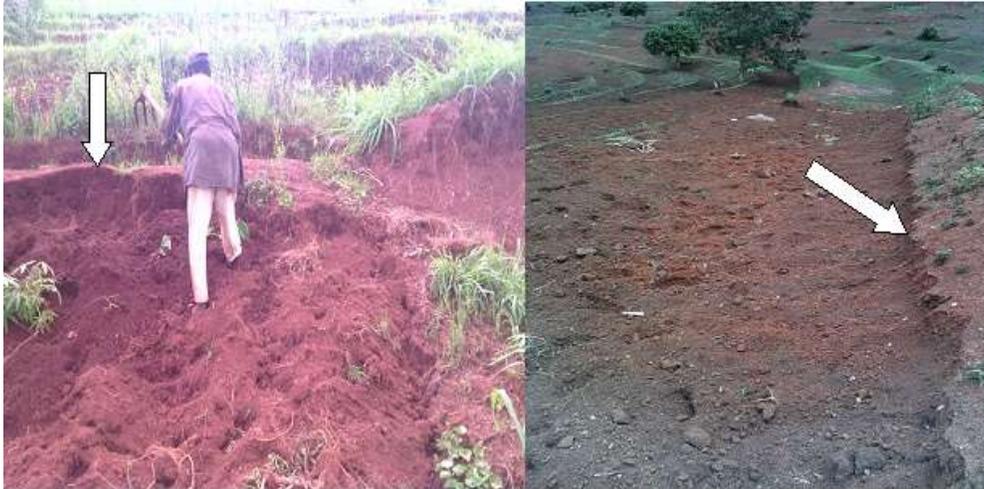
Plate 2. The old and new risers destroyed by farmers for increasing the cultivation area (photo taken on the field)

From the field results, the mean inward bed slope values range from 2.3 to 3.6%. These results are in range with recommended values; but if we consider site by site, several concerns are raised: some terraces constructed by VUP and PC are subjects to destruction by farmers' activities, few of them have been made outward instead of inward slope, some are used by farmers for burning charcoal (Plate 2) and free-grazing their cattle graze (Plate 3).

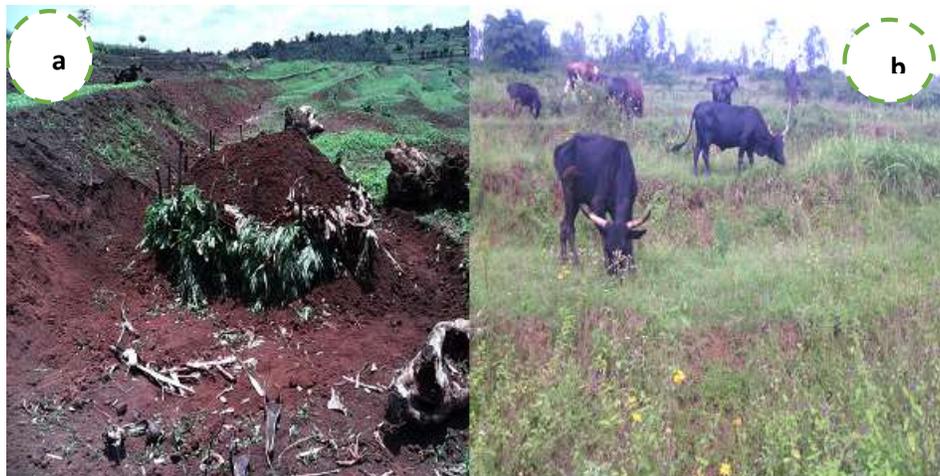
Plate 3. a) The farmers started burning charcoal on new terraces, b) the cattle grazing on bench of terraces (photo taken on Mugesera and Mushasites-Rwanda).
