Full Length Research Paper

Environmental damages of forest road construction by bulldozer on steep terrain

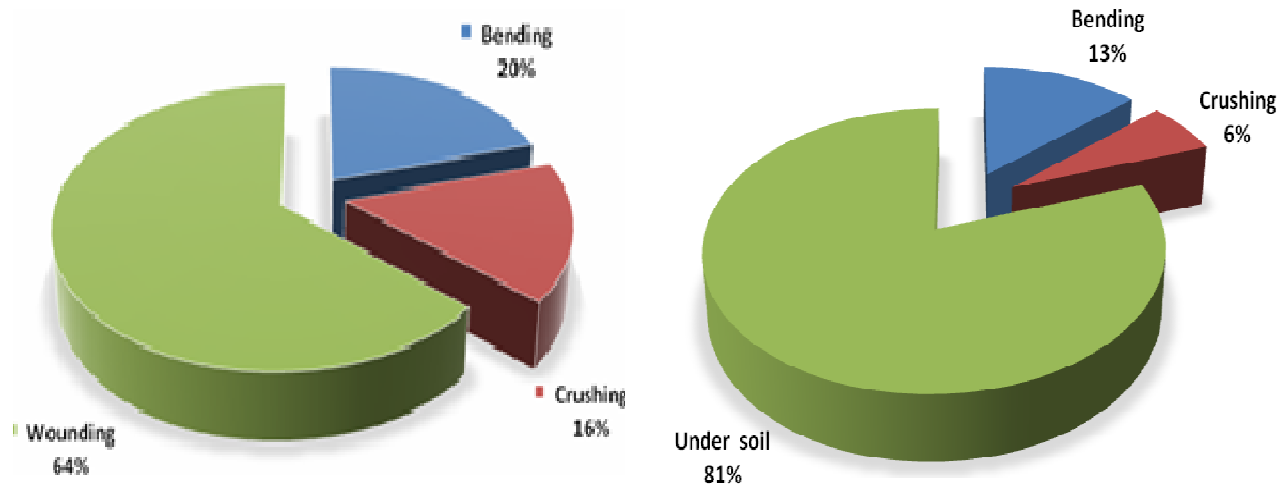
Figure 3. The rate of damages on trees and seedlings.

In this study, 36% of trees under the forest road construction were wounded and 43% of seedlings stayed under the soil for 56-80% ground slope. The portion of wounding in three type damages was 64%. The portion of stay under the soil was 81%. In a similar study conducted by Tunay and Melemez (2004) in Antalya, 55% of trees under the forest road construction in terrain further than 51% of ground slope were damaged.

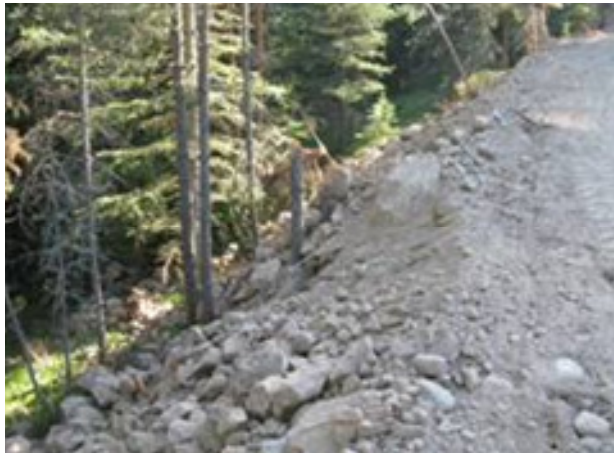
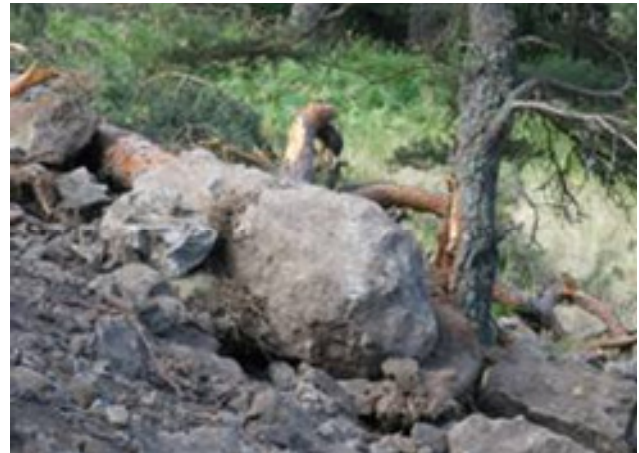
Figure 4. Environmental damages.

types namely bending of tree, crushing of tree and wounding of tree stem. The resultant damages at seedlings were three types. These types are bending of seedling, crushing of seedling and stay under soil of seedling. The number and rate of damaged trees and seedlings in study areas are showed Tables 3 and 4. The percent of damages as wounding, bending and crushing for trees are 64, 20 and 16%, respectively. Besides, the percent of damages as under soil, bending and crushing for seedlings are 81, 13 and 6%, respectively (Figure 3). The bark beetles can occur to damaged trees during road construction. The species of showing bark beetle in this region is *Pityokteines curvidens* (Germ). These beetles were composed to big damaged in this forest region. Thus, direct economic loss was increased on timber quality. The damages of road construction is showed Figure 4.

In this study, conifer trees in stands under road during forest road construction were damaged further than hardwood. Besides, wounding of trees bark is observed to thick diameter trees. Bending and crushing were observed to thin diameter trees. Environmental damages were affected by following factors; gradient of terrain, tree
