Full Length Research Paper

Comparisons of environmental effects and productivity by road construction machines in forest areas in Turkey

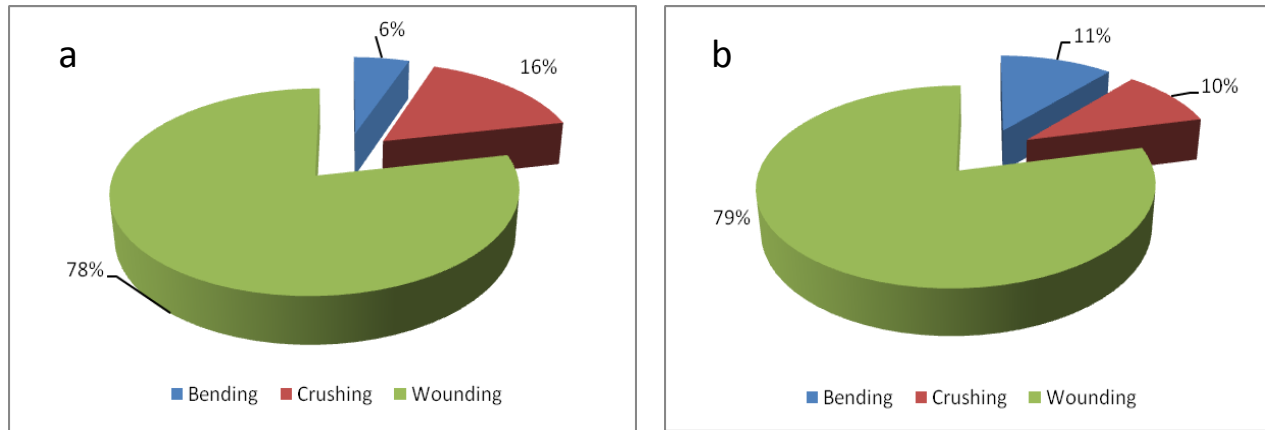
**Figure 3.** The percent of damages in (a) Aykırıcay and (b) Seyitgazi.

respectively. The damage rate of excavator is 23% and the damage rate of bulldozer is 40%. In the forested areas with greater than 55% ground slope, all excavated materials are scattered down than roadway by bulldozer. This situation of the roads is causing increase of damages. The percent of damages as wounding, crushing and bending for trees in Aykırıcay and Seyitgazi are 78, 16, 6% and 70, 10, 11%, respectively (Figure 3). In every study areas, the bark beetles can occur to damage trees after road constructions. These bark beetles caused big damages in these forest regions. Also, direct economic loss is increased for timber quality. The damages of road construction are shown in Figure 4.

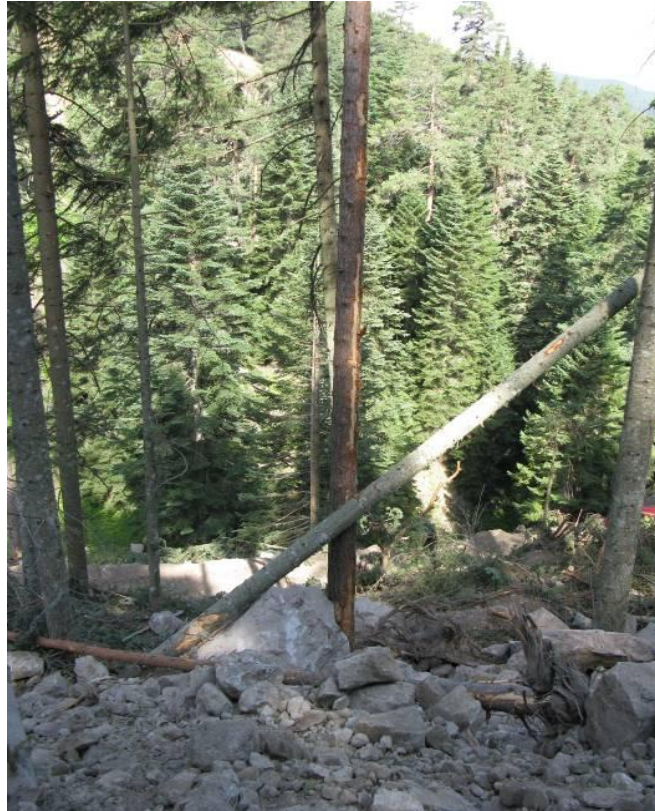
Figure 4. Environmental damages during forest road construction.
