Full Length Research Paper

Spatial analysis of elements at risk and household vulnerability to landslide hazards on Mt. Elgon, Uganda

S. Ratemo* and Y. Bamutaze.

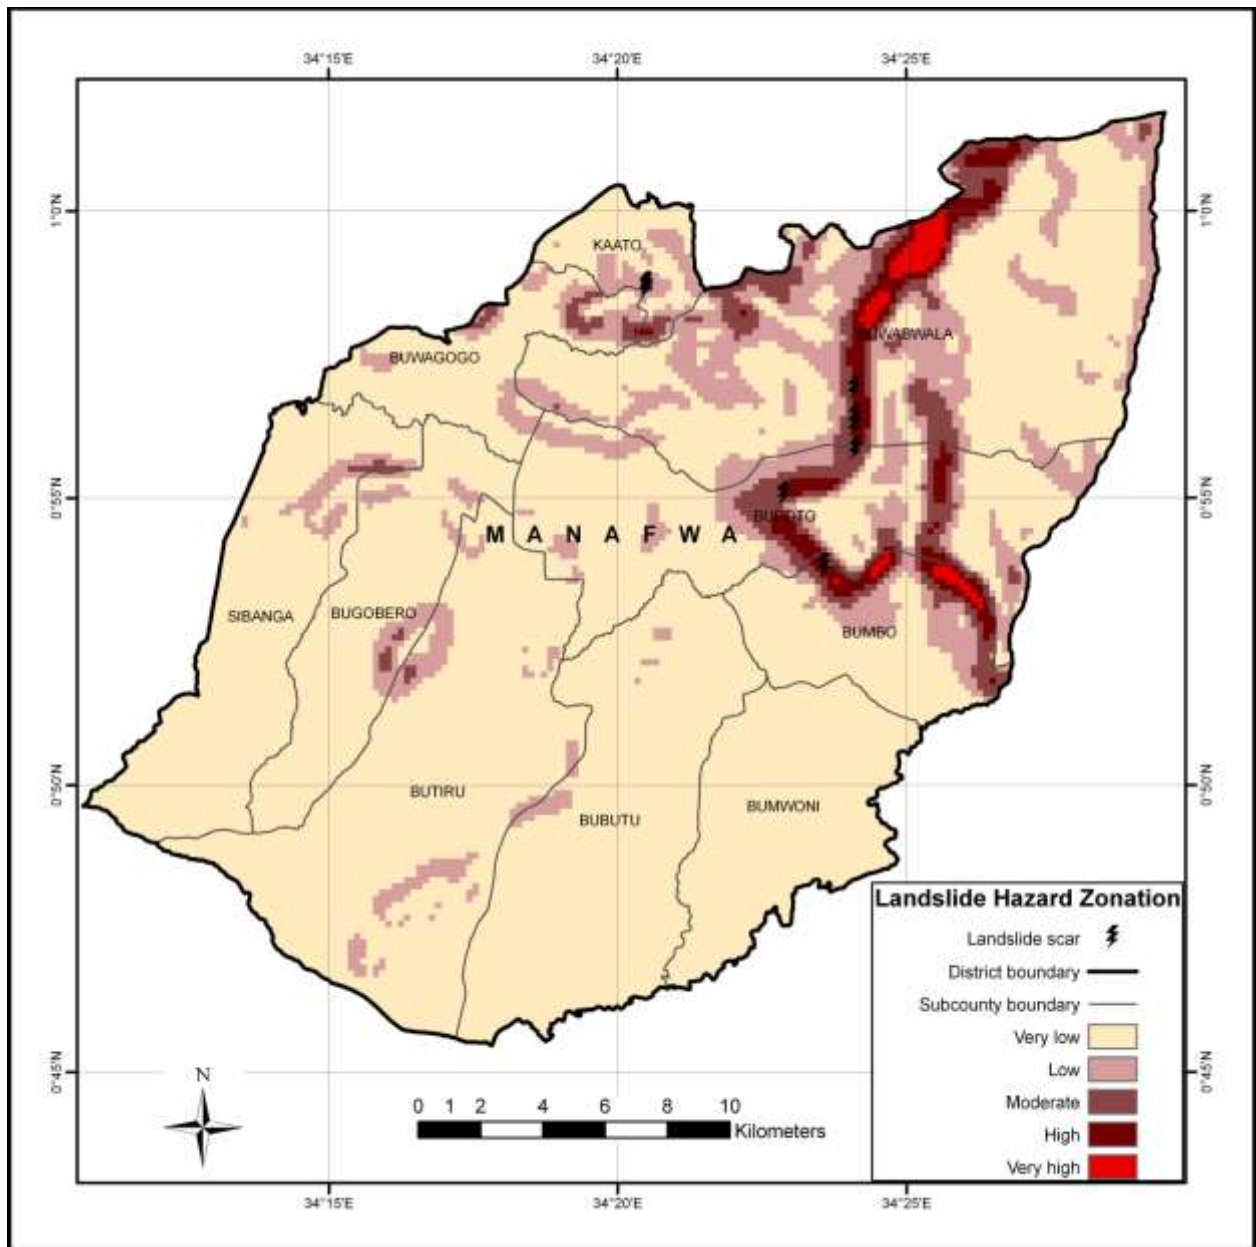
Figure 2. Landslide vulnerability map.

Using five classes of percentage increase of slope gradient (0 - 15, 15 - 25, 25 - 35, 35 - 45 and 45 -60°) and in relation to elevation, a hazard map (Figure 2) revealed the presence of very highly vulnerable areas (mostly encroached forest land) on altitude ranging from 1800 to 2000 m above sea level. This zone was characterized with a number of landslide events in the past years. Research finding indicates those areas with slope gradient ranging between: 35 - 45, 25 - 35 and 15 - 25° to be highly, moderately and lowly vulnerable to landslide, respectively. However, there were human settlements on both very high and highly vulnerable areas; this may be

The ranking metric used for each of the vulnerability indicators is shown in Figure 2.

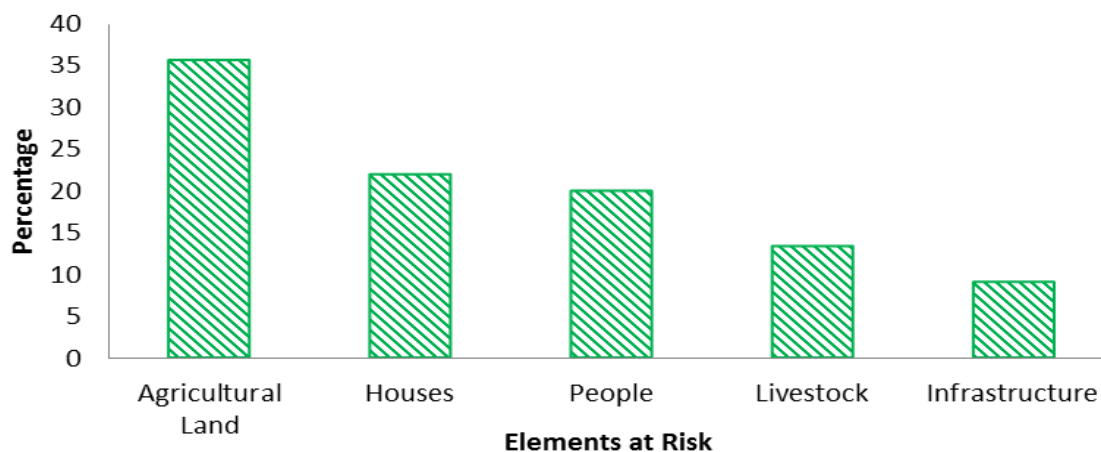
Figure 3. Elements at risk due to landslide.

The identified elements at risk to landslides in Manafwa District were; agricultural land (36%), houses (22%), people (20%), livestock (13%) and infrastructure (9%). Their quantitative and spatial extent is illustrated in Figures 3 and 4, respectively. Agricultural land is the most affected due to cultivation on the steep slopes of Mt. Elgon coupled with other anthropogenic factors. Houses and People accounted for almost the same count due to the correlation existing between the two elements at risk, whenever houses are affected, people are equally affected. The community members within the study area mainly cultivate crop with limited number of livestock (31% of the sampled population had livestock). Infrastructures in the study area are poorly developed and or not available in some area. They include: Community access roads, churches, mosques, maize mill and store, community wells, spring and water tanks. All sampled house had no piped water or electricity. The access roads to the study area are poor and in many areas it is totally non-existence hence less affected by landslides.

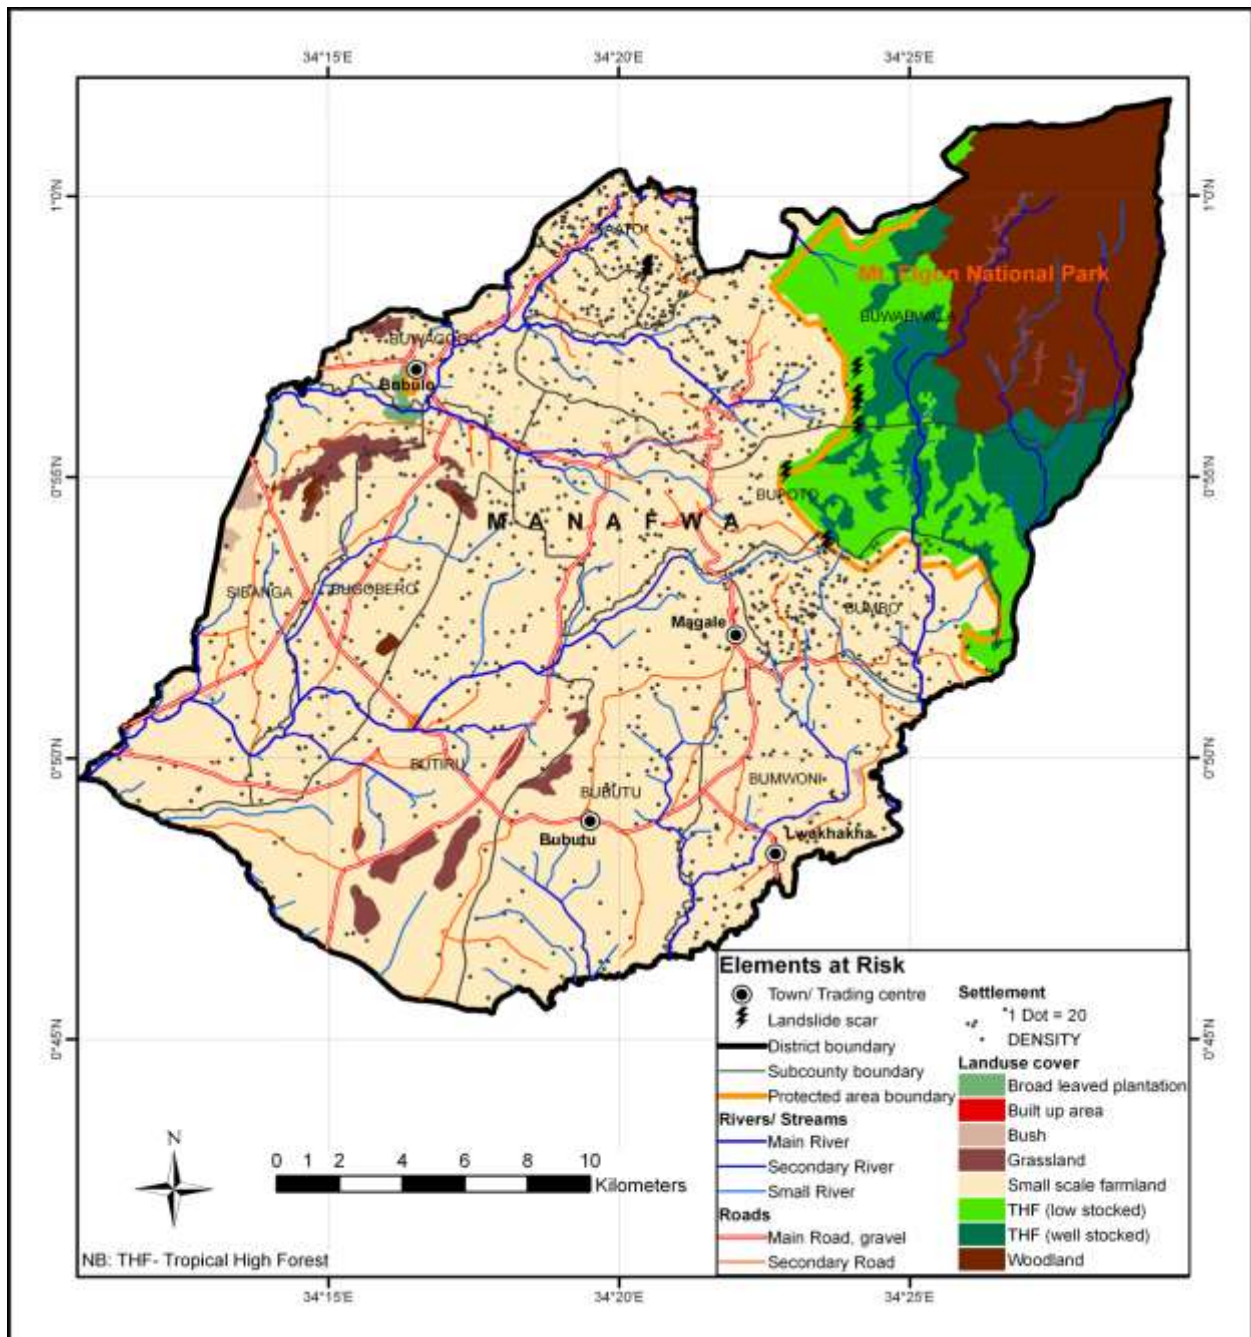
Figure 4. Spatial location of elements at risk.

In order to show the vulnerability level of community members to landslide hazard, a map showing elements at risk was overlaid with a hazard map to form an

integrated map (Figure 4). Areas bordering Mt. Elgon National Park were identified as landslide prone areas; these areas were zoned out as “high and very high” zone. Different elements at risk within the study area (Table 1) revealed that there were no Trading Centres, water points and road within high and very high hazard zone. However, there were 6, 19 and 91 households within very high, high and moderate hazard zones respectively.

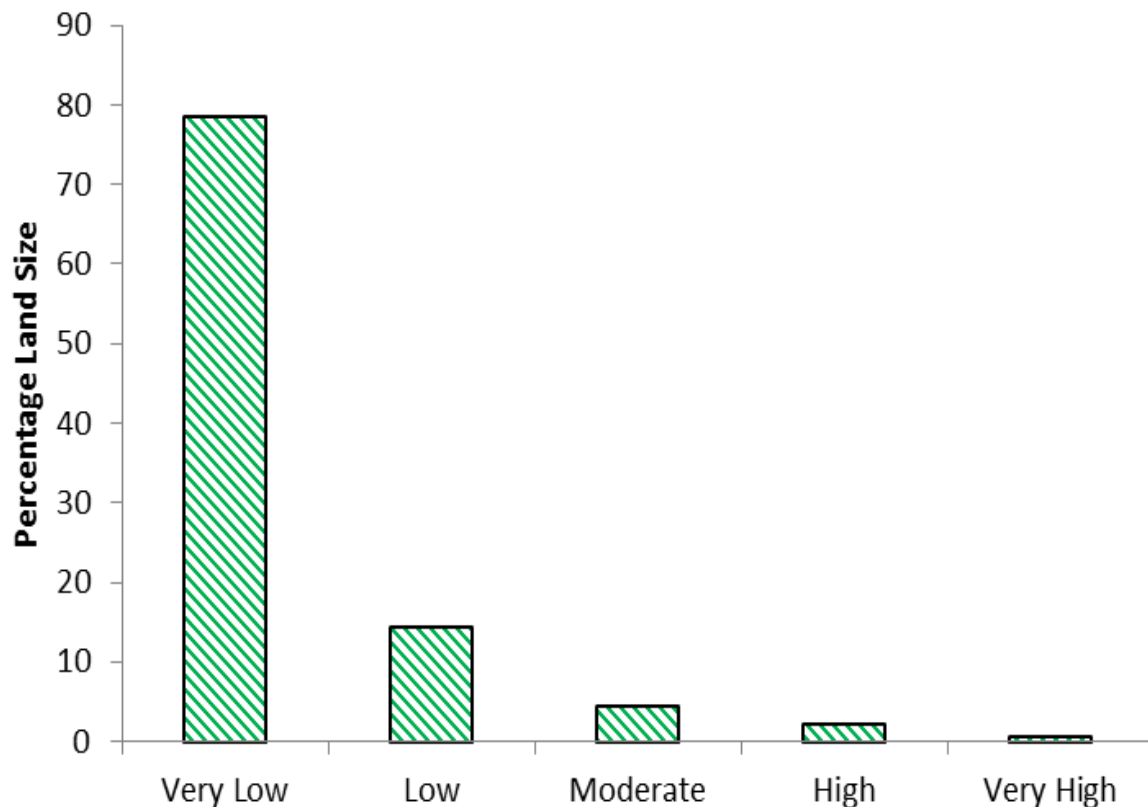
Figure 5. Land size coverage at different hazard zonation.

Evaluation of the percentage coverage of the land area (hazard zonation) revealed that the large percentage of the area is very lowly (78.4) vulnerable to landslide, followed in the sequence from low, moderate, high and very high with percentage coverage of 14.4, 4.5, 2 and

0.6% (Figure 5). However, the lowly vulnerable areas are less congested (population) compared to high and very high areas.
