*Full Length Research Paper*

# Troubled roads: Application of surface geophysics to highway failures of the sedimentary terrain (Iruiekpen-Ifon Road) of Edo State, Nigeria

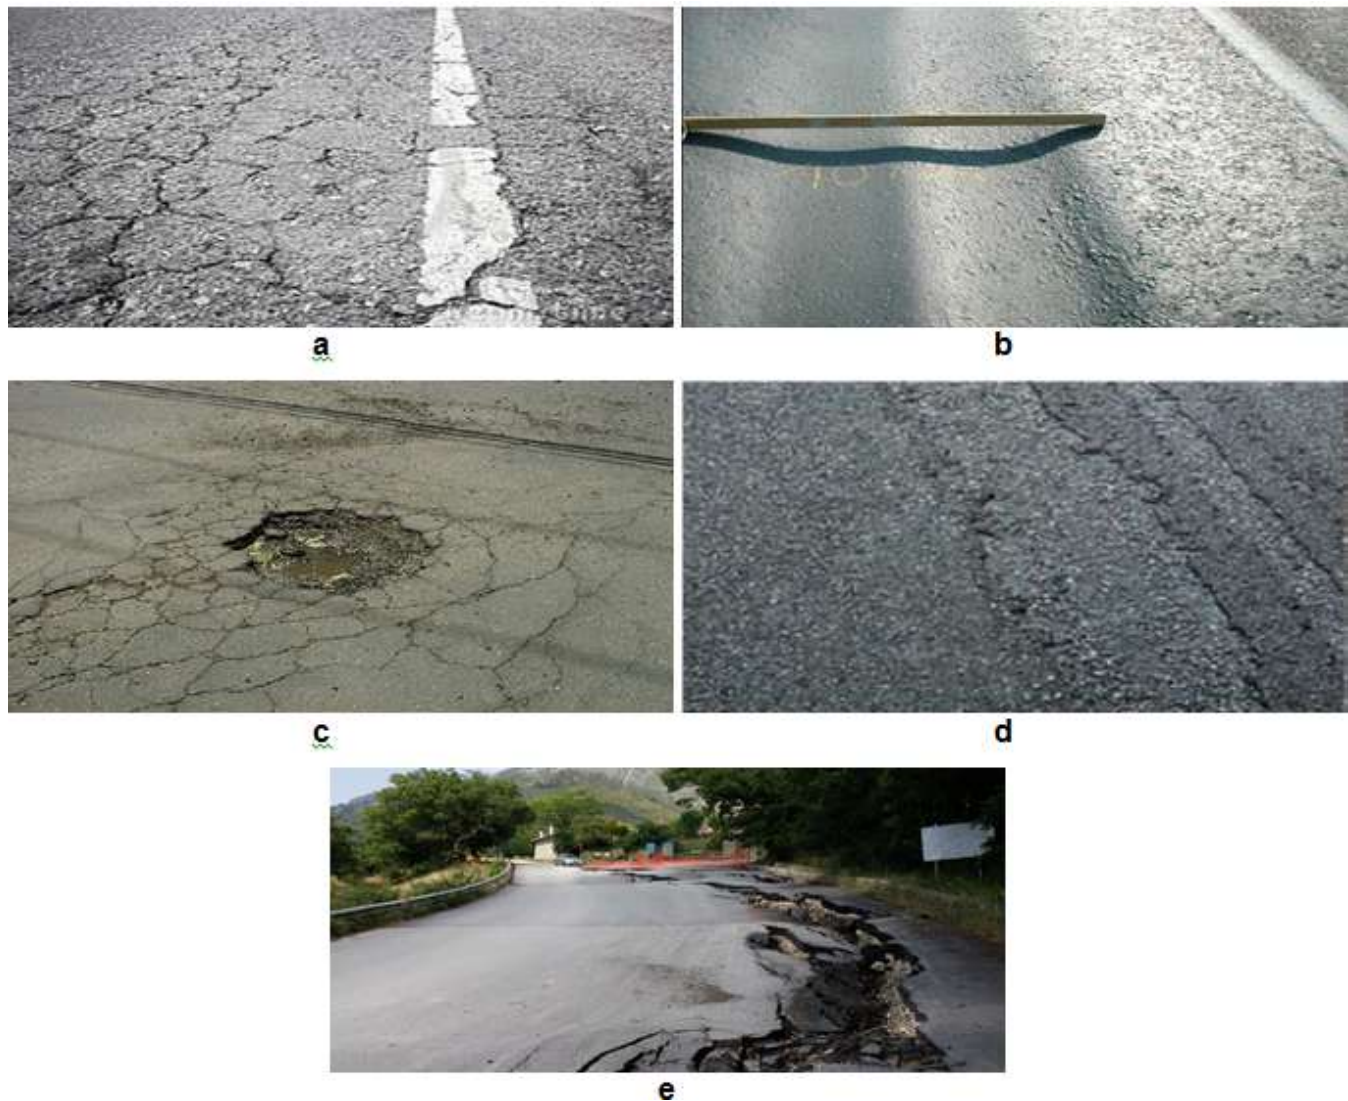
**Figure 1.** (a) Alligator cracking; (b) Rutting at wheel path; (c) Potholes; (d) Ravelling; (e) Block cracking.

series of small polygons resembling an alligator's skin (Figure 1a). This could result from the fatigue effect of repetitive heavy truck loads or ageing in combination with exponential loss of pavement thickness. It can occur with or without surface distortion and pumping.

A rut is a longitudinal deformation at wheel tracks mainly associated with shoving along the road (Figure 1b). This is caused by heavy loads and high tyre pressure, subgrade settlement caused by saturation, poor construction methods, or asphalt mixtures of inadequate strength.

Potholes are irregularly shaped holes of various sizes. These most often result from wear or destruction of the wearing course, sometimes from the presence of foreign bodies in the surfacing (Figure 1c). They can also be caused by water penetrating the surface and causing the base and/or subgrade to become wet and unstable. They are small when they first appear. In the absence of maintenance, they grow and reproduce in rows.

This is progressive loss of pavement material. The possible cause for ravelling could be separation of bituminous film from aggregates through stripping caused by deficiency of bonding or ageing of surface due to variations in climatic and loading conditions (Figure 1d). It can also occur due to the inconsistent deformation of the lower pavement layers.

This is block cracking leading to chipping of pavement surfacing and/or upheaval outside the tyre cracks with associated cracking. This could result from deficiency in cohesion and internal friction in pavement base structure due to ageing and fatigue (Figure 1e).

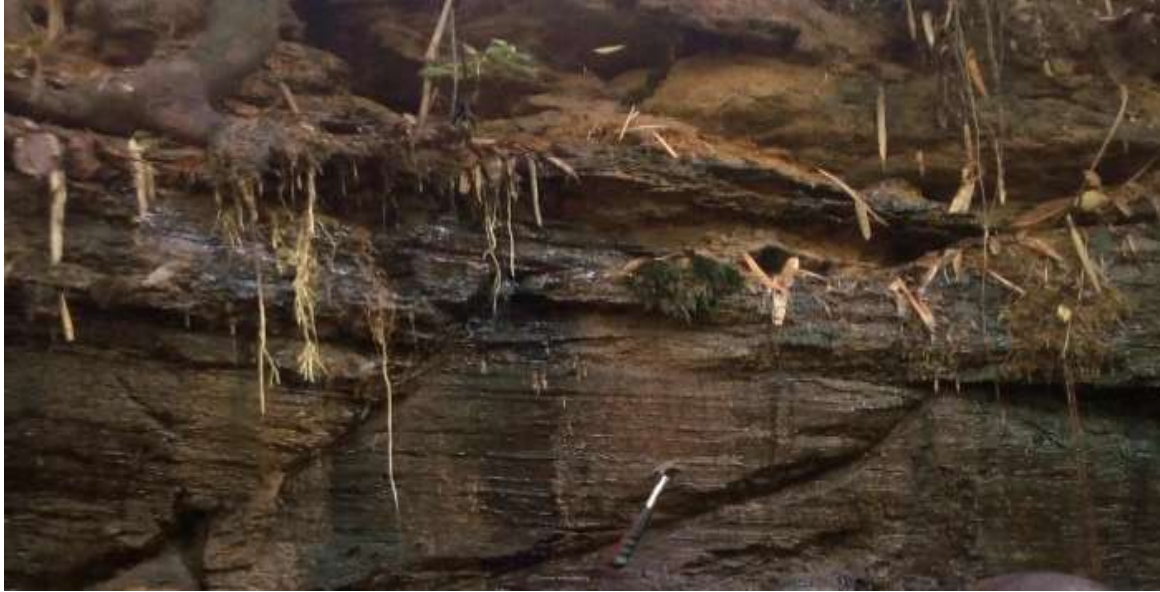
**Plate 1.** Geological setting showing beddings and faults of the rock exposures.

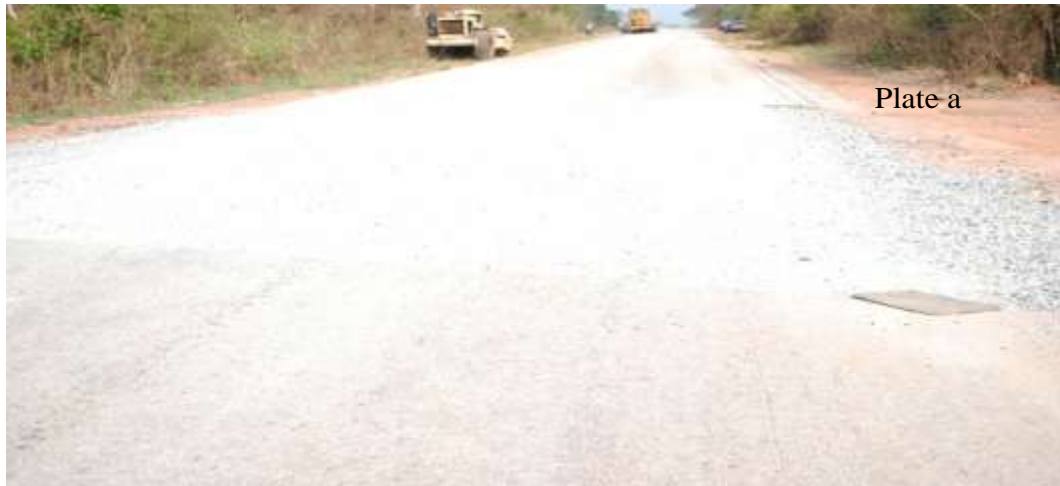
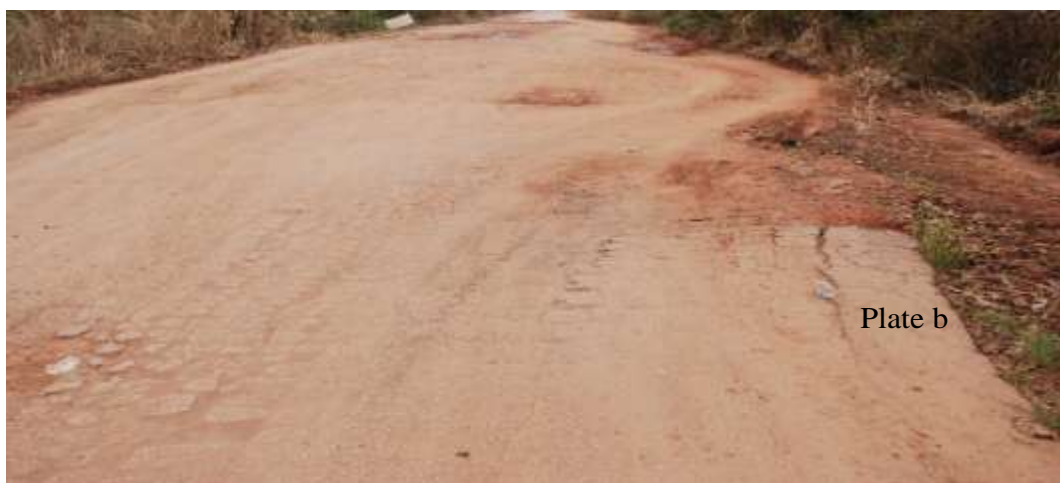
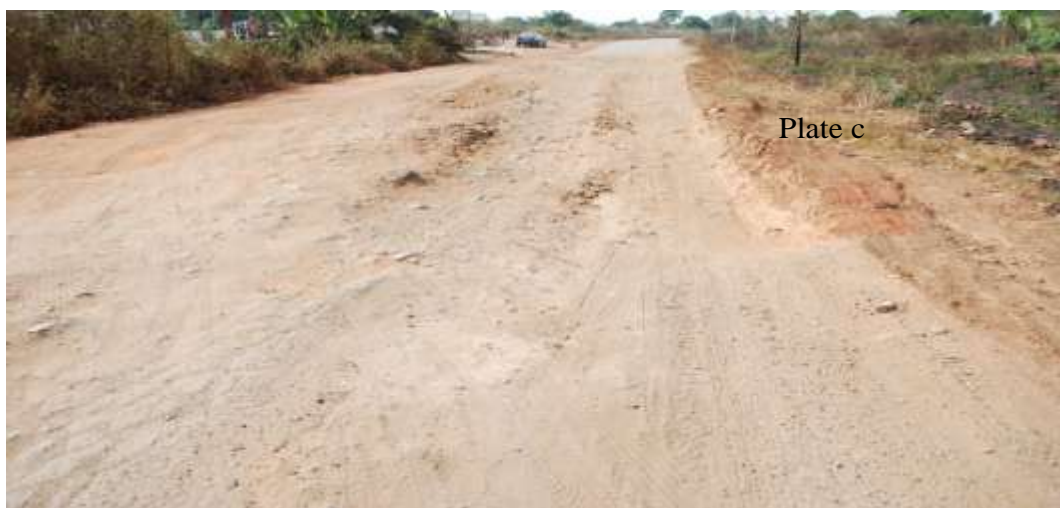
**Plate 2.** (a) Failed Section at Locality 1; (b) Failed Section at Locality 2; (c) Failed Section at Locality 3.

The approaches adopted for data interpretation are of two types, namely qualitative approach which involves visual inspection of Electromagnetic curves and quantitative approach which involves depth calculation of VES, dar Zarrouk parameters etc. The localities studied are variously shown in (Plate 2a to c).

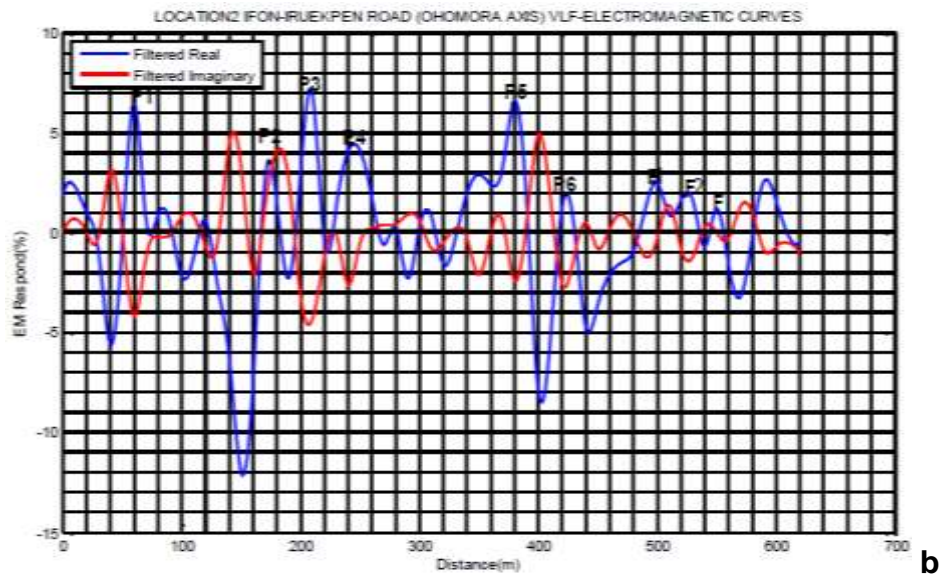
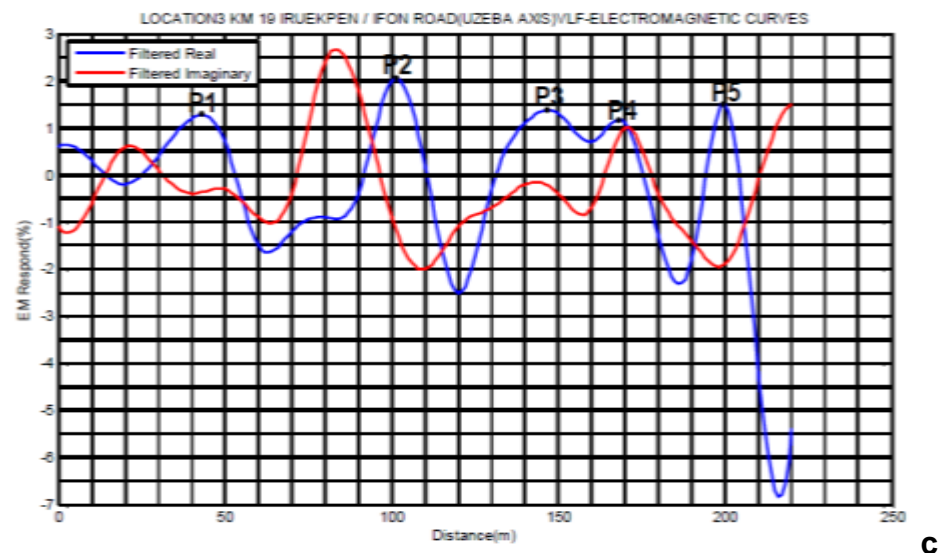
The positive peak anomalies P1, P2, P3 and P4 on the filtered real curve, revealed vertical and/ or near vertical conductors (Figure 3a).

In Figure 3b, the filtered real curve indicates conductors with positive peaks. P1, P2, P3, P4, P5, P6, F1, F2 and F. These conductors are 80, 175, 212, 245, 380, 420, 500, 522 and 550 m from the starting station (zero mark) of the survey profile.

In Figure 3c, the positive peaks anomalies P1, P2, P3, P4 and P5 indicated on filtered real curve, show locations of vertical and/or near vertical conductors. These anomalies are 42, 102, 143, 169 and 200 m from the starting station (zero mark) of the survey profile.

**Figure 3.** (a) VLF-EM Curves in locality 1; (b) VLF-EM Curves in locality 2; (c) VLF-EM Curves in locality 3.

Method (VLF – EM) is to qualitatively delineate the conductive zones and non-conductive zones in the study area. Graphic software, VELFAN 1.0 developed by Alberg Services Nigeria Limited (Geophysical Consulting Services), in MATLAB graphical user interface was used to plot the filtered imaginary and real Very Low Frequency- Electromagnetic curves. High positive values indicate presence of conductive subsurface structures while low or negative values are indicative of resistive formations, (Sharma and Baranwal, 2005).
