Full Length Research Paper

Using vertical electrical sounding and 2D resistivity tomography to investigate Osogbo central waste dumpsite, Osun State, Nigeria

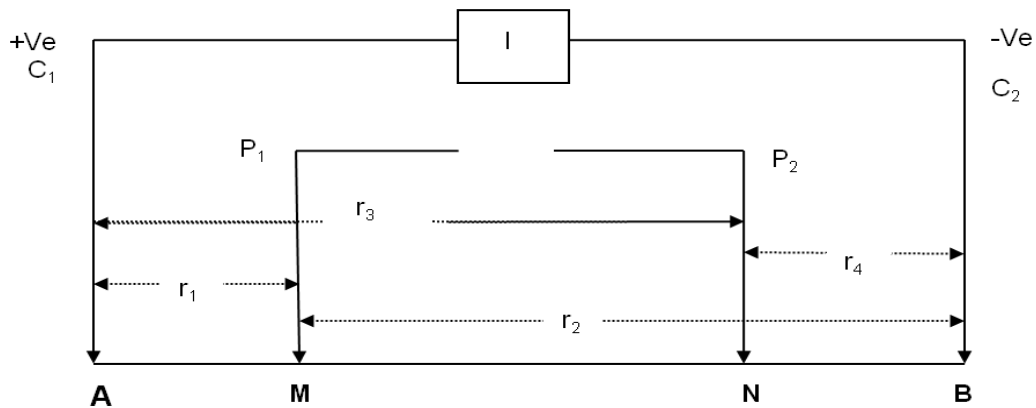
Figure 6. Generalized electrode arrangement for electrical resistivity survey. Source: Ward (1990).

Thirty-three (33) VES were conducted across various stations in the study area (Figure 5) using ABEM Terrameter SAS 300. The measurement technique adopted was Schlumberger configuration with a maximum spread length of 100 m. The depth range of the measurement was customarily increased by an outward displacement of the current electrodes. The typical field procedure was to transmit current (I) through the electrode (C_1 and C_2), while the resulting ground voltage (V) was measured with the potential electrode (P_1 and P_2) (Figure 6). Details about the survey and

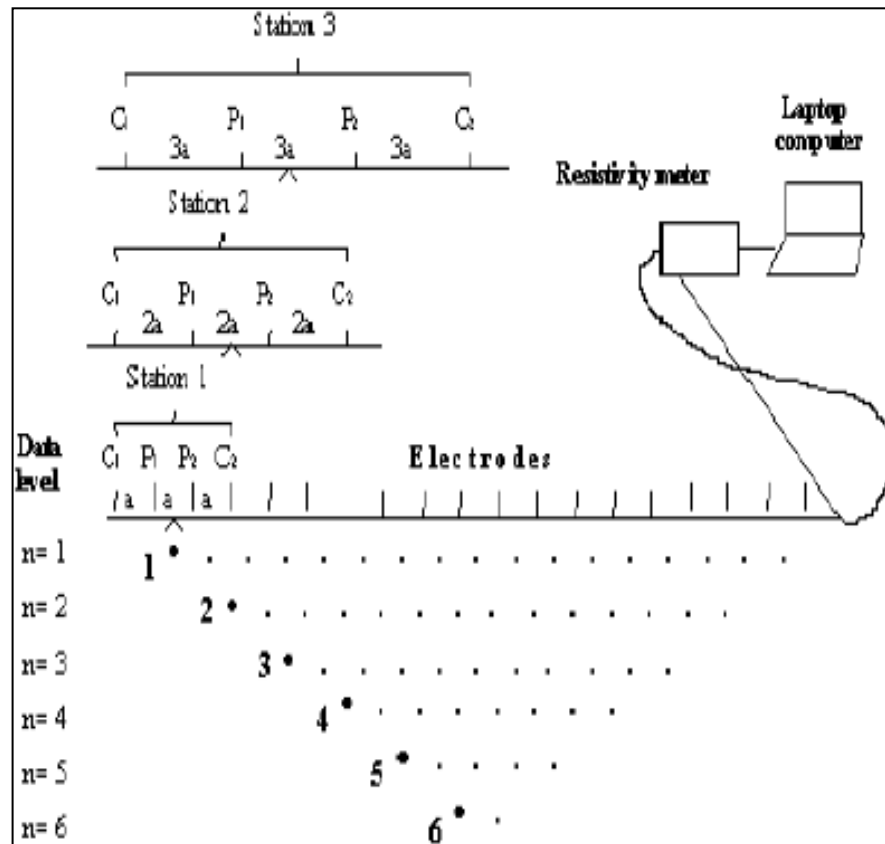
Figure 7. The arrangement of electrodes for a 2-D geoelectrical imaging survey—and the sequence of measurement used to build up a pseudo-section. *n* represents the number of times the pair of potential electrodes were moved.). Source: Samsudin et al. (2006).

To interpret the 2-D resistivity data, a 2-D model for the subsurface consisting of a large number of rectangular blocks was used (Figure 7). The inversion software, Kigam Dipro for Windows version 4.01 (2001), was used to determine the resistivity of the

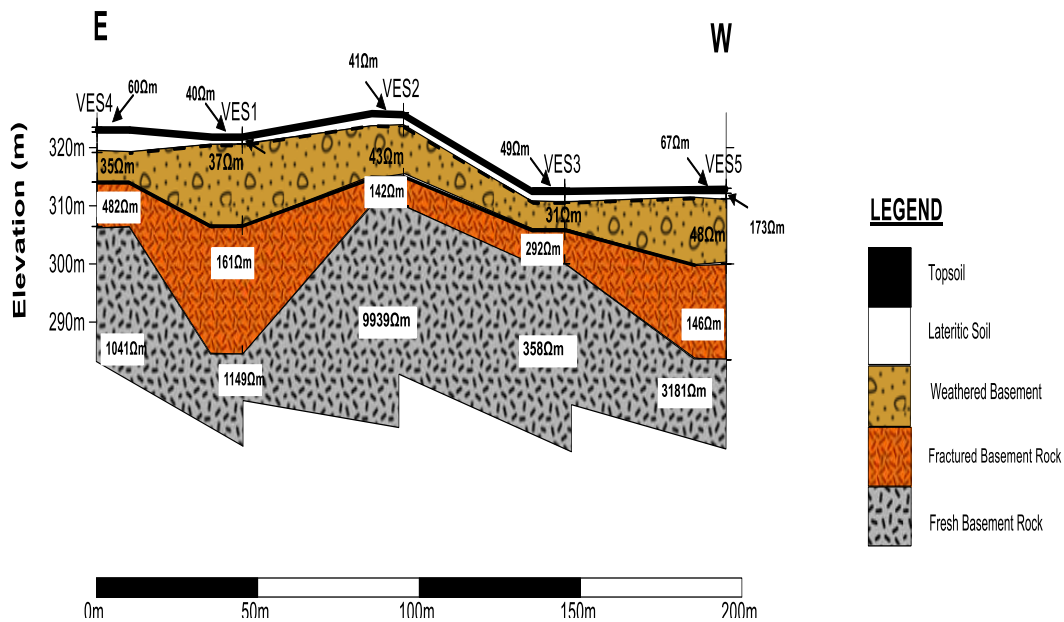
Figure 8 provides a representation of VES lithotypes images. It shows a layer of top soil that was directly underlain by another layer of lateritic soil. Both were less than 5 m thick. The resistivity values for top soil range from 40 to 67 Ωm; 31 to 48 Ωm for lateritic soil located at the west end of the site and at an average depth of 20 m. At such low resistivity, pollution was eminent. About 15-m to the base of the fractured layer at the east end, where the resistivity value was as high as 482 Ωm, there could be very little or no contaminants. The weathered layer was aquiferous, though its integrity might be in doubt, as a result of its proximity to the overlying thin layers of top soil and laterite.

Figure 8. Geoelectric cross-section along the east-west direction of the study area. Source: Authors 2022

A quick vertical glance at the ERT images (figure 11 to 14) confirms the sequence as seen in Figures 8 to 10, from the porous and permeable weathered zone to the impermeable fresh basement zone. It showed that the pollution plumes were concentrated at the near surface zones, at west of the study area.

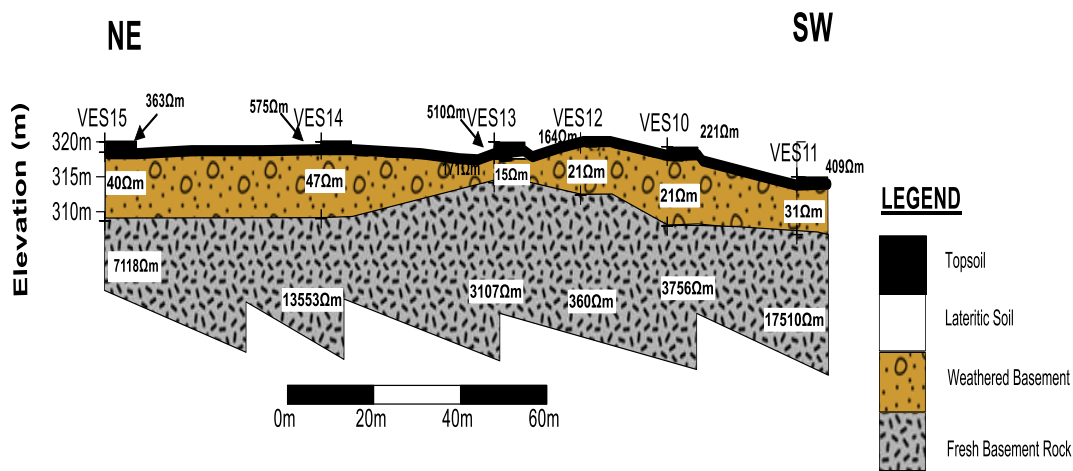
Figure 9 trends NE-SW direction with top soil overlying the weathered layer. Between the two layers, a very thin smear of lateritic soil was interposed. The aquiferous

weathered layer has very low resistivity signature, between 15 and 47 Ωm, and a thickness of about 10 m, hence, prone to pollution.

Figure 9. Geoelectric cross section along the Northeast-Southwest direction of the study area. Source: Authors 2022

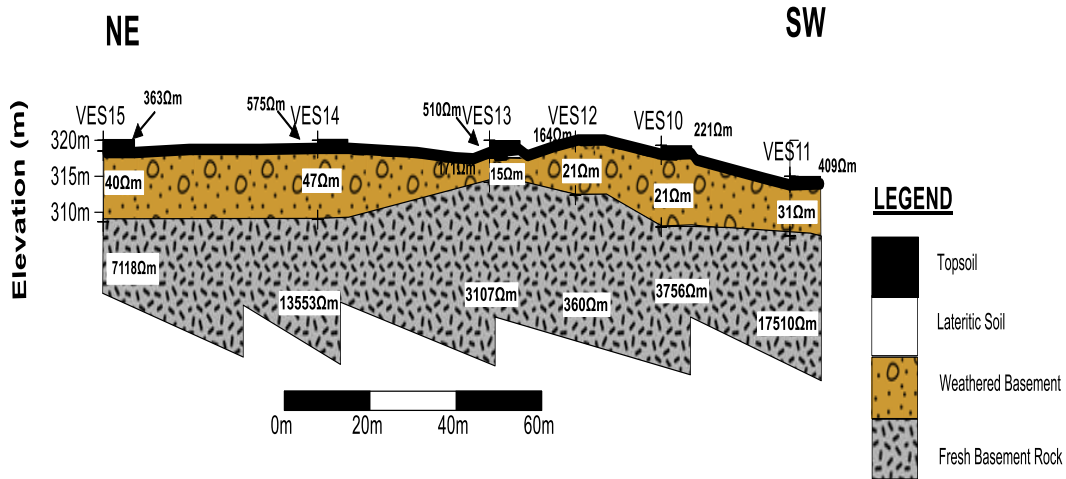
The-section of Figure 10 trends NE-SW direction with top soil overlying the weathered layer. Between the two layers, a very thin smear of lateritic soil was interposed. The aquiferous weathered layer has very low resistivity signature, between 15 and 47 Ωm, and a thickness of about 10 m, hence, prone to pollution.

Figure 10. Geoelectric cross-section along the northeast-southwest direction of the study area. At the far right is the legend of the cross-section.
Source: Authors 2022

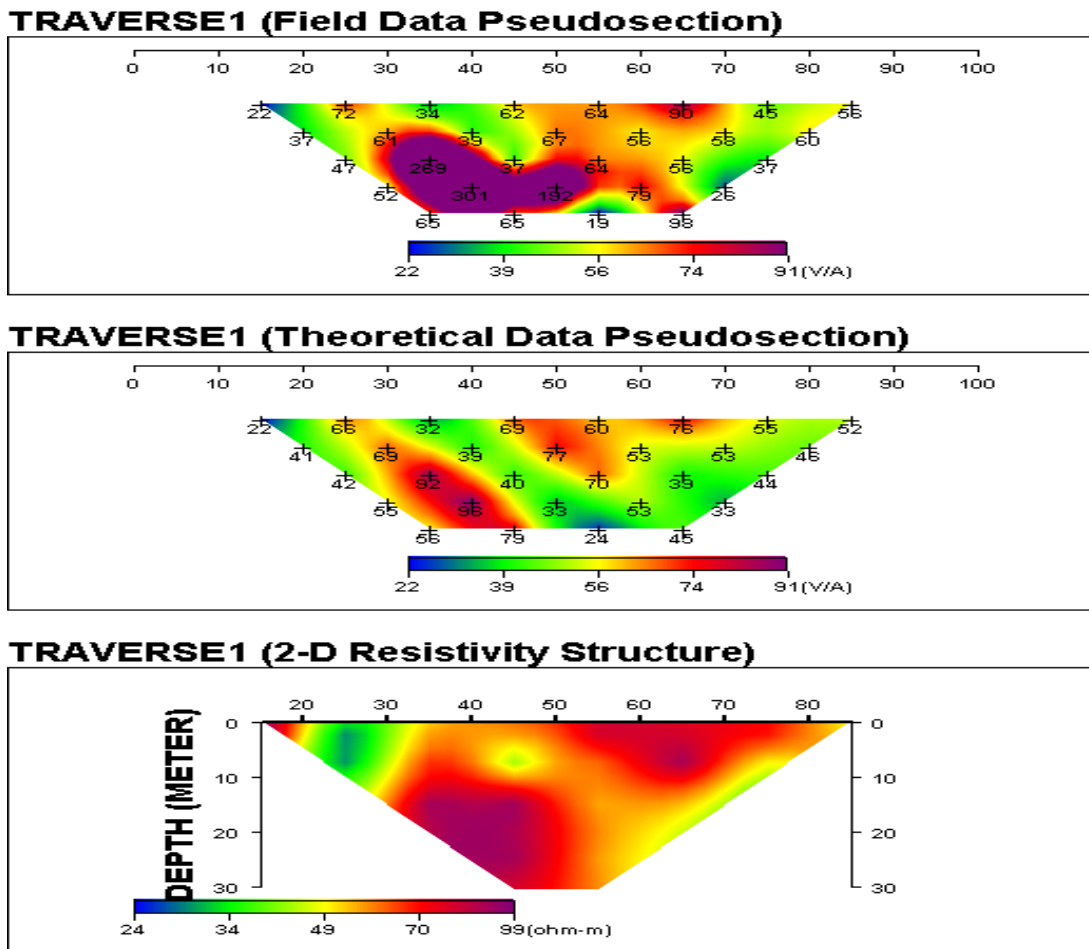
These results agreed with the 2-D results, as shown in Figures 11 to 14. In all the 2-D structures, the blue-green colour shows areas with low resistivity values, suspected contaminant plumes and weathered zone; while red to purple colour indicates the presence of areas with high resistivity values. In traverse 1 (Figure 11), the low resistivity areas recorded values ranging from 24 to 34 Ωm, which was an indication of pollution. Other areas within the sub-surface as shown in the 2-D image, which had purple colour, might be fractured basement rock that may be free of pollution. The results of the VES and the 2D imaging agree with the work of Bayowa et al. (2015).

Figure 11. Field data pseudo-section, the theoretical pseudo-section, and the Interpreted 2-D resistivity image of traverse 1, depicting the lithotypes/pollution plumes within the subsurface.
Source: Authors 2022

m for traverse 1 (Figures 11 and 12), traverse 3 (Figure 14) and traverse 4 (Figure 15), respectively, while traverse 2 (Figure 13) was equal to 150 m.

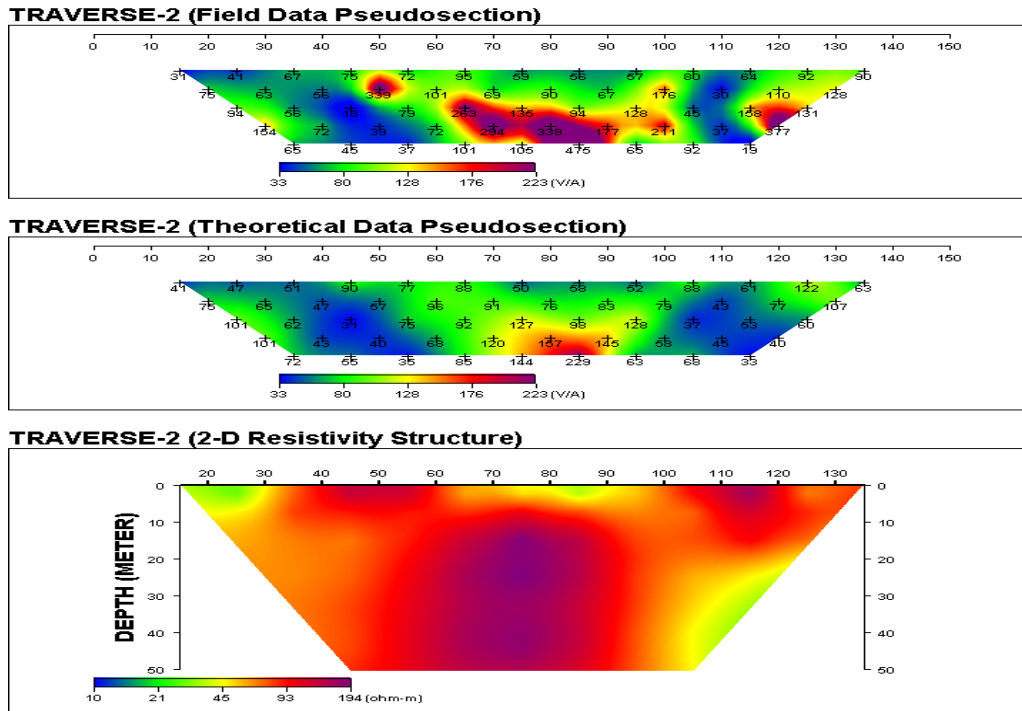
In traverse 2 (Figure 12), the resistivity values were

relatively low, ranging from 10 to 21 Ωm. The yellow to red zone was a transition from low to high resistivity. Areas within the sub-surface, as shown in the 2-D image which had purple colour, were relatively areas with high resistivity values, which indicated minute or non-presence of pollutants at the fractured basement.

Figure 12. Field data pseudo-section, the theoretical pseudo-section, and the interpreted 2-D resistivity image of traverse 2, depicting the lithotypes/pollution plumes within the subsurface. Source: Authors 2022

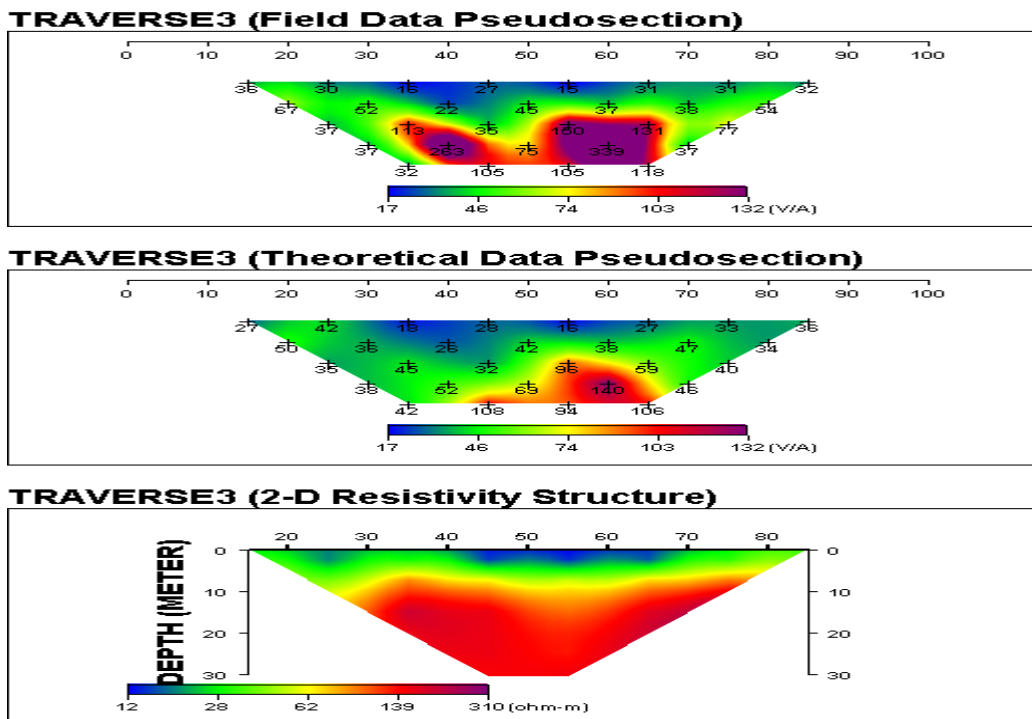
In the 2-D resistivity structure of traverse 3, as shown in Figure 13, the resistivity values of these areas were low, ranging from 12 to 28 Ωm. Other areas within the sub-surface, with purple colour, were zones of high resistivity

(greater than 300 Ωm) and might be pollutant free. The yellow to red colour zone is suspected to be a transition area, from the very low to high resistivity section, with resistivity values of about 55 to 170 Ωm. The zone might be fractured basement rock and suspected to be free of contamination.

Figure 13. Field data pseudo-section, the theoretical Pseudo-section, and the Interpreted 2-D resistivity image of traverse 3,-colour-variation depicted the lithotypes/pollution plumes within the subsurface. Source: Authors 2022

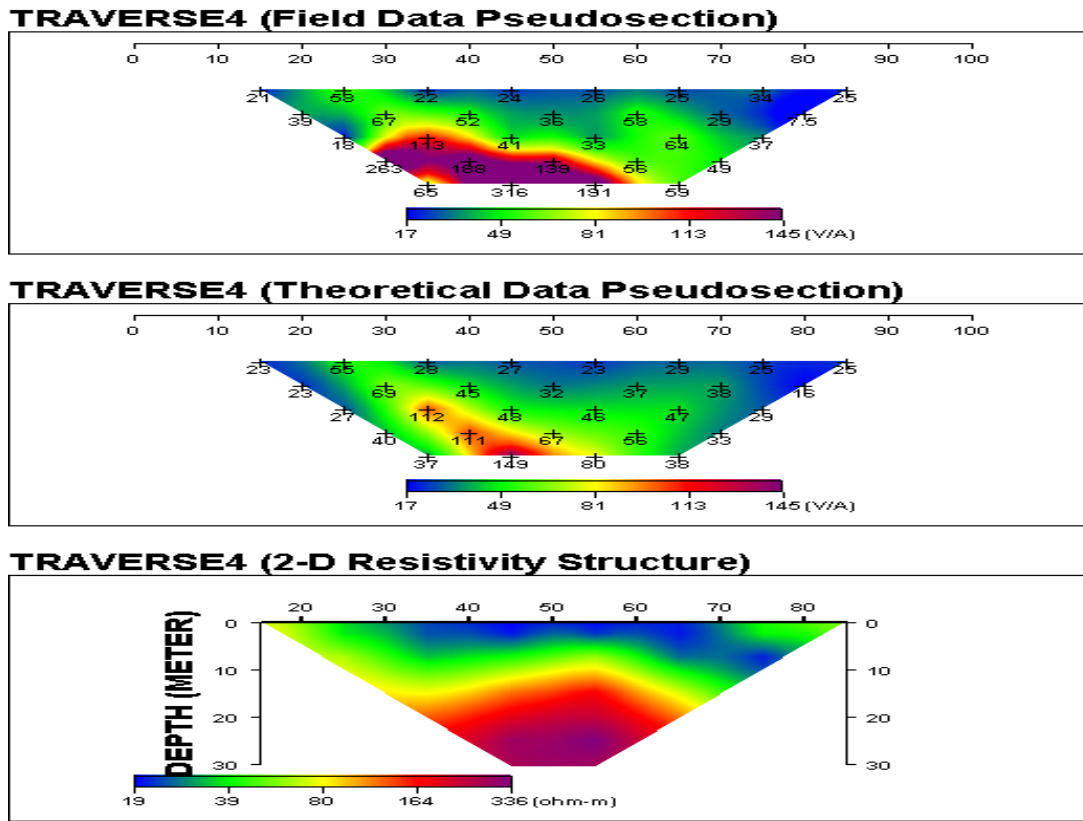
In the 2-D resistivity structure of traverse 4, as shown in Figure 14, blue and green coloured zone shows areas within the subsurface with relatively low resistivity values suspected to contain the contaminant plumes. The blue

Figure 14. Field data pseudo-section, the theoretical pseudo-section, and the inverted 2-D resistivity image of traverse 4, the colour-variation is-pollution indicator and lithotypes sequence, within the subsurface. Source: Authors 2022

colour indicates the presence of areas that were suspected to be polluted. The resistivity in these areas is relatively low, with values ranging from 19 to 39 Ωm . Areas within the subsurface, which has purple colour, have relatively high resistivity, greater than 300 Ωm . These areas are suspected to be fractured basement rock.
