*Full Length Research Paper*

# Improving out-of-plane strength and ductility of unreinforced masonry walls in low-rise buildings by centrally applied FRP strip

**Keywords:** Earthquake, masonry, seismic, out-of-plane, FRP.

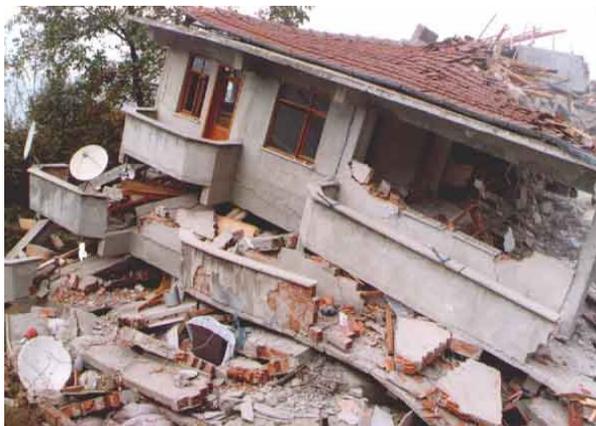
**Figure 2.** The URM building is very susceptible to seismic attack.

The collapse of URM buildings in recent earthquakes prove how susceptible URM buildings are to seismic forces, Figure 2. Consequently, the earthquake design forces to be considered in newly designed URM buildings are increased by as much as 50% (Paulay and Priestley, 1992). Therefore, those URM buildings which do not satisfy recent earthquake codes and most of them do not, have to be strengthened. In order to begin strengthening efforts of URM buildings, their seismic behavior must be well understood. It is obvious, of course, which the URM building collapses following the collapse of the load bearing walls.

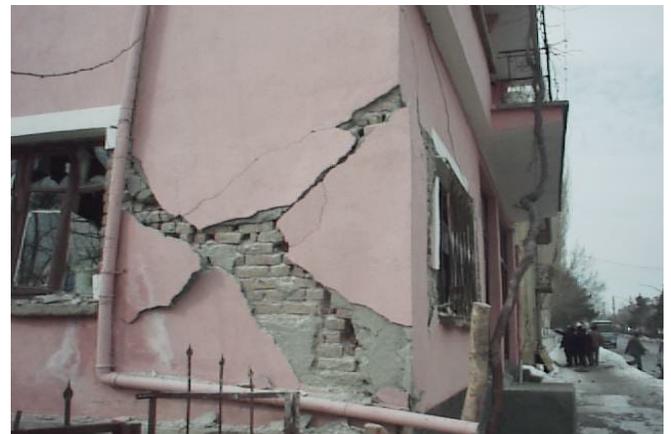
**Figure 4.** In-plane shear failure of the URM wall.

Figure 4 shows the in plane failure of an URM wall in the Marmara Earthquake. It can be observed that in-plane failure of an URM wall is rather severe. The X-cracks are wide and the wall is partially displaced in-plane from its original position. However, it must be observed that wall B is still in place and total collapse has not occurred. Therefore, wall B is still capable of transmitting gravity loads. It is obvious, of course, that if vertical force equilibrium is maintained, the building does not collapse.

The X-shaped in-plane shear failure of the wall has occurred in the ground floor. This is expected due to the fact that maximum in-plane shear forces and moments occur in the ground floor.

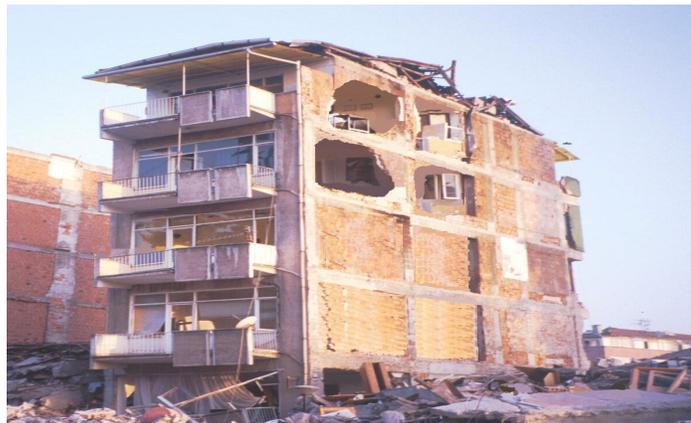
**Figure 5.** Out-of-plane failure of an URM wall in a low-rise multi-storey building.

In the three storey URM building considered in Figure 3, another and probably more severe failure of the URM wall occurs, known as the out-of-plane failure, particularly in the walls at roof level. Figure 5 shows the out-of-plane failure of a wall in the Marmara Earthquake. As can be observed, contrary to the in-plane failure of Wall A which is located in the ground floor, the wall located in the upper floors have collapsed out-of-plane. From observa-

It can be easily observed from Equation 8 that the most vulnerable wall to out-of-plane failure is the wall at roof level because  $a_{(avg)}$  is maximum at this level. This level, observation agrees well with the out-of-plane failure of wall shown in Figure 5.

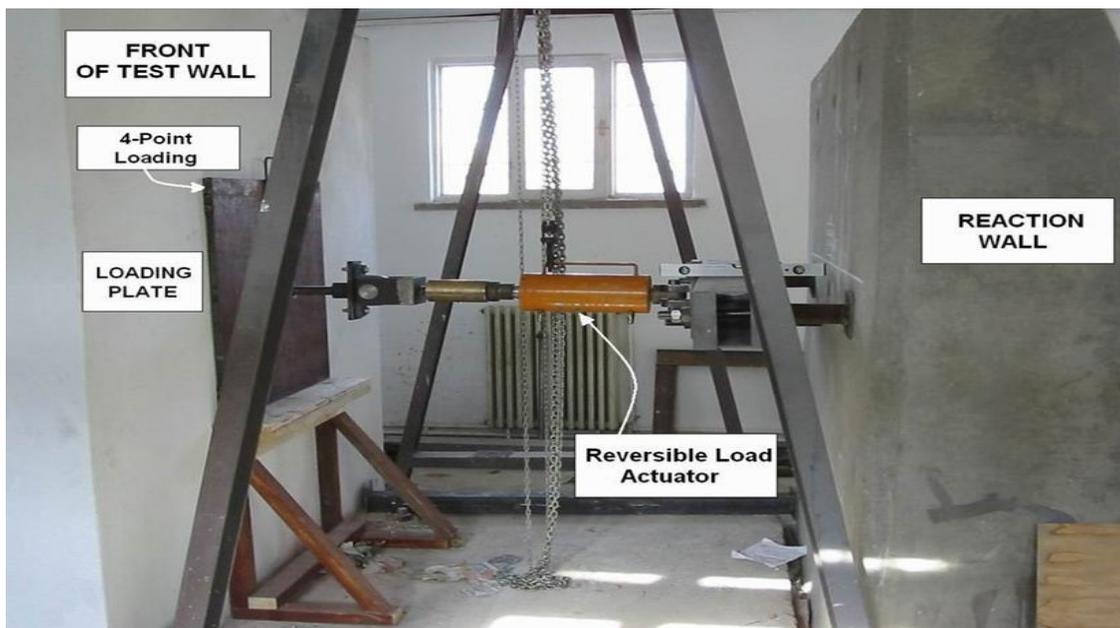
Figure 10. The reversible loading set-up.

It is assumed that the four point loads, as placed, would produce a moment distribution on the wall which would be similar to that produced by distributed seismic forces acting out-of-plane. The test load is applied in increasing steps and in reversing fashion by an actuator as shown in Figure 10.

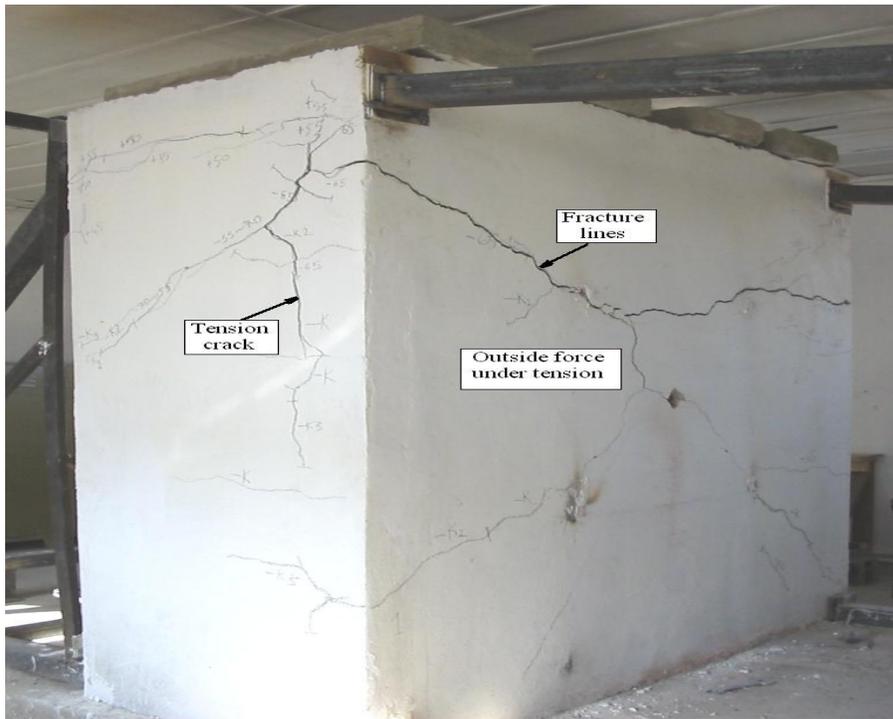
Figure 13. Crack formation at outside surface of URM test wall at final failure.

put the corners under tension, in the direction away from the room, into the street. The crack which has formed on the wing wall at ultimate failure stage parallel to the corner extending from top to bottom of the wall, as shown in Figure 13, indicates the existence of this tension force. Under this (+) loading condition, the wall is subject to flexural tension forces at the outside surface. This is an important observation to make which will be useful in decision making of how to reinforce the URM wall against out-of-plane failure. This observation proposes the possibility that reinforcing only the outside surface of the wall may be enough. The purpose of this possible strengthening will be to increase the strength as well as the ductility of the wall above the seismic demands to be imposed by the design earthquake. Another important advantage of this method of strengthening only from the outside surface of the wall, if it is determined to be adequate, is that it will impose minimum discomfort to the occupants.

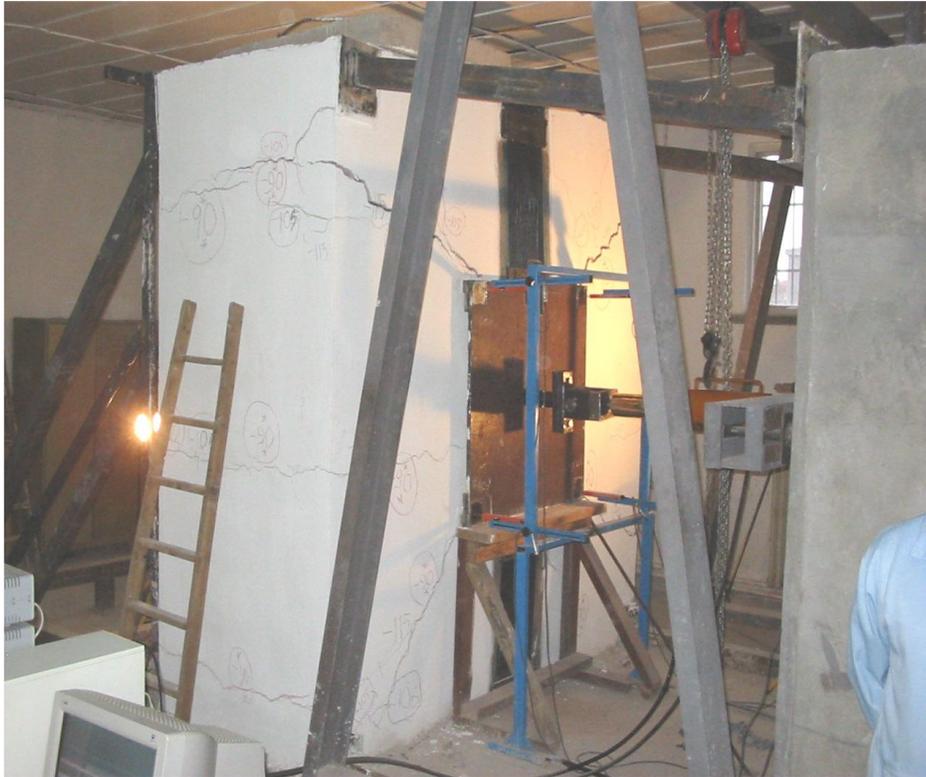
**Figure 19.** Loading and final surface cracking of test specimen  $S_{(FRP)}$  with the FRP strip applied at mid-centre.

was also tested in similar incremental steps of reversing loads which was shown in Figure 12. The final surface cracking and the hysteresis relationship of applied load and central wall deflection are shown in Figures 19 and 20, respectively.
