# Evaluation of a collapsed anchored bored pile retaining system by using finite elements method

Devrim ALKAYA\* and Burak YEŞİL

Pamukkale University, Faculty of Engineering, Department of Civil Engineering, Denizli, Turkey.

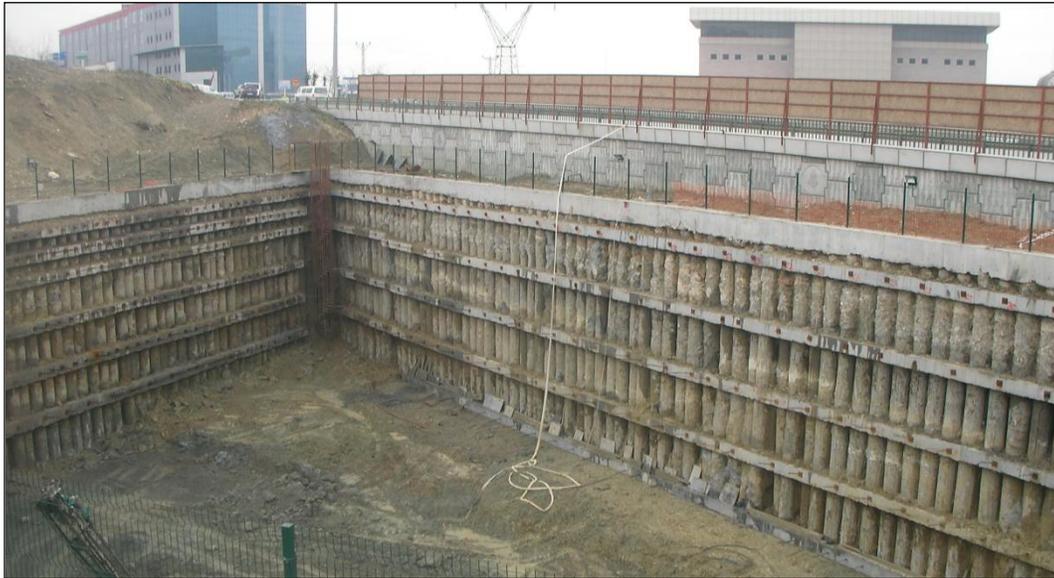
**Figure 1.** Non-deformed Condition of the Excavation Site

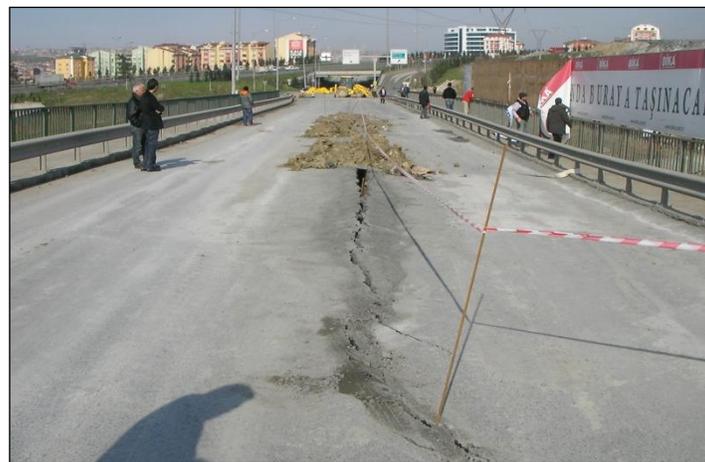
**Figure 9.** Filling of the Cracks with Concrete

As the first step, the occurred cracks were closed by filling them with concrete (Figure 9). The cracks gradually expanded as a result of the continuing deformation; and the road was closed to the traffic.

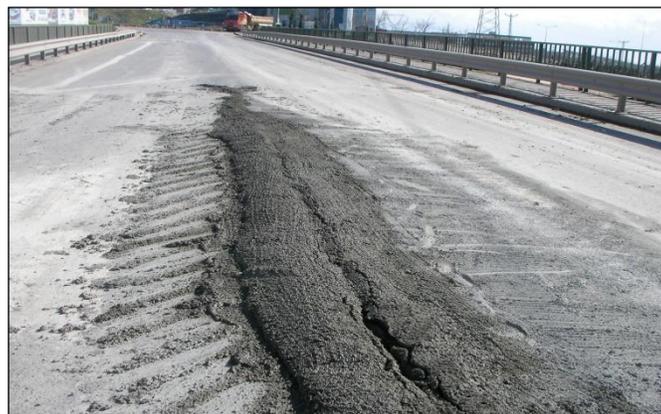
**Figure 10.** The Backfill Procedure

The backfilling procedure was implemented, in the meantime, to prevent the down throw of retaining system. Since the collapse was not expected, the backfilling procedure was implemented too late (Figure 10).

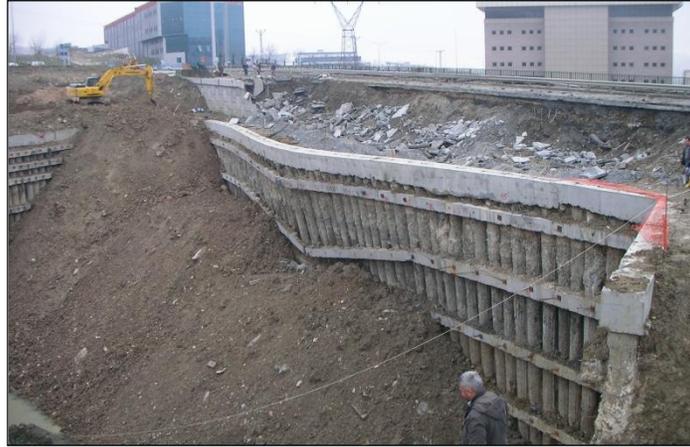
**Figure 11.** Encounter with Groundwater

In the controls conducted, it was determined that some sections of the anchors were scraped and became dysfunctional. Water, at

11 to 12 m depth, was encountered inside the soil (Figure 11). In the soil survey, the groundwater level was determined as 20 m. Nevertheless, groundwater was encountered during the excavation after the retaining implementation. Deformations, due to the water pressure and dysfunctioning of anchors, were increased; and, ultimately, bored piles were overturned and collapsed (Figure 12).

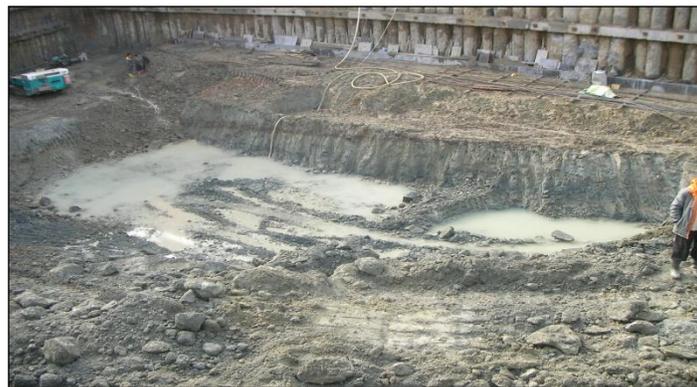
**Figure 12.** Collapsed Bored Piles
