Evaluation of canal water conveyance and on-farm water application for a small-scale irrigation scheme in Ethiopia

Key words: Lemchek-Sewur SSI scheme, conveyance efficiency, application efficiency, evaluation, Ethiopia.

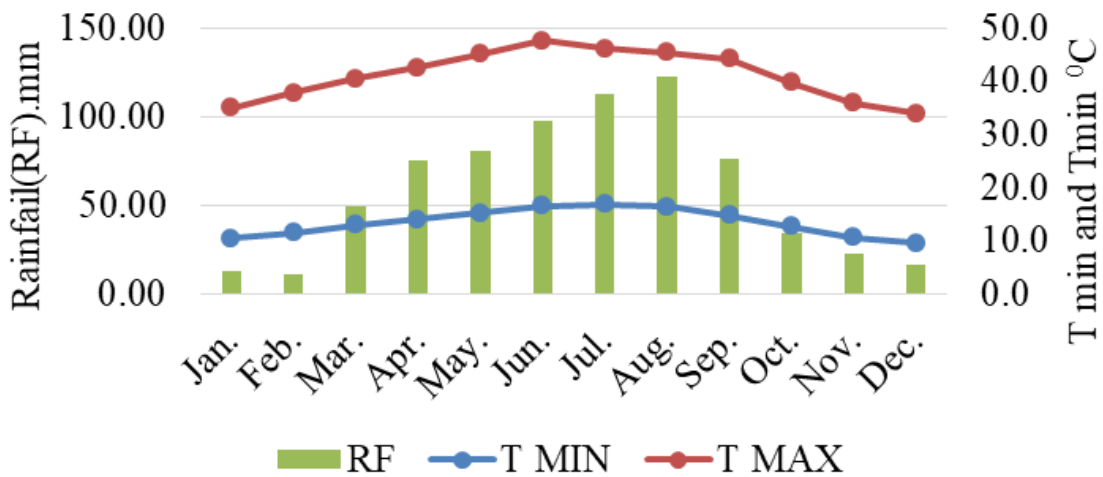
Figure 3. Variation of mean monthly climatic data.

The mean monthly minimum temperature (T_{min}) in the study area varies from 9.6°C in December to 16.9°C in July with yearly average value of 13.5°C. Similarly, the mean monthly maximum temperature (T_{max}) varies from 24.3°C in December to 31.0°C in June with yearly average value of 27.7°C. The rainfall distribution in the study areas is 'unimodal' rainfall pattern. The main rainy season is from July to early September. The mean annual rainfall (RF) in the study area is 712 mm. The graphical variation of mean monthly climatic data is as shown in Figure 3.

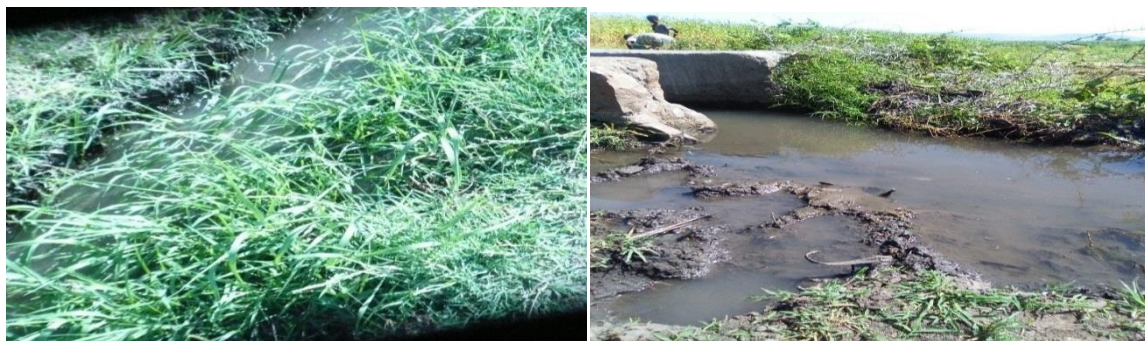
canal varied from 52.49 to 96.02% with average value equal to 86.26%. The water conveyance losses per 100 m length of secondary canal varied from 0.731 l/s/100 m to 7.858 l/s/100 m with average value equal to 2.617 l/s/100 m. The lowest values of water conveyance efficiency was observed for canal section at 1500 to 1750 m. Reason being this section was highly cracked which caused high seepage and leakage losses. It was observed during the field visit that the water was leaking from different locations, wherever, canal was breached. The measurements for replication 2 were done after the maintenance of the secondary canal. Therefore, the values of conveyance efficiency for second replication in some of the cases were higher as compared to replication 1. The major reasons for high water conveyance losses in the secondary canal of the scheme

Figure 4. Canals covered by weeds and mud.

different places, canals under design with smaller cross sectional area which resulted in water overflow, sides and beds of the canal were greatly damaged by scouring due to steep bed slope, absence of drop structures and flow

control structures (Figure 4).

(3) Canals, especially tertiary canals require continuous maintenance to keep them free from weeds and reduce the deposition of silt. Continuous removal of sedimentation, preventing large logs and debris throwing into the canal, constructing water control structure across the canal and canal bank protection are some of the necessary activities. Therefore, WUA and the beneficiaries' farmers should work together in coordination with each other.

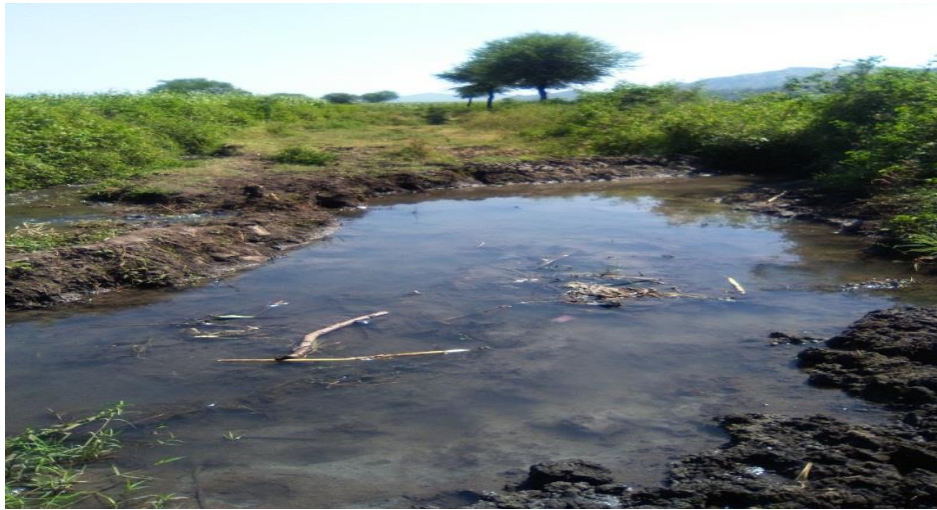
Figure 5. Silt deposition in tertiary canal.

(1) The physical conditions of some of the tertiary canal structures were not as per designed specifications. The sidewalls were eroded (width was widened) and plants/grasses were growing in the canals. The canal bed slope was also causing backflow when sufficient water was not supplied in the canals. In some of the tertiary canals, there was siltation problem, which decreased water flow depth and widened canal widths (Figure 5).
