Full Length Research Paper

Geoelectric study of major landfills in the Lagos Metropolitan Area, Southwestern Nigeria

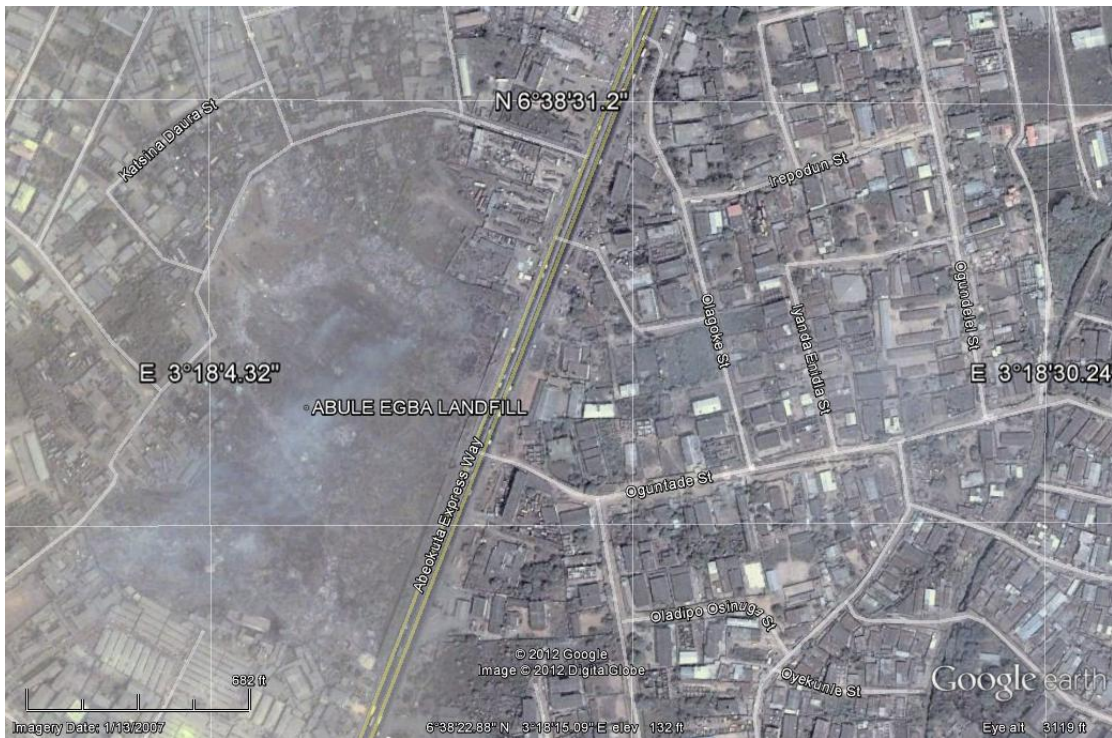
Figure 3. Satellite image showing the location of Abule Egba Landfill.

Abule Egba landfill (Figures 3 and 4) is situated on the NNW flank of Lagos along the Lagos – Abeokuta highway. The site occupies a land of about 10.2 ha in the Western part of Lagos in the Alimosho Local Government and receives waste from the densely populated area. The residual life span is approximately 8 years. The Abule Egba landfill has been inactive since 2008. Four Vertical Electrical Sounding (VES) points were occupied within the refuse dump area while one VES point was occupied along Balogun Crescent as control. VES 1 and VES 2 data were acquired within the old refuse dump where landfill activities commenced in 1992. VES 3 data were

acquired in area of fairly recent refuse dump (2006 to 2007 phase). VES 4 data were acquired within area of long abandoned dump.

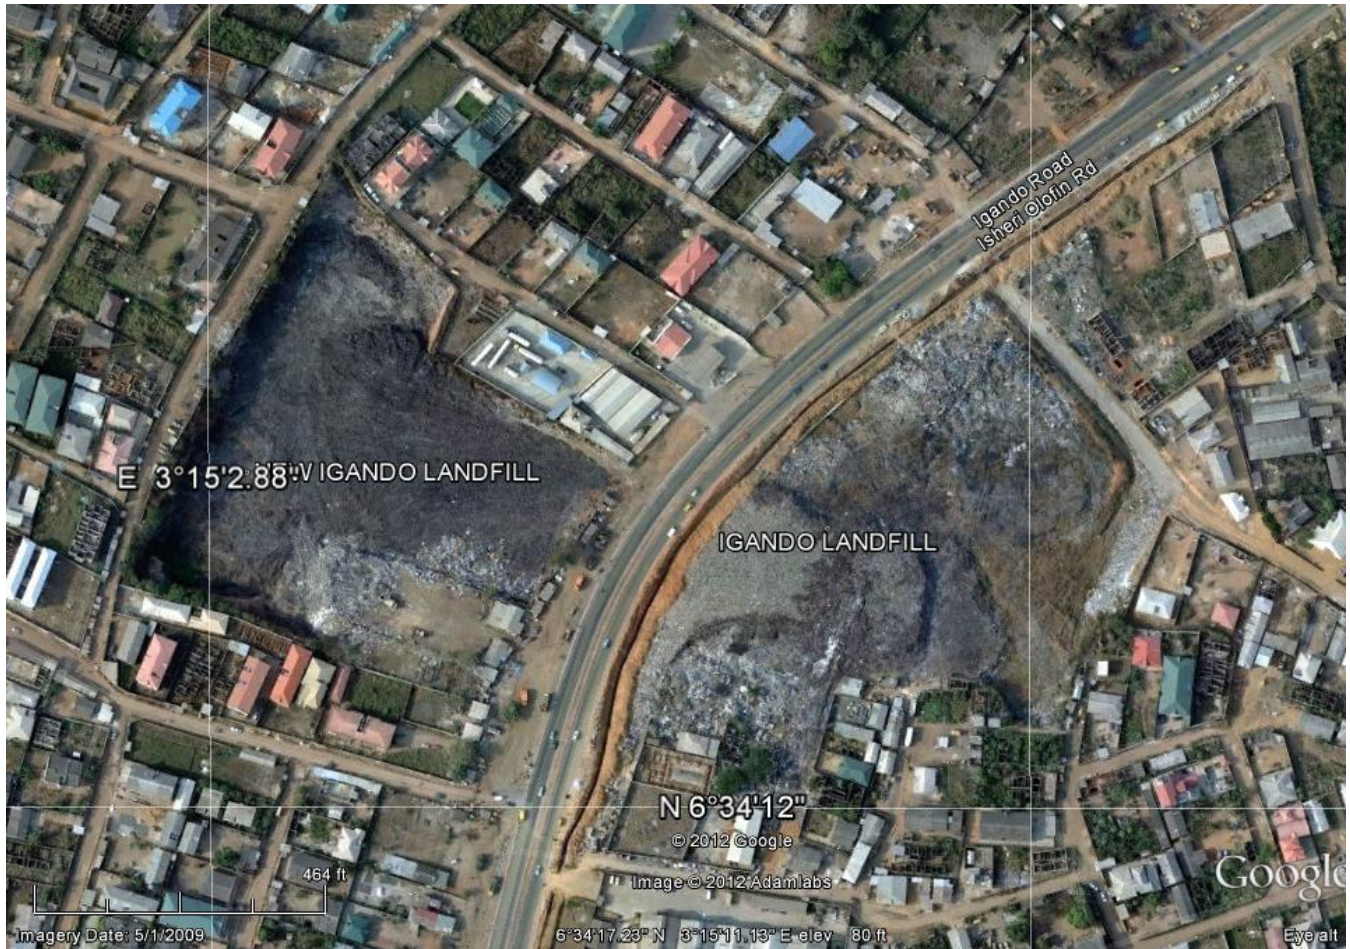
Figure 5. Satellite image showing the location of Igando Landfill (landfill east of motorway is under reference).

Igando landfill is situated along Lagos State University – Iba Road on 7.8 ha of land (Figures 5 and 6) with average life span of 5 years. The landfill has not been active since 5th October 2006. Four VES points were occupied (Figure 6). VES 1 was located in the central area of the landfill. VES 2 was located on the western limit of the landfill. The data were acquired on cut segment of the burrow pit. VES 3 was located on area of recent dump with fairly unconsolidated refuse. VES 4 was located close to the Lagos State University/Ojo – Idimu roadway and served as control to enable the understanding of hydrogeologic setting in the Igando area. Olushosun landfill (Figures 7 and 8) is situated in the northern part of Lagos within Ikeja Local Government and receives approximately 40% of the total waste deposits from Lagos. The size is 42.7 ha and a residual life span
