Salt weathering, bio-deterioration and rate of weathering of dimensional sandstone in ancient buildings of Aachen City, Germany

Kamh G. M. E.

Geology Department, Faculty of Science, Menoufiya University, Egypt. E-mail: g_kamh2000@yahoo.com

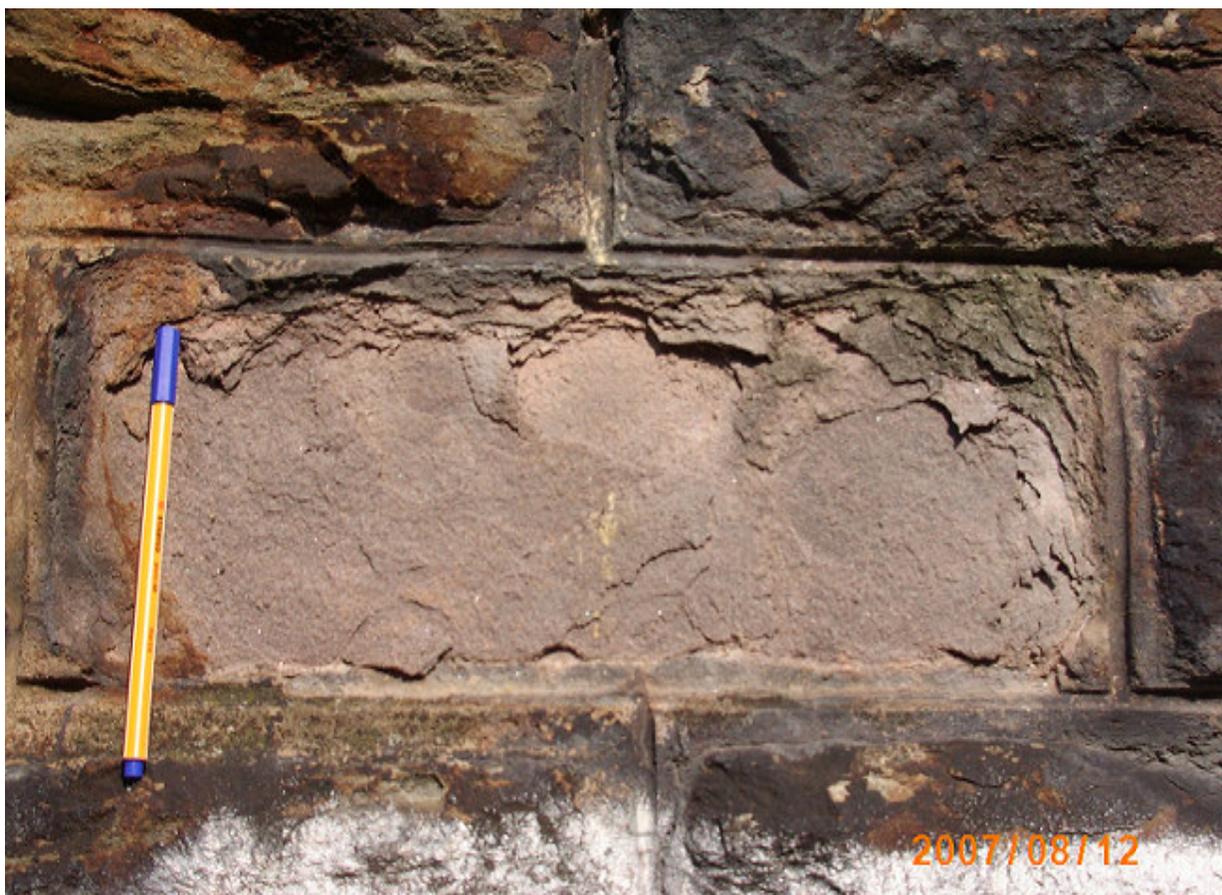
Figure 3. Back weathering and multiple scaling, white salt efflorescence and blackening of stone surface of construction rock of the walls under investigation.

The variation in rock's strength from stone's surface to deep inside due to weathering and deformation of rock on both nano-scale (Figure 7) and mega-scale (Figures 1 to 6) is graphically and numerically presented in the non-linear direct proportional relation at the weathered parts (Figure 15), and the semi-linear relation at the massive less weathered parts of this construction rock (Figure 16) of the drilling resistance curves for the testing points examined on these walls. The very high rate of drilling at the lime mortar of these walls (Figure 17) indicated that it is a good and an easy stuff for weathering (especially chemical weathering) by acid rain resulting in high limit of total dissolved salts (Table 3), with dominance of sulphates that easily attack the rest of this mortar creating the protruded stalactites (Figure 1b) and probably migrates to the margins of the surrounding construction rock (Figure 5) resulting in creation of the reported weathering forms (Figures 2a, 3 and 4a).

The microbial noted either on stone's surface (Figures 1, 4b and 6) or within rock's texture (Figures 8 to 10) contributes to stone deterioration by both chemical and/or mechanical mechanisms. The mechanical action of hyphae causing stresses, movement and cracking of the stone's matrix (Del Monte and Sabbioni, 1986). The forces exerted by hyphal growth can lead to considerable disruption of the stone matrix and also result in lifting and flaking of stone's surface (Figures 2b, 6 and 10). Mechanical and biochemical deterioration can act together to bring about mineralogical alteration within the stone matrix (Koestler et al., 1985). The deterioration and powdering of dimensional stones (as noted for the buildings under investigation) can be a result of physical decay by fungal hyphae (Caneva et al., 1993; Danin and Caneva, 1990; Krumbein and Dyer, 1985). It can also share in creation of such weathering forms (scaling and exfoliation) noted at the study area (Figures 2a, 2b, 3, 5 and 6).

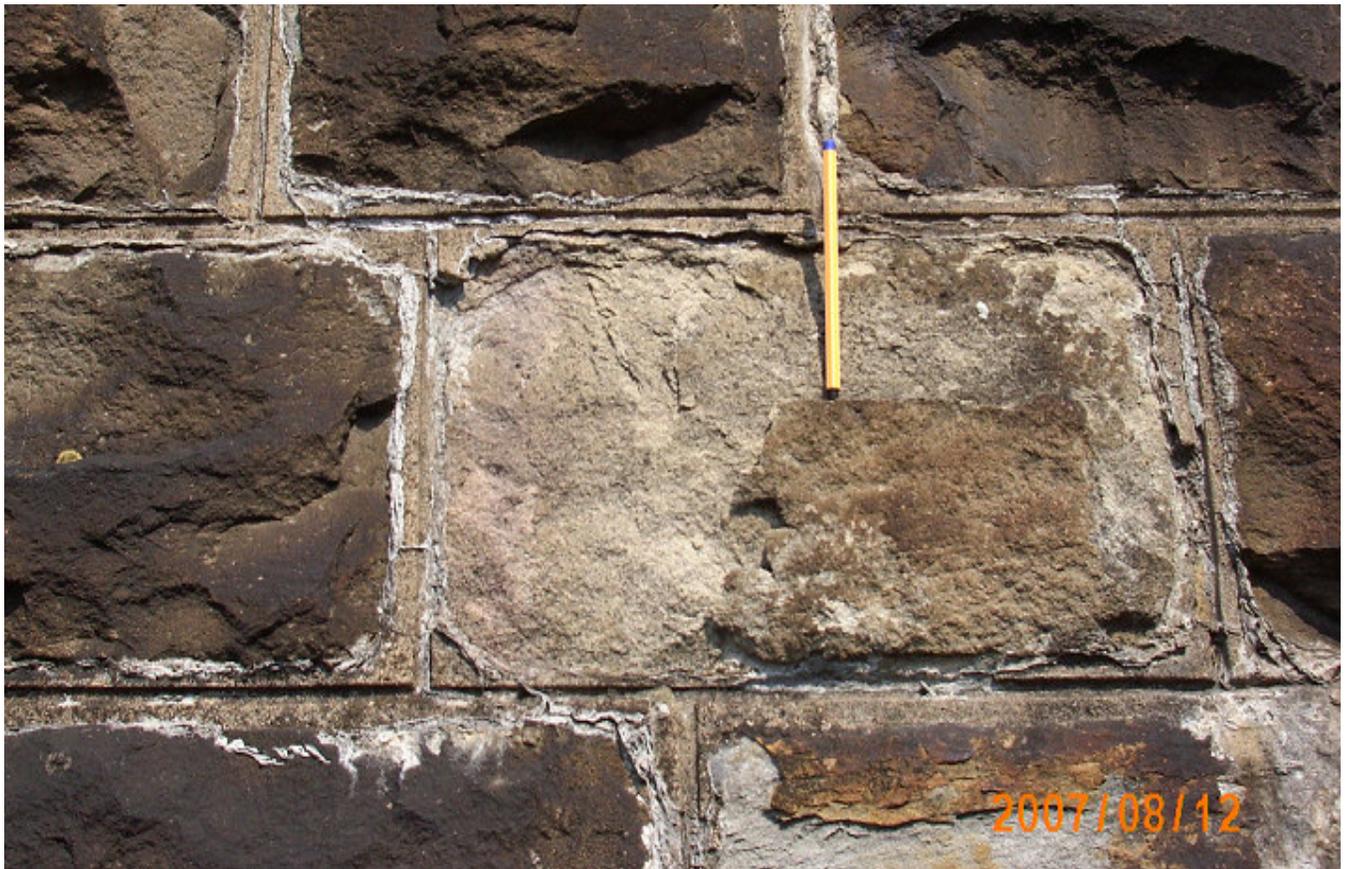
Figure 5. Stone surface damage by single scales and fragmentation into sand-grain size, intense linear salt efflorescence at stone's margins, blackening stone surface.

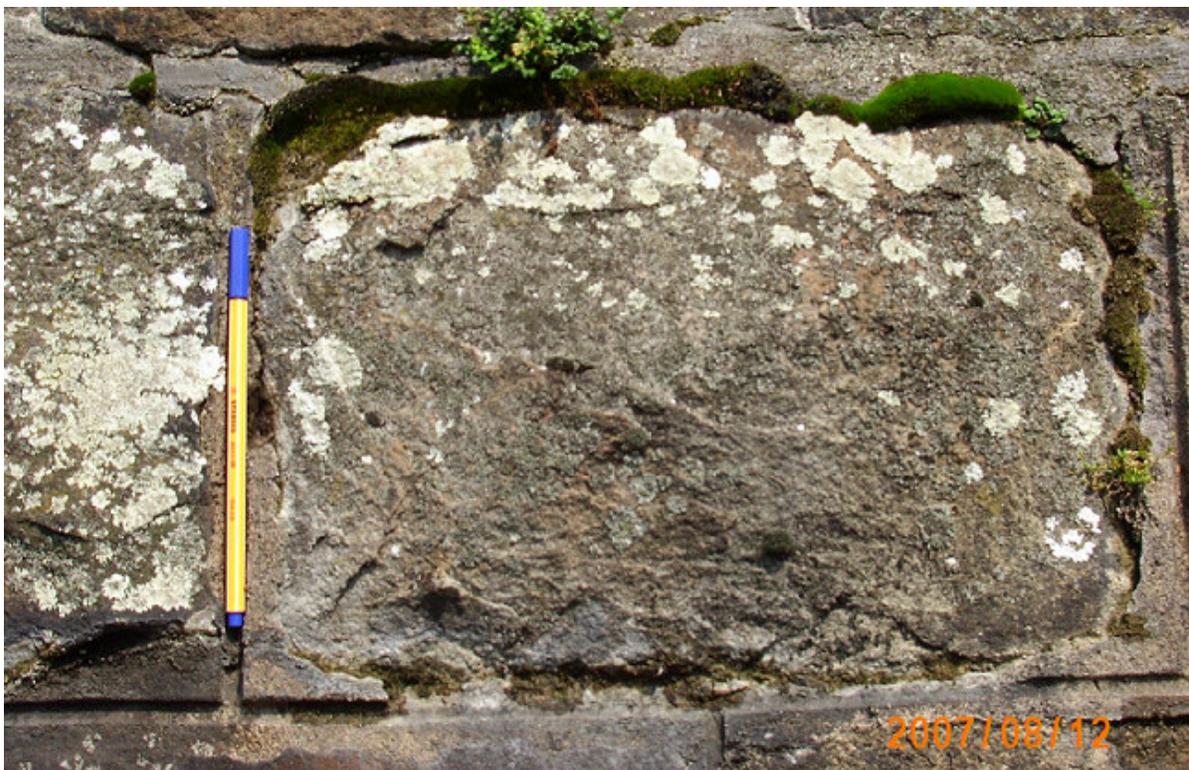
Figure 6. Structuring stone's surface into domal form, single scales, intense Lichens growth, microbial growth as fibrous soft tissue between stone's margins and the surrounding re-pointing mortar.

The high limit of air relative humidity and acid rainfall (a result of high pollution limit noted as blackening of sheltered and semi-sheltered stone surfaces) at Aachen City result in flourish of micro-organisms for example, Lichens' patches at stone surface free from salts and pollution, green algae at wet surfaces as noted in Figures (4b and 6), fungal hyphae and bacterial cells within rock

micro-thickness sheet adhering to this lichens (Figures 2b and 6).
