Full Length Research Paper

Rangeland rehabilitation using micro-catchments and native species in Turkana County, Kenya

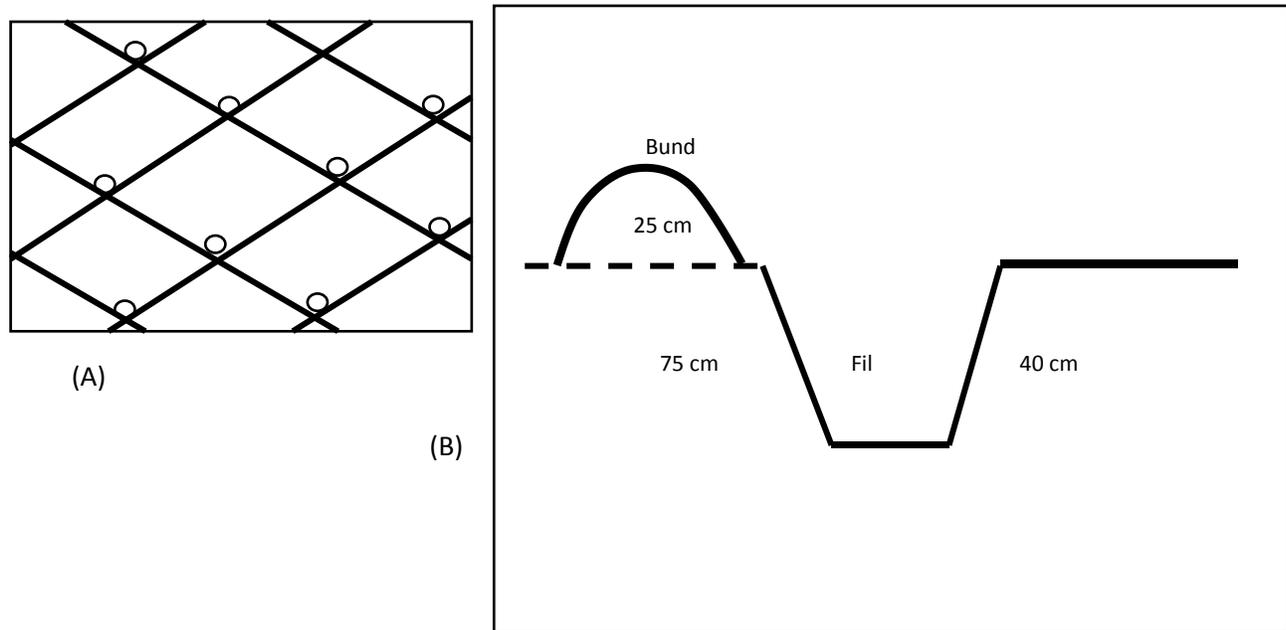
Figure 1. Micro-catchments in a plot (A) and a side view of bund and hole for trapping water in a micro-catchment (B).

Baseline and monitoring data were collected from each experimental site. The height and the root collar diameter of all the trees planted were taken after six months, using the height pole and vernier calipers, respectively. The species count was done for the two sites, and also vegetation counts in the two sites according to Muturi et al. (2014). The design of a micro-catchment is a 1.5 m arc (Figure 1 and Plates 1 and 2).

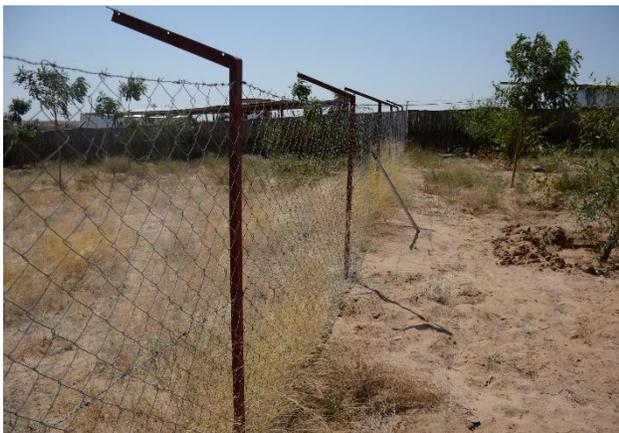
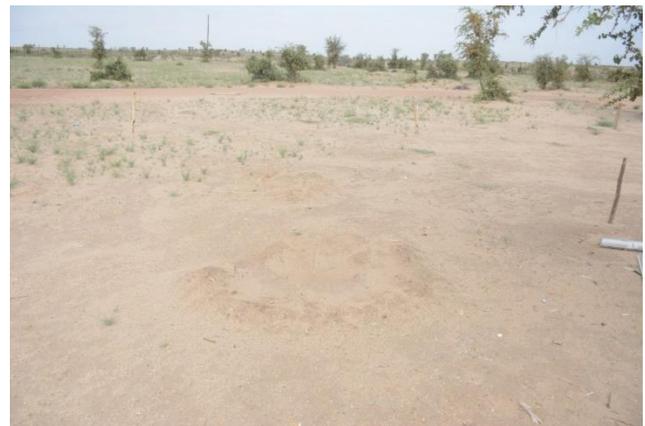
Plate 1. Plant species in the micro catchment of fenced (A) and non-fenced (B) plots.

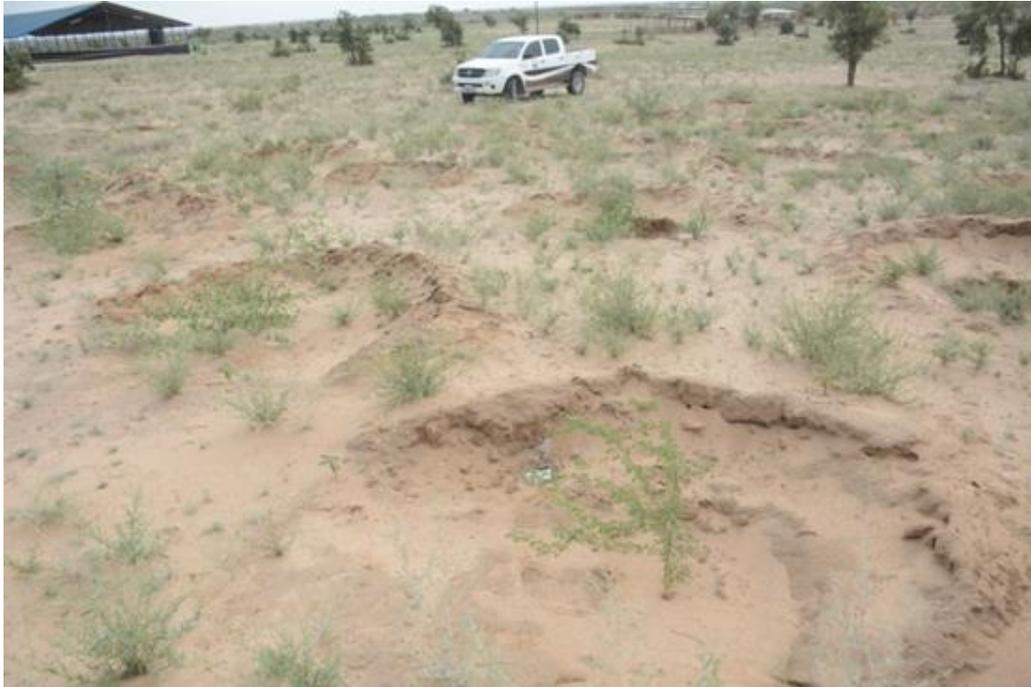
Plate 2. Area with micro-catchment and the abundance of vegetation.

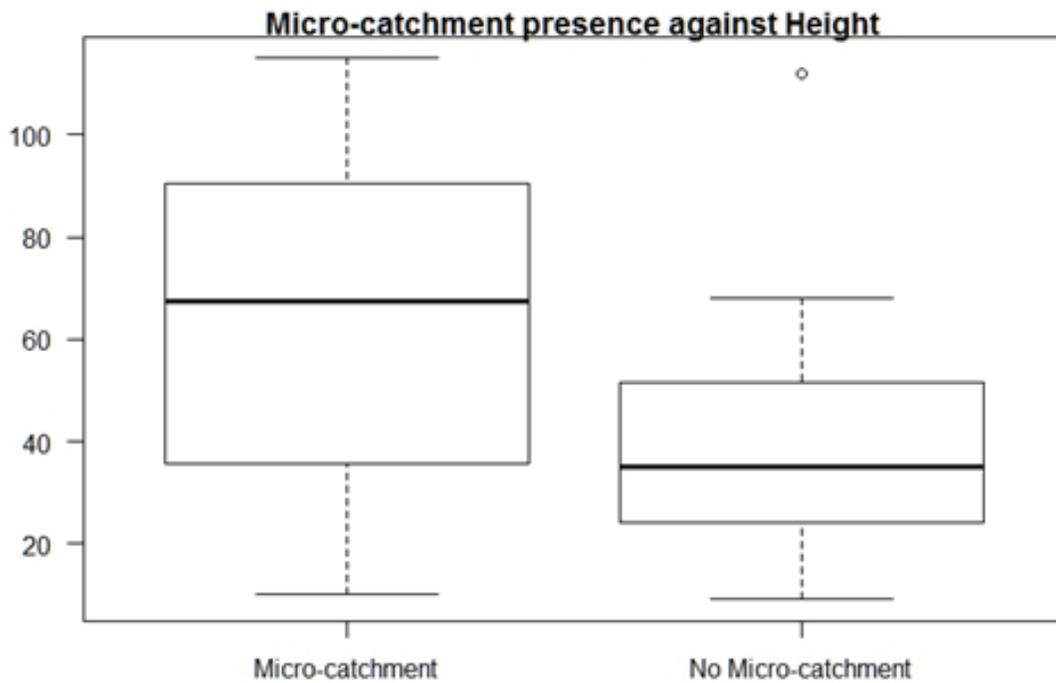
Figure 2. Boxplots showing tree species height comparison in micro-catchment and non-micro-catchment plots.

The boxplot shows the median height of species planted in micro-catchment and outside micro-catchment. Tree species planted in the micro-catchment shows a median height of 67.5 cm, while tree species planted outside micro-catchment show a median height of 35 cm. Most trees in the micro-catchment had height between 36 and 90 cm; and height as low as 10 cm and as high as 115 cm. Most tree species outside the micro-catchment had a height of between 24 and 56 cm; and height as low as 9 cm Figure 2.

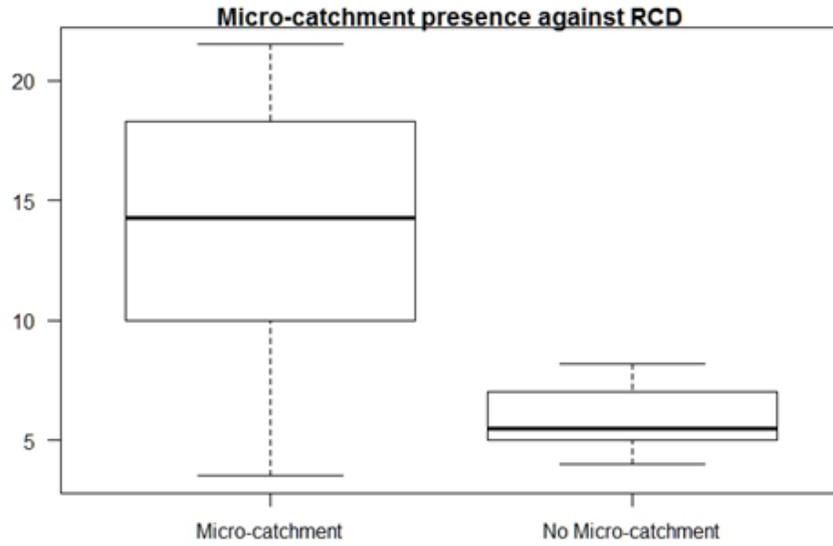
Figure 3. Boxplots showing tree species root collar diameter comparison in micro-catchment and non-micro-catchment plots.

The boxplot results show the median root collar diameter (RCD) of tree species planted inside the micro-catchment and outside micro-catchment. The median RCD of tree species inside the micro-catchment was 13.6 mm, while the median RCD of tree species planted outside micro-catchment was 5.5 mm. Most trees in the micro-catchment had RCD between 10 and 18.1 mm; and RCD as low as 3.5 mm and as high as 21.5 mm. Most tree species outside the micro-catchment had RCD of between 5 and 7 mm; and RCD as low as 3.5 mm and as high as 8.2 mm (Figure 3). The results of the assessment of the tree species planted using micro-catchments and without micro-catchment showed significant differences. The results showed that the mean height of trees planted with micro-catchment was higher (57.9 cm) compared to those planted without micro-catchments (39.6 cm). *A. senegal*, *A. mellifera*, *D. glabra* and *C. sinensis* in the micro-catchments had a higher mean growth in the heights of 95, 66.5, 31, and 79.4 cm respectively than those planted without micro-catchment at six months old. *Adenium obesum*, *Melia volkensii*, and

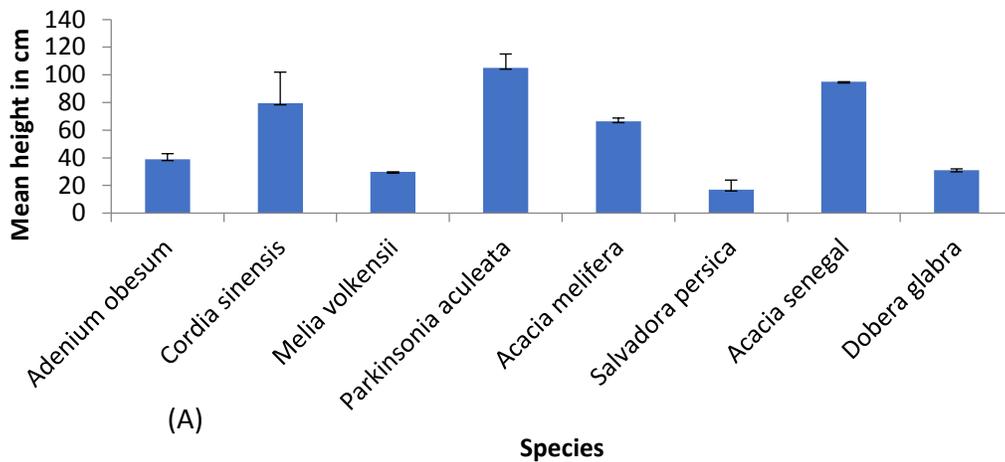
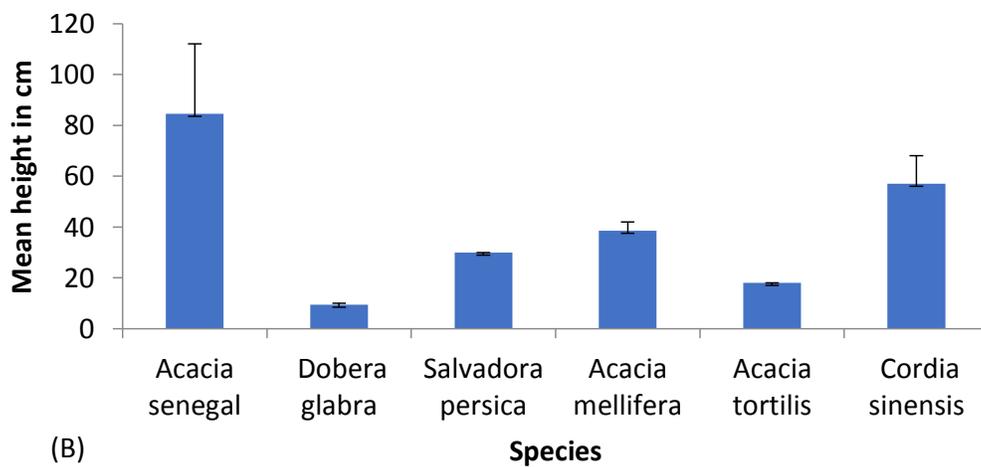
Figure 4. Mean heights of the plant species in (A) micro-catchment and (B) non-micro-catchment plots after six months of planting.

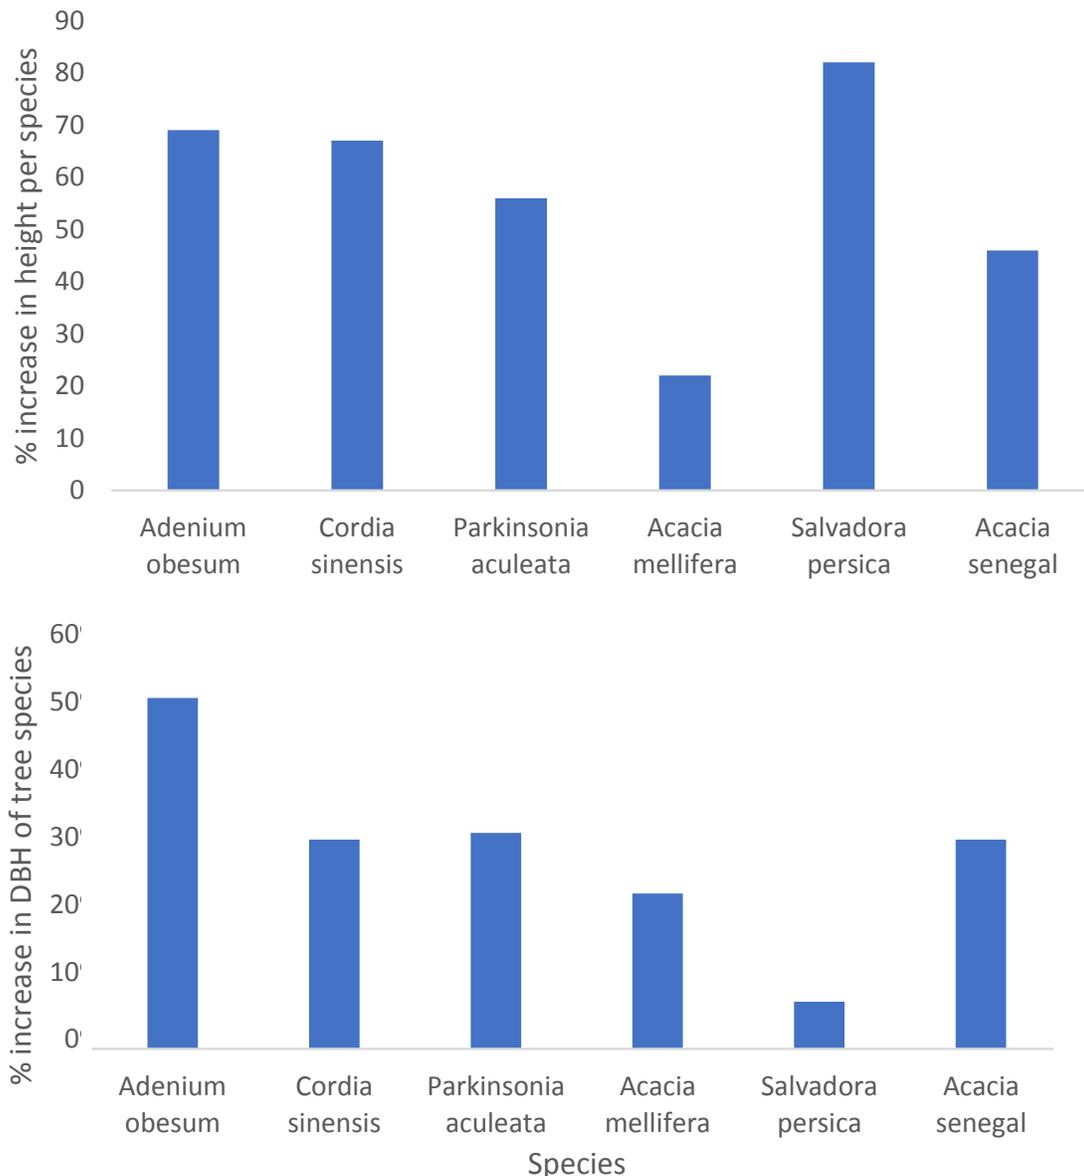
Figure 5. The percent increase in mean height and DBH of species in the site with micro-catchment after two years of establishment.

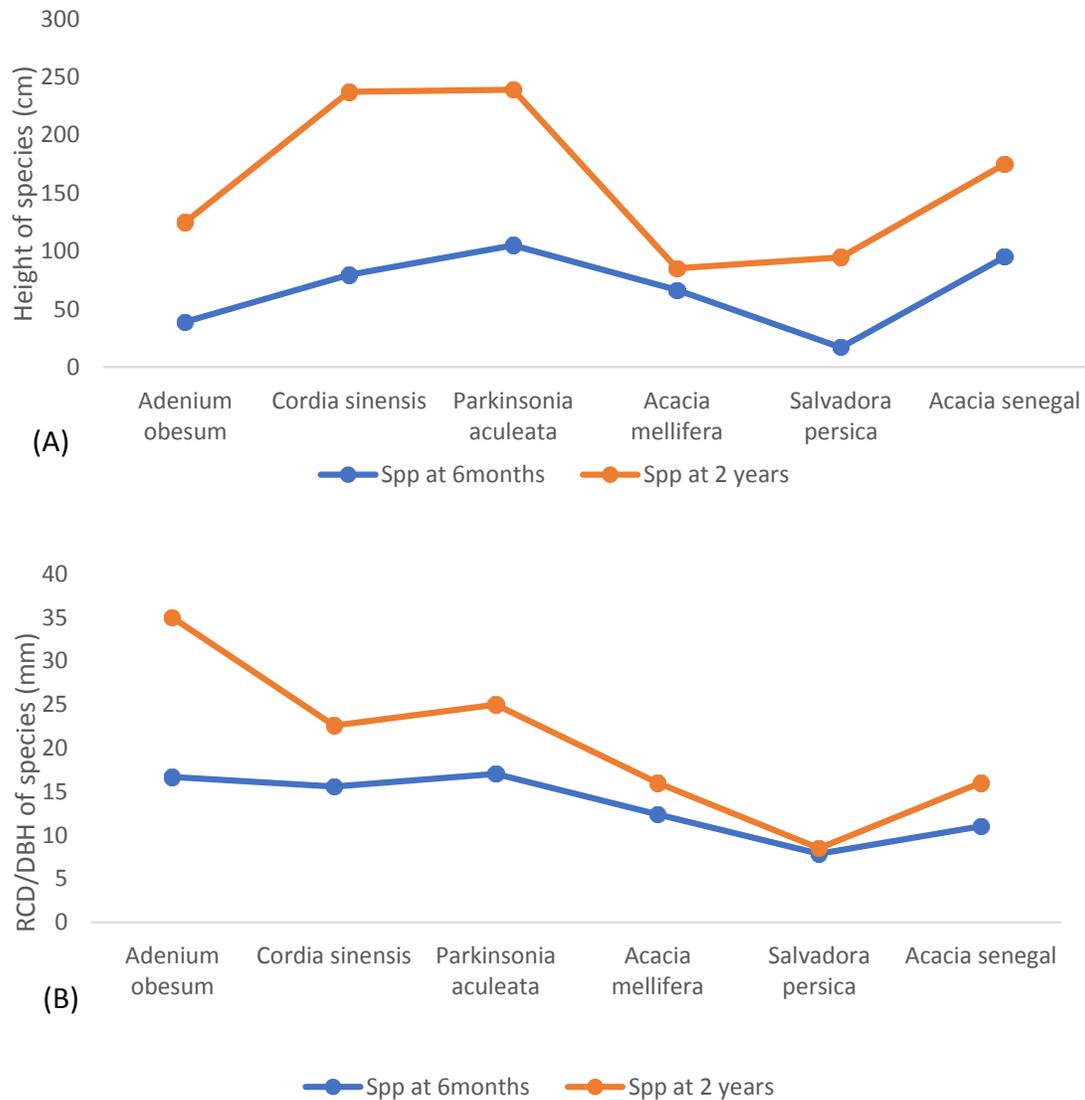
Figure 6. (A) Mean height of spp in micro-catchment, (B) Mean RCD/DBH of spp in micro-catchment at 6 months and 2 years old.
