Full Length Research Paper

Socio-economic effect of gully erosion on land use in Gombe Metropolis, Gombe State, Nigeria

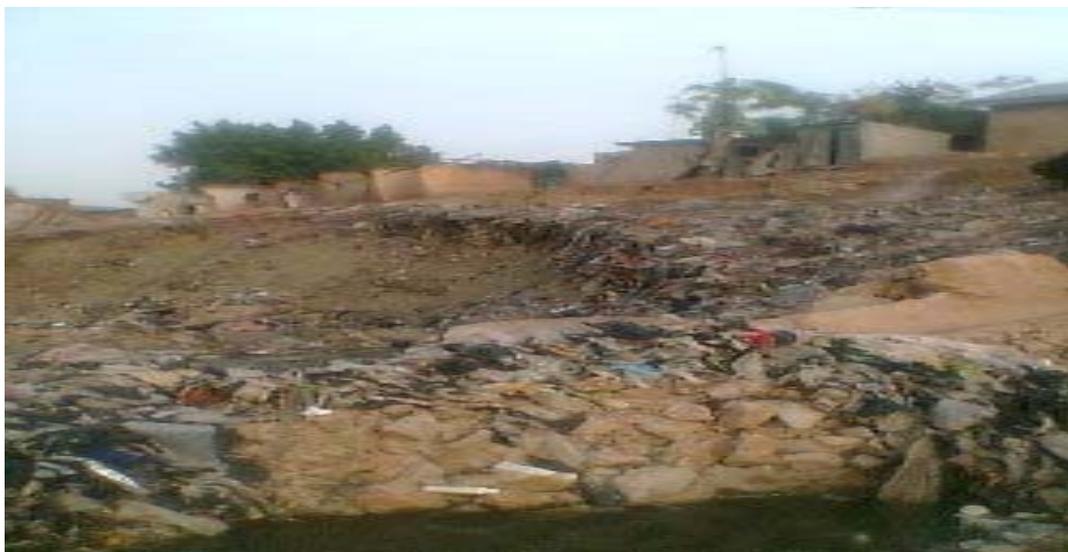
Plate 1. View part of houses destroyed at Herwagana by gully erosion
Source. Fieldwork, 2011.

destroyed by gullies are directly affected within the residential land use, but a total of four persons were affected by gullies in the agricultural land use and none identified to be directly affected in the other two land use areas (commercial and educational). Cracking and falling of buildings and other physical structures into gully sites are common features in the erosion prone areas within the study area. Shown in Plate 1.

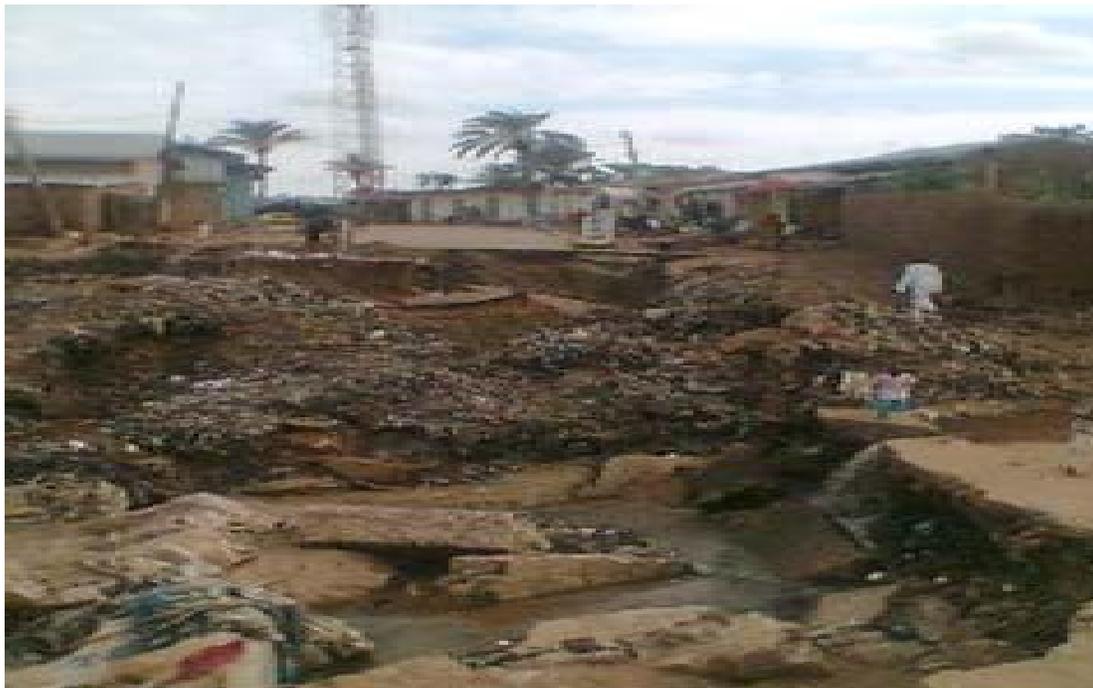
Plate 2. Bello Sabo Kudi road/ bridge destroyed by flooding in 2004.
Source. Field work, 2011

numerous, some of which are identified both through questionnaire administration and physical observation shown in Plate 2.
