# **A research on Karamursel region volcanic tuff as a pozzolanic additive in repair mortars used for historical buildings**

**Mustafa Ozgunler<sup>1</sup> and Seden Acun Ozgunler<sup>2\*</sup>**

<sup>1</sup>Department of Building Materials and Physics, Faculty of Architecture, Mimar Sinan Fine Arts University, Turkey.  
<sup>2</sup>Department of Building Materials, Faculty of Architecture, İstanbul Technical University, Turkey.

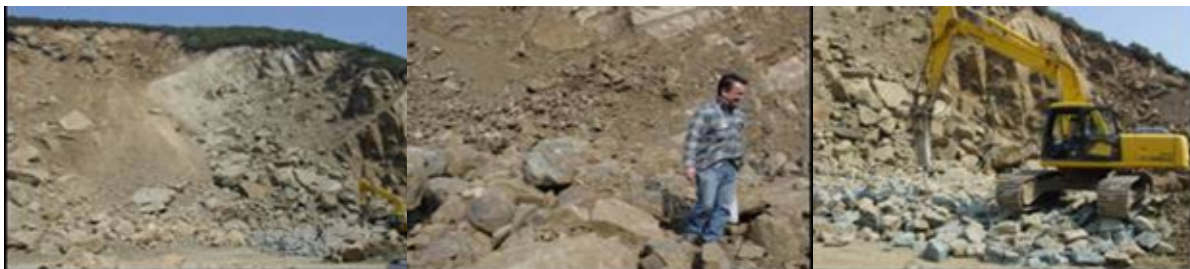
**Figure 3.** The photographs of the natural pozzolana sources in Kaytazdere.

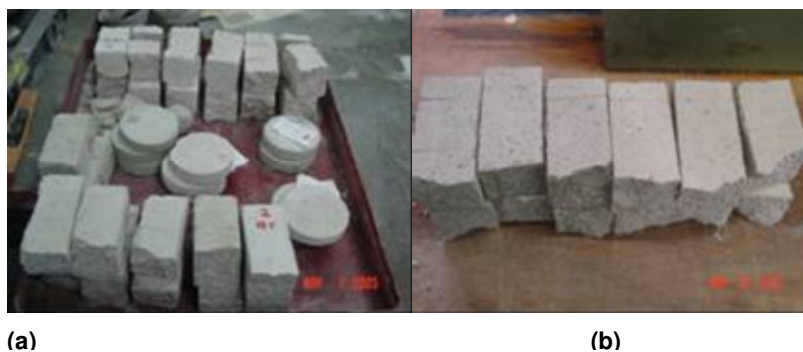
**Figure 5.** The mortar samples which were produced in laboratory conditions (TS 25).

cooling process, tensile and compression tests were performed. The results are shown in the following, Table 3, Figure 5.

According to TS 25, The compressive strength must be at least 4 MPa for the samples after 7 days of curing time and the tensile strengths must be at least 1 MPa. As the results were above the minimum values. These results indicated that the volcanic tuff which was used as a pozzolanic additive, was very active for silicate forming reactions. The results were given in Table 3.

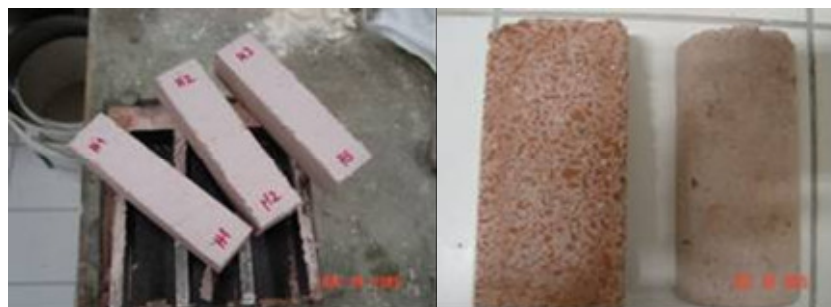
**Figure 6.** The Khorasan mortar samples which were produced in laboratory conditions.

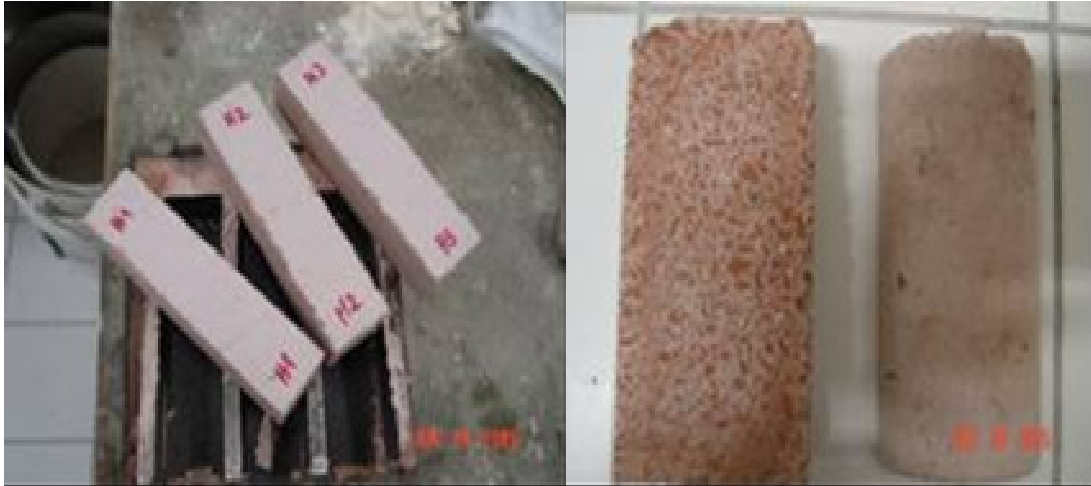
**Figure 6.** The Khorasan mortar samples which were produced in laboratory conditions.

researched. In Turkey, “Khorasan mortars” are mostly known as traditional mortars especially Roman, Byzantine and Early Ottoman Buildings. These mortars are also lime based mortars but crushed brick and dust were used as aggregate. For this purpose, mortar samples were prepared with the addition of pozzolana in the amount that will react with lime in line with lime, brick dust and crushed brick ratios of the samples taken from a historical building (Figure 6); after one week long curing process average of 10 MPa (100 kgf/cm<sup>2</sup>) compression strength was found (Gürdal et al., 2010).

The samples prepared as 8 mm and smaller sized crushed brick aggregated from the same mixture were kept in a moist environment for 1 month after production. Within this period, it was seen that the mortar did not crack and its strength increased to 14 MPa.

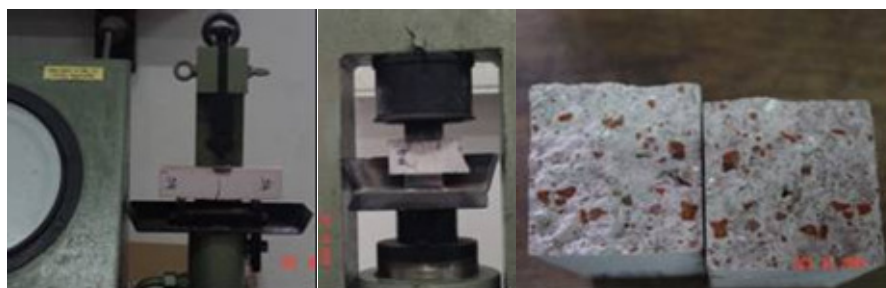
**Figure 7.** The mechanical property test photographs of the repair mortars.

In order to research the mechanical properties of the samples prepared as repair mortar under different curing conditions, tensile and compression tests were conducted and the results of the experiments were compared. The results of these experiments are shown in the following, Tables 4 to 7, and Figure 7. It has been concluded that in the case of using Kaytazdere origin material in mortars prepared with lime by grinding to the thinness specified in the standard (TS 25), it binds by making calcium water silicates and as a result of these reactions it gains sufficient amount of mechanical strength and doesn't display the week resistance and dissolution with water contact which are generally seen in lime mortars.
