Full Length Research Paper

Using spatial technologies for the planning of coastal zones: A case study of Kaynarca coast in the Sakarya Delta

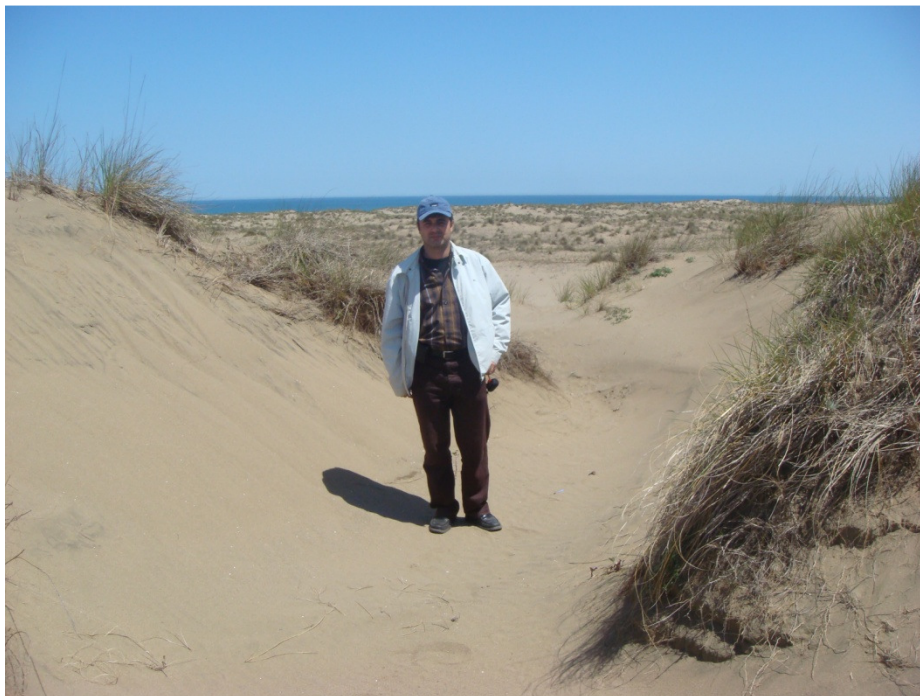
Figure 2. A View from Sand Dunes.

Sakarya Delta has a view of a coastline running alongshore, at the back a new dune chains, as to at the far behind old dune chains, trenches and plains between

these (Figure 2). The main unit of delta morphology consists of dunes which are formed by sea waves and wind together. In this area houses are constructed in the sandy territory. Agricultural soil is sand dune. Animals ramble in the sand area; roads are constructed along the sandy area (Inandik, 1963).

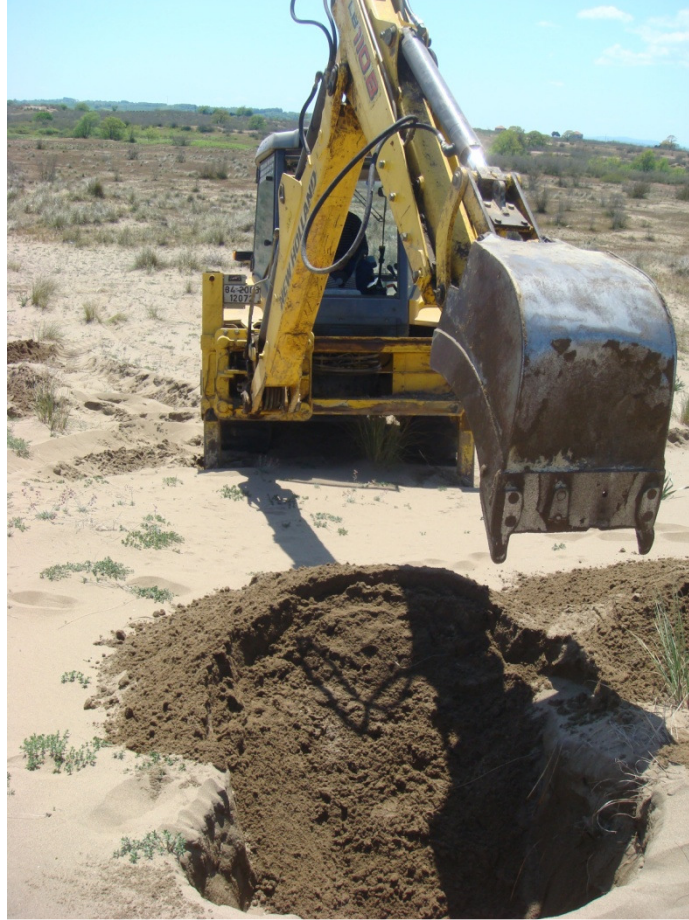
Figure 4. The sample dug parcel.

As understood from the excavations and surface observations in study area, almost all of the parcels in litigation are located on the beach sand that degree of sorting is high and well-washed. There are no clay-sized particles in the beach sand. In some places, they are composed of brown materials of fine sand and silt size with thin layers or lenses. This material is enriched with ferrous minerals in some places is composed of principal components of beach sand.
