Full Length Research Paper

The effects of locational factors on vandalism in the seaside parks

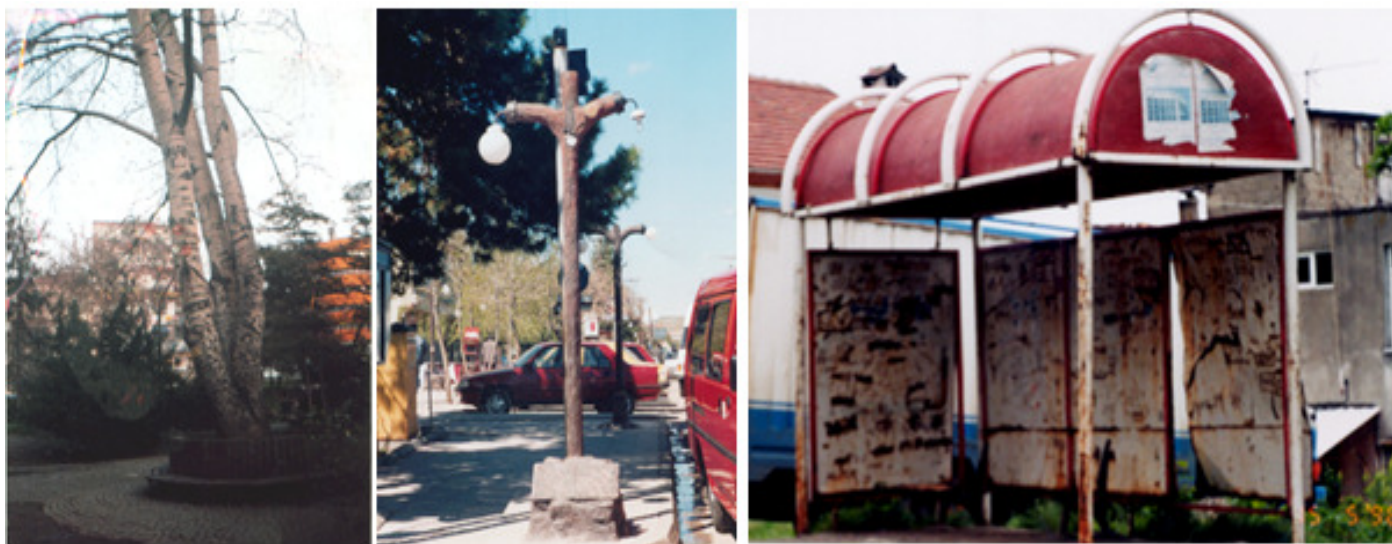
Figure 1. Some examples of vandalism.

Vandalism is one of the general dangers in the public realm, especially in public open spaces (Lynch, 1971). Studies carried out for many years in disciplines such as psychology, sociology, criminology, linguistics and more recently in design, showed that vandalism has made significant destructions in public spaces and has been considered to be a danger for the cities and people who live in them. Stanley Cohen, a psychosocial researcher, describes vandalism as illegally destroying the goods belonging to someone else or spoiling their appearances (Ward, 1973). Acts of vandalism can be seen at various places as shown in Figure 1 (Yildirim, 2000).

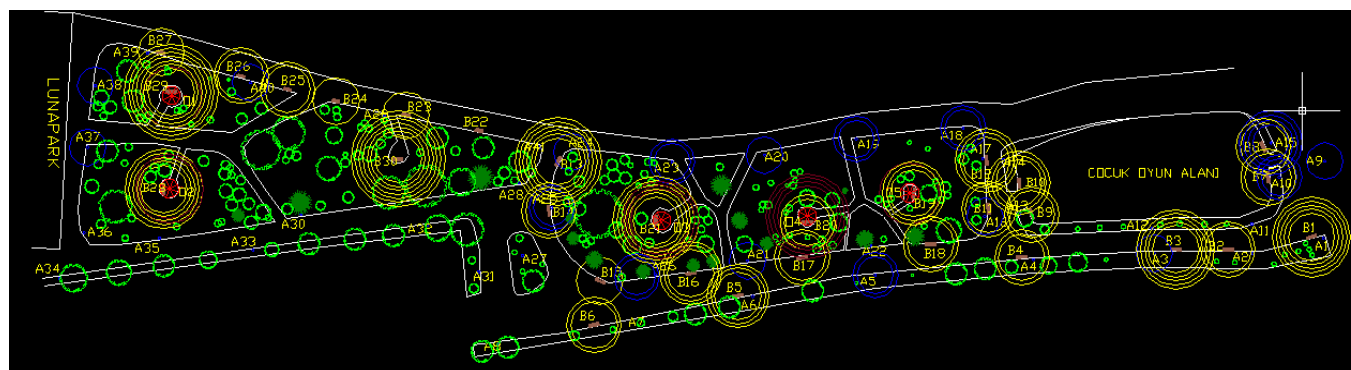
Figure 2. Ahmet Sener park.

- Number of the months in which damages were found at the benches
- Number of the months in which damages were found at the elements under sunlight
- Number of the months in which damages were found at the elements of covering

In Ahmet Sener Park, the benches numbered B13, B20, B21, B28, B29 and B30, located in semi-closed places surrounded by either partly or fully covered dense plants, have been damaged more than the others. This may be due to the fact that benches are situated on the secondary roads which are far from the road junctions

In Ahmet Sener Park, damaged elements of illumination are densely found around the centre of the park. The broken elements of illumination that are not repaired afterwards increase the possibility of vandalism on others around it. The damages observed on the neighbouring illumination elements, A25, A26, A18, A10, A9 and A24, support the possibility that damage at an element causes damages on the elements located nearby (Underwood, 1980).

Visibility of the lighting and illuminating elements numbered A30, A31, A32, A33, A34 and A35 are screened by groups of shrubs which appear to decrease the incidences of vandalism, especially in the seasons when these plants have leaves. Similar observations were made in Adnan Kahveci Park. The illumination elements located in poorly planted areas were more often targets for vandalism while illumination elements located in shrubs and bushes numbered A27, A28, A29, A30, A31, A32, A33, A34, A35, A36 and A37, were not

damaged as much (Figure 2). Some illumination elements numbered A17, A18, A20, A21, A22, A24, A25, A50, A53 and A54, located among bushes and short trees, were also vandalized.

In Ahmet Sener Park, sunshade elements are situated on secondary roads. In addition, they have been partially screened by plant groups that can be seen from the main roads in the park. Although there are many different sunshade elements in different locations in this park, that those conditions are considered to be effective one by one in damaging these elements. Sunshade element Ö4 that is out of control because of the dense plantation (Figure 1) is damaged more in comparison to others which have similar location with the other elements. Damages have also been observed at the sunshade elements under the flyover in Adnan Kahveci Park (Figure 2). This area planted with tall plants is used more occasionally than others, in which the furniture is much exposed to vandalism.

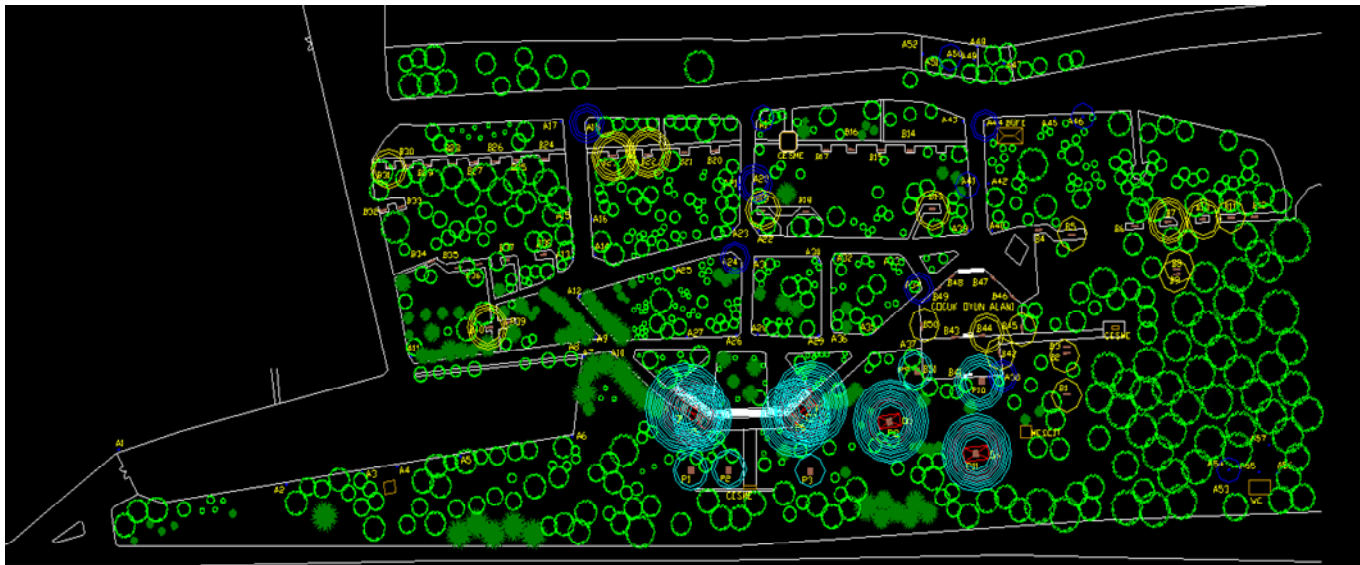
Figure 4. 100. Yil park.

- Number of the months in which damages were found at the benches
- Number of the months in which damages were found at the elements under sunlight
- Number of the months in which damages were found at the elements of covering

In 100.Yil Park, in which sunshade elements already exist are most exposed to vandalism because their visibility from the secondary roads has been partly screened by plant groups and are obscured visual controls (Figure 4).
