Full Length Research Paper

Monitoring land use changes in tourism centers with GIS: Uzungöl case study

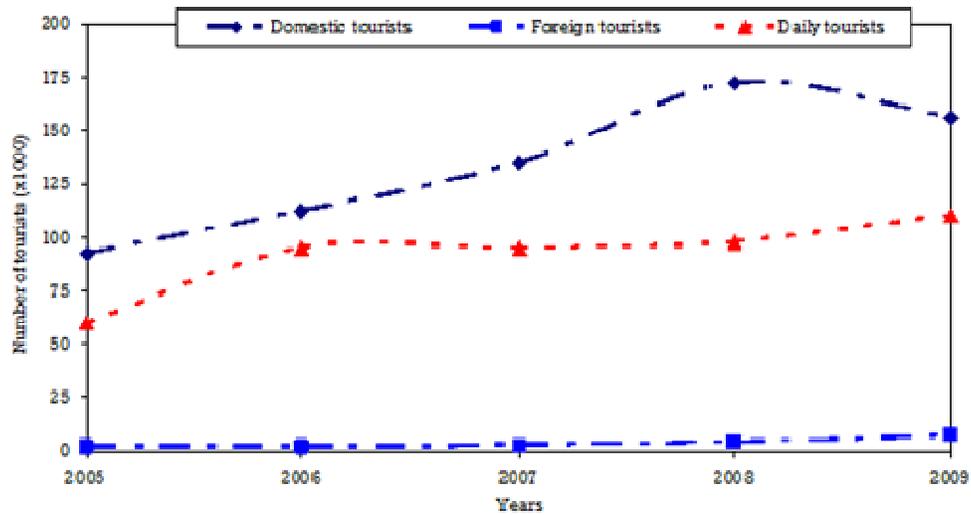
Figure 2. Distribution of number of tourists visited Uzungöl in the last five years.

dations (Hotels, Motels and Pensions) in the region was 41, and the total bed capacity of these enterprises was 1191. When the last five-year data was taken into consideration, it was shown that, the region was subject to intense tourism activities (Figure 2). In 2005, 92,348 domestic and 1,790 foreign tourists stopped by the region, while approximately 60,000 people visited daily. In 2009, these figures were 156,000, 7,000 and 110,000, respectively. When the last five-year values were compared, the increase in the number of domestic tourists that spent the night was 69%, while the number of foreign tourists staying was observed in a significant increase with 290%. A total of 1,142,907 domestic and foreign tourists that clearly shows the region's tourism that potentially visited the region in the last five years.

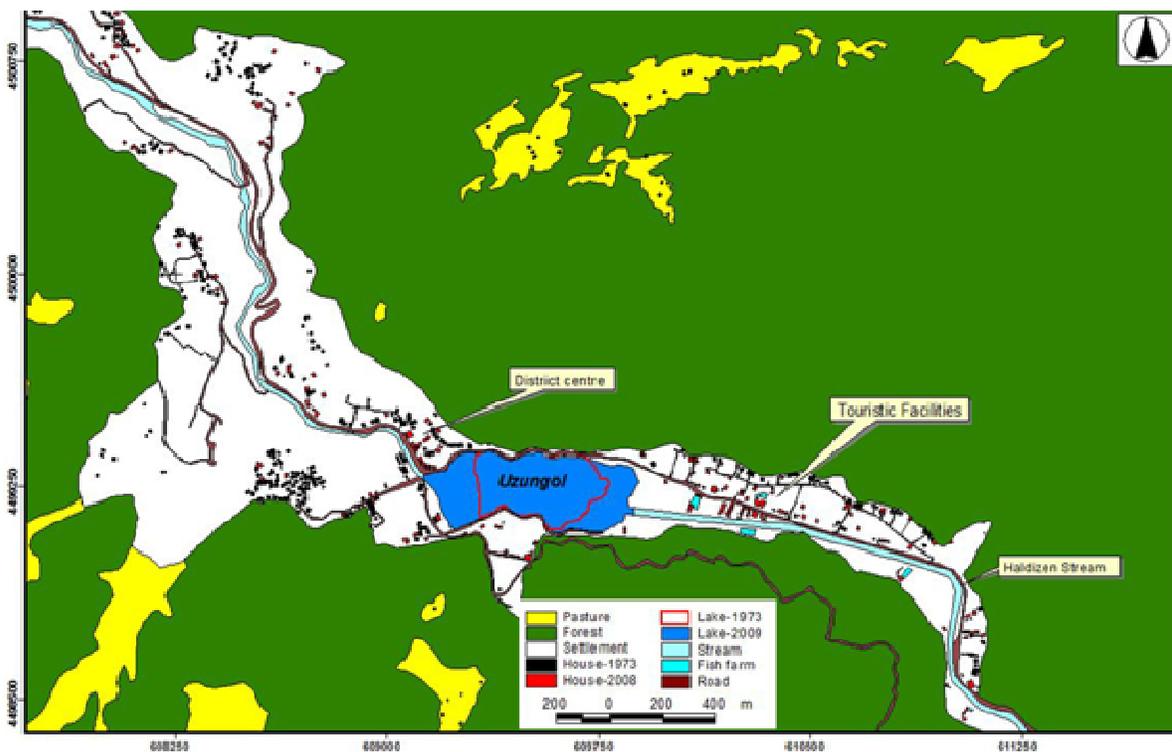
Figure 3. Temporal land use changes in Uzungöl between 1973 and 2008.

In the Eastern Black Sea region, depending on topography, rural settlements are very scattered to a greater extent (Anonymous, 2000). This structure rarely appears in Uzungöl (Figure 3). Because of adverse terrain of the region and lack of suitable land for habitation, a collective settlement is almost observed. Analysis results showed that the total settlement area was 194.66 ha in 1973, while, in 2002, it was increased to 195.25 ha (Table 1). Approximately, 0.6 ha that observed increase was due to the decrease in the river bed area as a result of improvement works conducted by the XXII Regional Directorate of the State Hydraulic Works (DSI) in 1998. It was known that, significant disasters such as floods and landslides often experienced in the region have cause loss of life and property. Therefore, the negative effects of construction on stream bed are taking place from time to time in the region.

On the other hand, changes experienced between 1973 - 2008 in road network and construction in Uzungöl SEPA are shown in Table 1 and Figures 3 and 4. According to Table 1, there were 299 houses in the area in 1973 with a total area of 37.8 ha. In 2002, there were 560 houses (an increase of 87%) with an area of 59.5 ha. Between 2002 - 2008, a small increase in the number of houses (571) was observed with an area of 6.08 ha. In 2004, the area was covered by the SEPA and illegal construction has decreased significantly through strict measurement. Overall, a significant increase in the number of houses (91%) has been observed for the last 35-years. This significant increase in the housing in Uzungöl

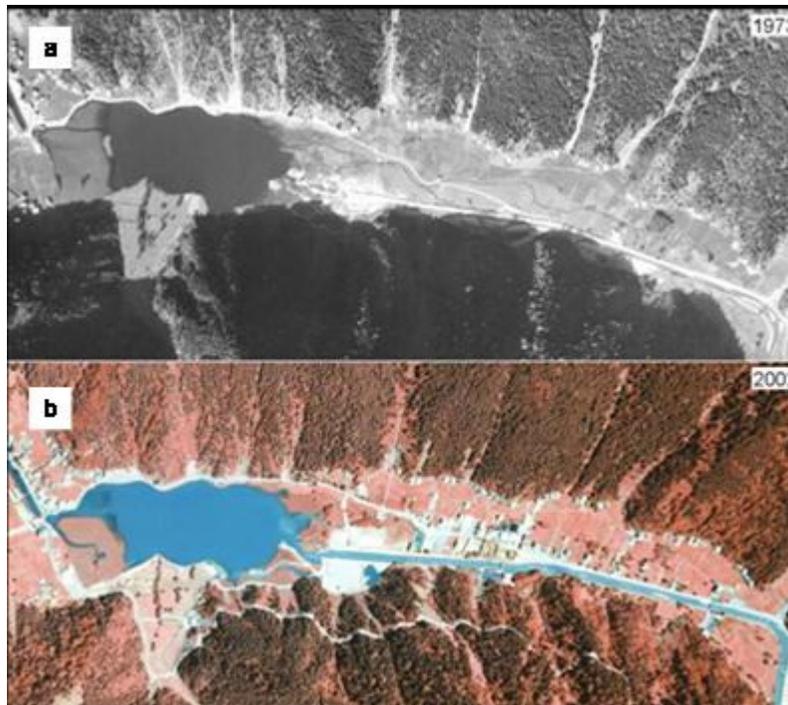
Figure 4. Temporal changes observed in Uzungöl between 1973 and 2002.

A dense concrete structure was observed in the natural lake park of Uzungöl (Figures 4 and 5). There were 97 houses in the vicinity of the lake in 1973 with a total area of 1.33 ha, while the average area of the houses was 137 m². It can be seen that almost all were built on private property on the edge of the forest away from the lake and river basin (Figure 4a). Since landslides and flooding were frequently occurred in the lake and river basin as a result of the rugged terrain of the region, this is an

built for pension and hotel-style accommodation purposes. It can also be seen in Figures 4 and 5 that most of new houses are built within the lake basin.

Results of photogrammetric analysis show that lake area in 1973 was seen as largely filled (Figures 4 - 6). Indeed, water covered lake area was found to be 8.71 ha. In 2002, this figure is measured as 10.39 ha. Two sedimentation preventative bents were constructed by DSI in 1991 and in 1993, in order to prevent the rapid filling of Uzungöl. In a study of hydrology, erosion and sedimentation of this basin has also shown that the filling of the lake was largely caused by soil erosion (Önsoy et al., 1995). Artificial lakes were formed behind these two bents. Areas of these lakes are not large enough to

Total forest area was 746.14 ha while, it was determined as 744.4 ha in 2002. 1.73 ha decrease in the forest area is a result of roads opened for field trips in the forest by the Forest Administration Directorate (Figure 4). Between 2002-2008, no change was detected for the forest lands. The road construction works undertaken in the foot slope of the valley completely disturbed the balance in Uzungöl basin and new artificial landslides were observed subsequently. In addition, it caused an enormous increase in the amount of sediments in the stream. During road expanding works at the southern section of slope by road vehicles, the southern banks of the river were filled with excavated material. As a result, the flow rate of the river was increased due to narrowing of the river bed. This situation caused by severely eroding of land at the northern slope and the new landslides were recorded (Altundağ, 2008). Pasture area between 1973, 2002 and 2008 was 43.84 ha without any change. Pasture lands are generally used for livestock grazing in the region.

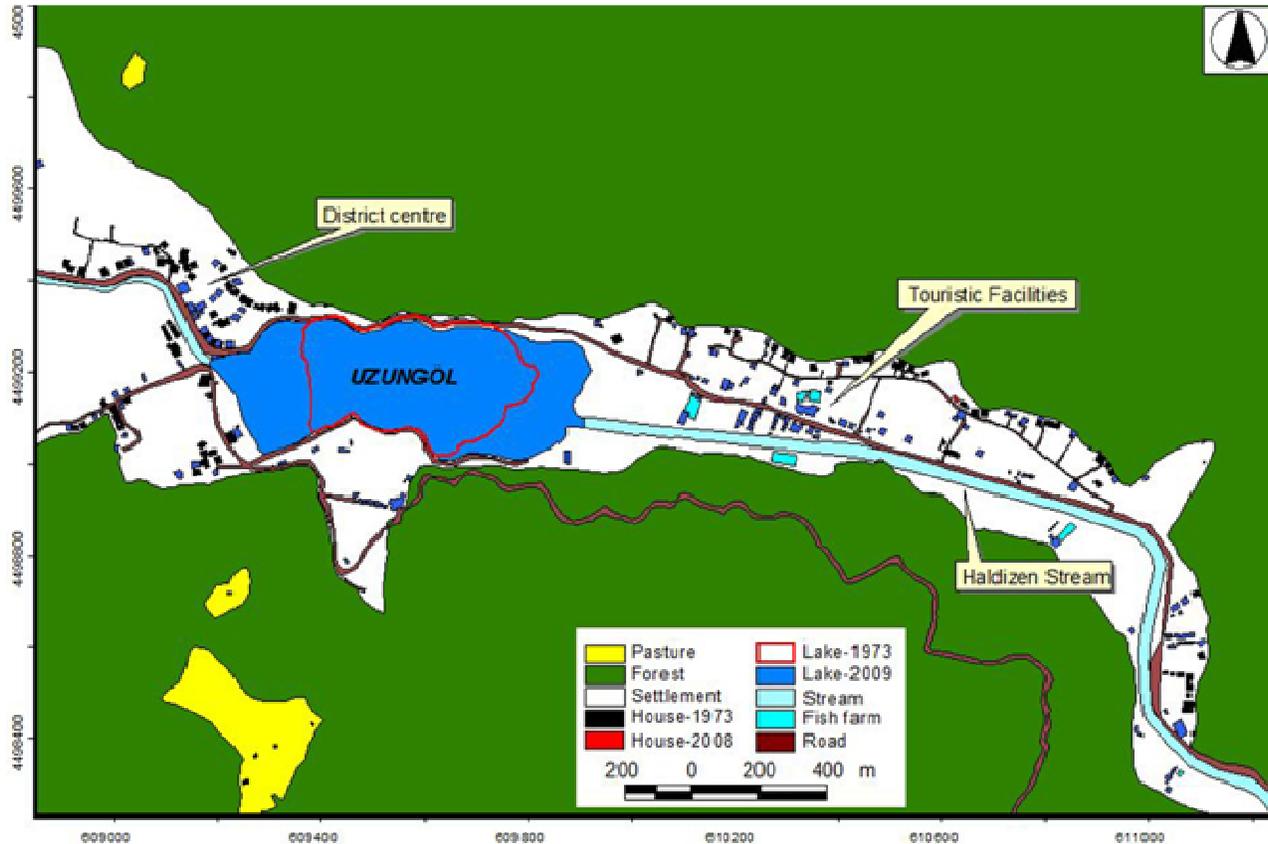
Figure 5. Temporal land use changes in Uzungöl lake basin between 1973 and 2008.

On the other hand, in 2002, while there were 293 houses, the residential area of these houses covered 2.98 ha in total and the average area of houses was found as 102 m². In 2008, the number of houses was 295, the total residential area was 2.99 ha, and the average was 101 m². In addition, six fish farms are located in the lake basin with a total area of 3,108 m². Some of the houses around the lake were built according to actual restoration of old houses in 1973 and most of them were being used for tourism purposes, while some have been completely reconstructed. Almost all the additional houses consist of accommodation and catering facilities (Figure 5).

The completion of the road initiated in 1990 to connect Çaykara to Uzungöl has become the starting point for the tourism in the region. After that, local people having real estate in the lake basin were accelerated for construction facilities for tourism. Increased tourism activities were also resulted in private sector investment in the Uzungöl. Especially, a sudden increase in the construction of touristic accommodations and restaurant facilities was observed in the region. 8 hotels were constructed by the private sector with a total area 250 m². Some of the private sector houses consist of home-style wooden bungalows. Almost all the facilities are situated in the lake basin. 125% increase in the amount of construction within the lake basin has been determined for the last 35 year period (Figures 5 and 6b, c). Rather than being built in the traditional architectural style new houses are mostly

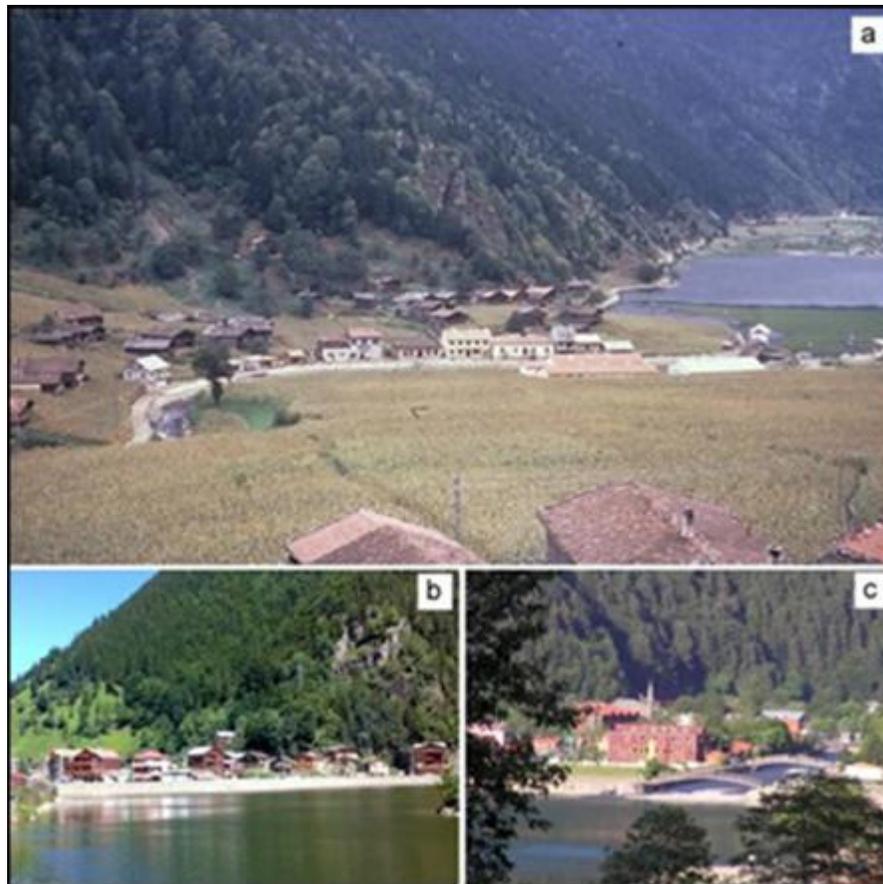
Figure 6. Experienced dense construction in Uzungöl SEPA.

Due to region's rugged land morphology, there is a collection of settlements on hill foots (Figure 6). Houses in the region are constructed according to traditional architecture of the region and they are attractive buildings in aesthetic view. Section of buildings used as a stable was constructed from stone, but parts are used as housing was entirely made of wood (Figure 5). For the construction of old houses, the necessary materials have been provided from the surrounding forest. The houses are generally two-storey, but three-storey ones are also common. In the majority of dwellings, the lower parts excavated in the slope were being used as the stable, where the upper portions were being used as the residence. In these type of houses, sub-floor used as a stable is made of stone, while the second floor is entirely made of wood.

A large part of these houses was built in concrete construction techniques and they were re-arranged using wood veneer in fronts in order to simulate regional architecture (Figures 6b, c). In addition, newly constructed houses are made of wood with a larger floor area and multi-storey (3 or 3.5) like apartments (Figure 6c). Therefore, protection barriers of urban planning can be prevented by building new houses instead of the former traditional wooden houses (Figure 6a). Because of special importance of the region, Protection of Natural Heritage Committee in 1998 was declared Uzungöl Municipality and surrounding villages as I and III Degree Natural Protected Area. Due to the increase in profit, it was difficult to prevent illegal construction. As a result, the traditional architecture and character of local structures were moved away towards new applications to meet the daily requirements. New construction adversely affects texture and silhouette of traditional houses and it causes visual pollution. Rather than to meet the accommodation needs of those living in the area, houses built in the last 35 years were mostly constructed to respond touristic accommodation facilities. This indicates that construction in Uzungöl now comes to the fore as the

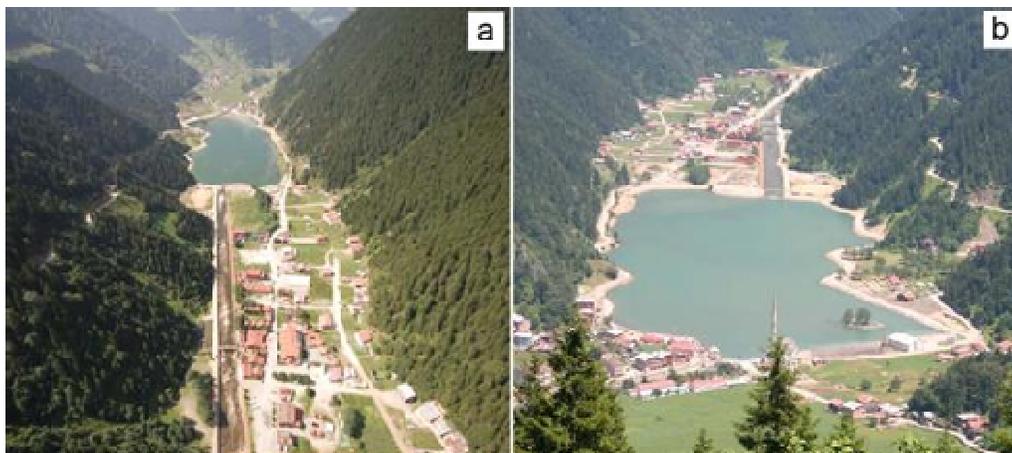
Figure 7. Size of construction in Uzungöl basin in 2008.

comprehensive lake cleaning work was conducted in 2004 by DSI. The amount of material removed was approximately 250,000 m³ (Altundağ, 2008). In 2008, a result of the cleaning operation of water-covered by area of lake to reached 14.59 ha (Figure 7a, b) and it corres-

ponds to 67% increase in the lake area compared to 1973. The bathymetric measurements conducted in Uzungöl lake showed that the deepest part of lake was 9 m in 1969 and it fell under 8 m in 1994 (Alkan, 1996). After the cleaning work, the deepest part of lake was 25 m and the shallowest part was measured as 7 m.
