# Evaluation of sustainable urban preservation concept via Ankara Hamamönü example

**Key words:** Sustainable preservation, historical city centre, Ankara Hamamönü.

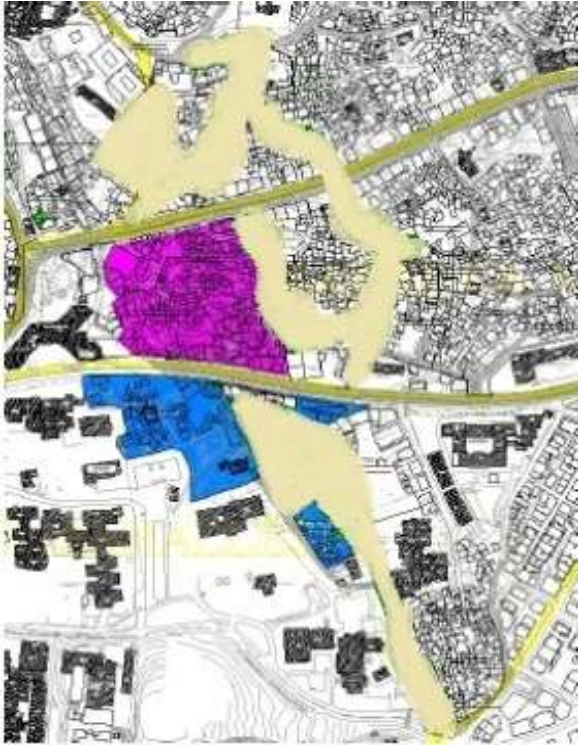
**Figure 1.** Types of Intervention (Source: Municipality of Altındağ, 2014).

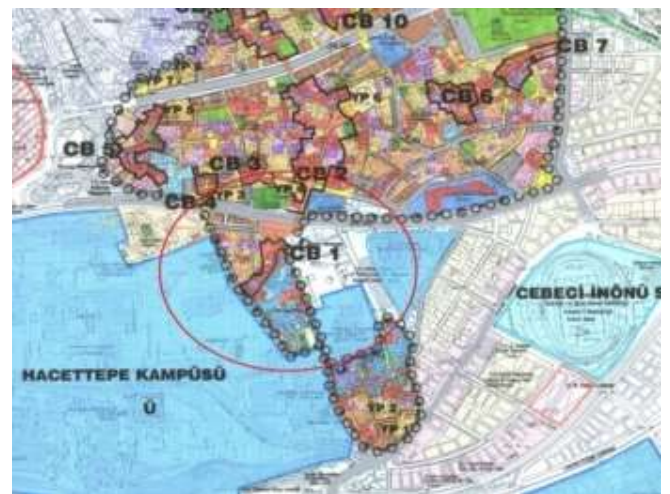
**Figure 3.** Revitalization areas (Source: Municipality of Altındağ, 2014).

Nine street rehabilitation projects were prepared in the region between Ankara Castle and Hacettepe University Hospital (Figure 2), which are boundaries of Hamamönü (Figure 3). The intervention area involves approximately 21.8 hectares. In the context of street rehabilitation project studies, totally 259 buildings were rehabilitated from 2006 up to 2010 (Arslan, 2012). Generally within the

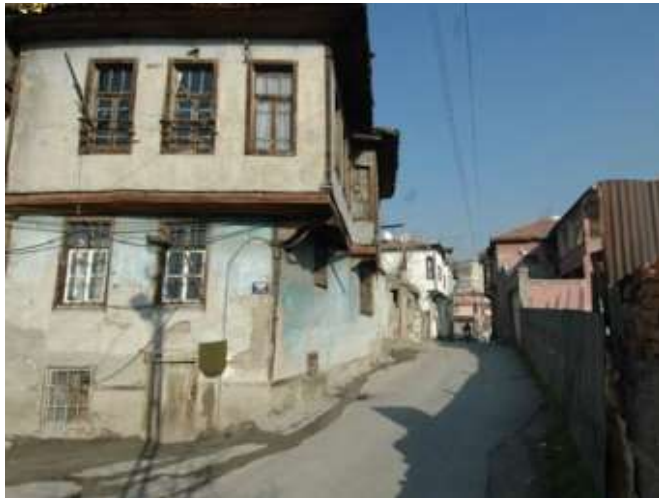
**Picture 1.** İnci Street, before restoration (Source: altindag.bel.tr,2014)

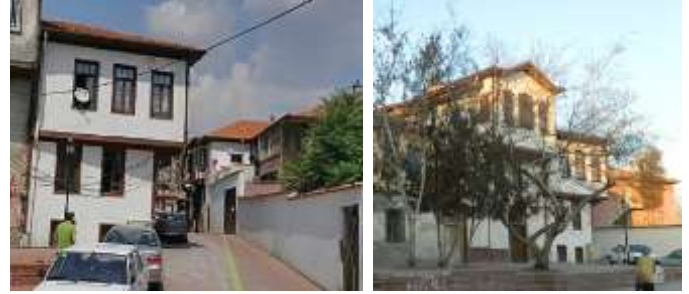
**Pictures 2 & 3.** İnci Street, after restoration current status (Source: Writer, 2014).

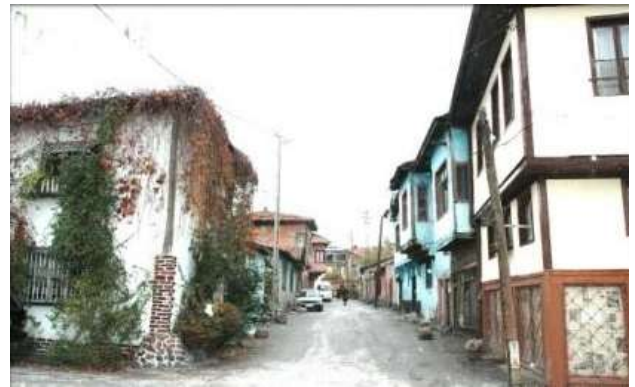
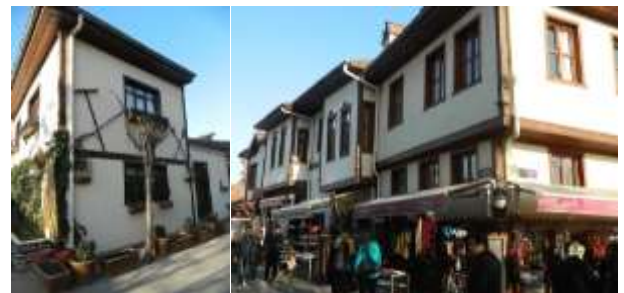
**Picture 4.** Dutlu Street, before restoration (Source: altindag.bel.tr, 2014).

**Pictures 5 & 6.** Dutlu Street, current status (Source: Writer, 2014).

İnci and Dutlu Streets were determined priorly as “1st Revitalization Area” because of the closeness to the Hacettepe University, in 2006 (Arslan, 2012: 81). 20 of the 36 buildings which were held through street rehabilitation projects were registered officially (Figure 4). The front facades of buildings were restored primitively (Municipality of Altındağ, 2014) (Pictures 1, 2, 3). Nowadays, these buildings generally function commercially like restaurant, cafe, pharmacy or market etc (Picture 4, 5, 6).

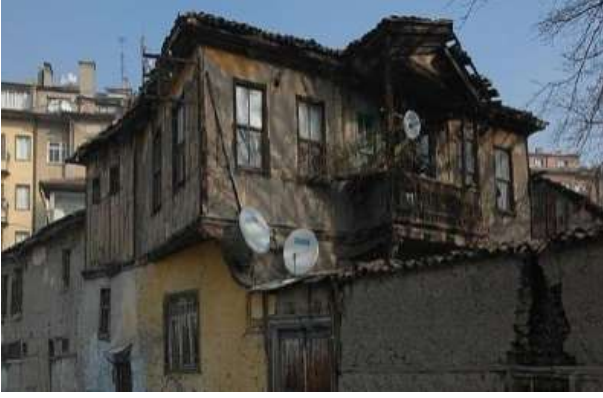
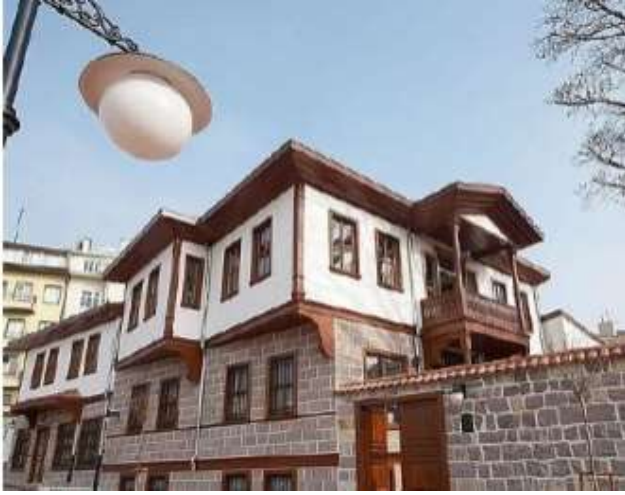
**Picture 7.** Beynamlızade's Mansion, before restoration (Source: altındag.bel.tr, 2014).

**Picture 8.** Beynamlızade's Mansion, current status (Source: Writer, 2014).

Second stage of the project consists of the rehabilitation of four streets close to the Hacettepe University. At the renewed wooden window elements original details were lost, uniform frames were used (Pictures 7 and 8).

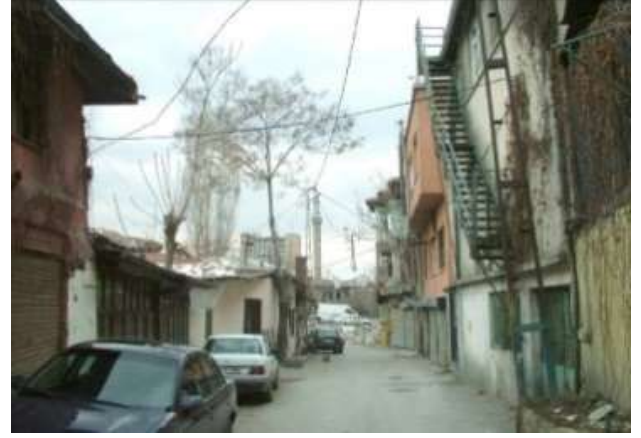
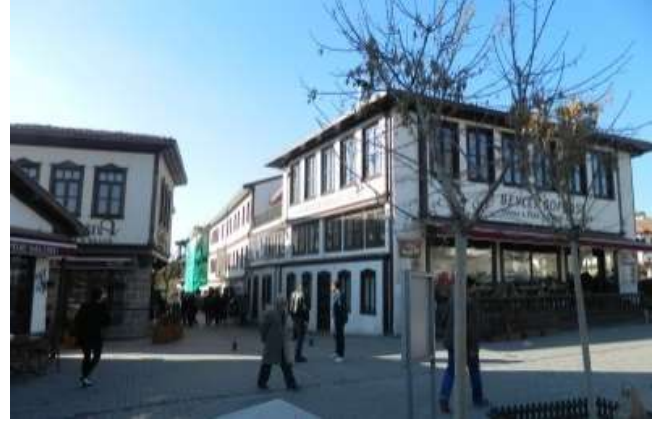
**Picture 9.** Hamamönü Street, before restoration (Source: altındag.bel.tr, 2014).

**Picture 10.** Hamamönü Street, after restoration (Source: Writer, 2014).

In the context of the project, which was prepared by a technical team of the municipality, totally 17 buildings were rehabilitated, 3 of them were officially registered (Arslan, 2012) (Pictures 9, 10, 11, 12, 13 and 14).

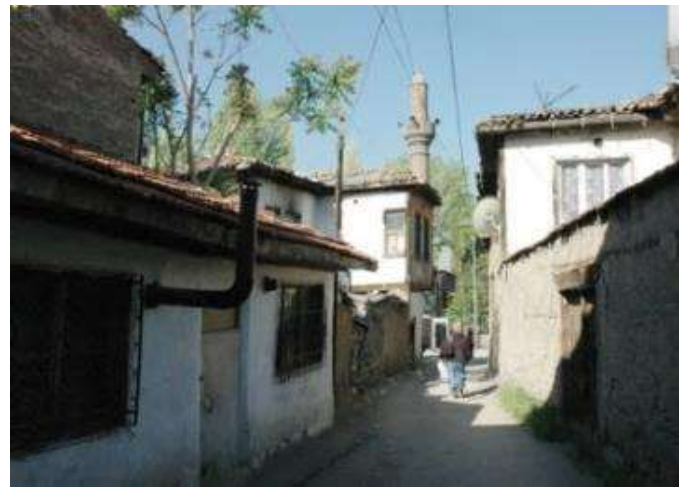
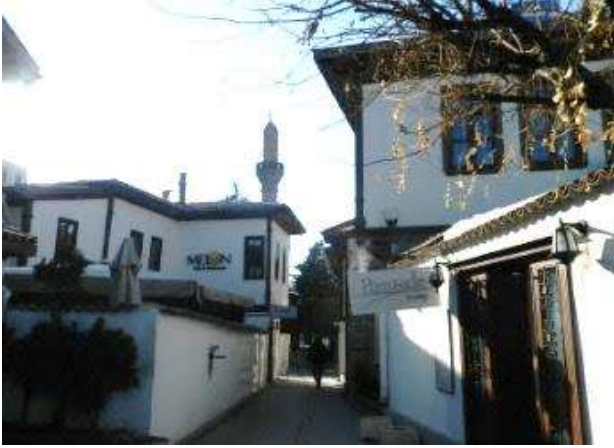
**Picture 11.** Fırın Street, before restoration (Source: altındag.bel.tr, 2014).

**Picture 12.** Firin Street, after restoration (Source: Writer,2014).

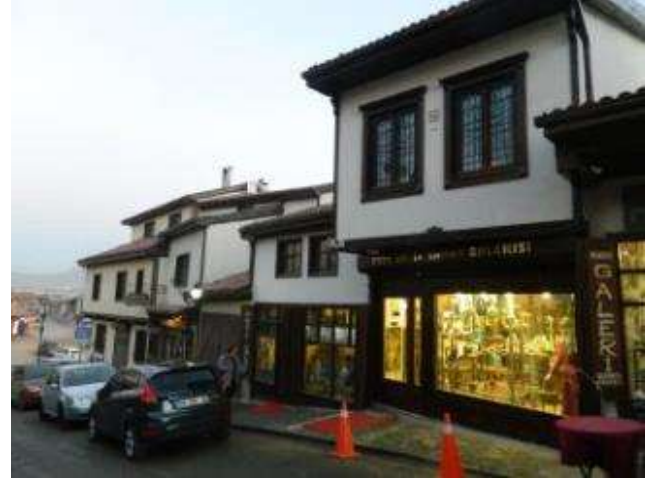
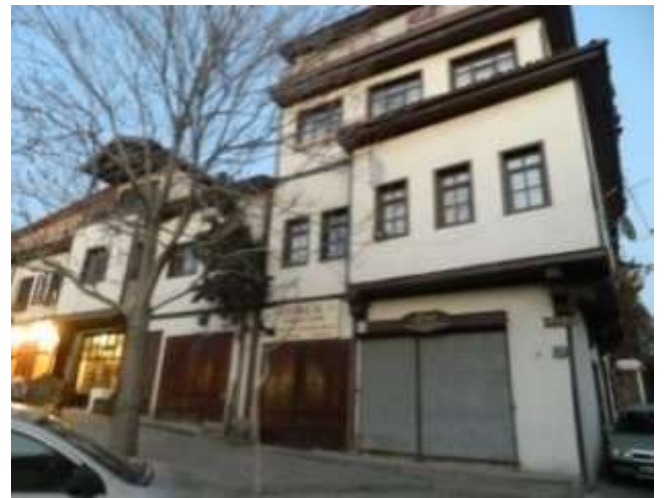
**Picture 15.** At pazarı Street, current status (Source: Writer,2014).

**Picture 16.** Can Street, current status (Source: Writer, 2014).

the city. Within the Project, 55 buildings were rehabilitated 9 of those were officially registered (Picture 15, 16). Because the main functionality of the area is commerce space, the shop windows and pull-down shutters were designed monotypically (Figure 5).

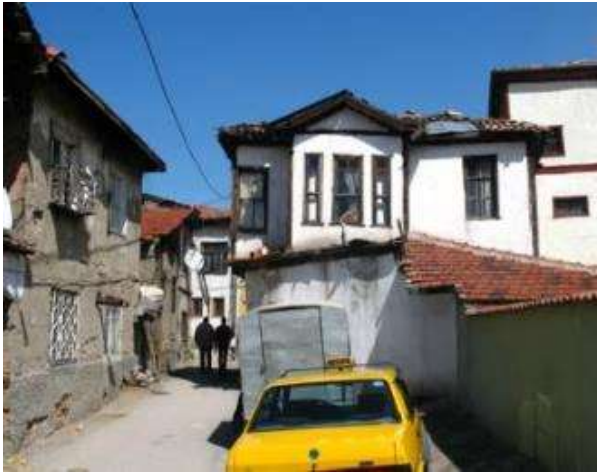
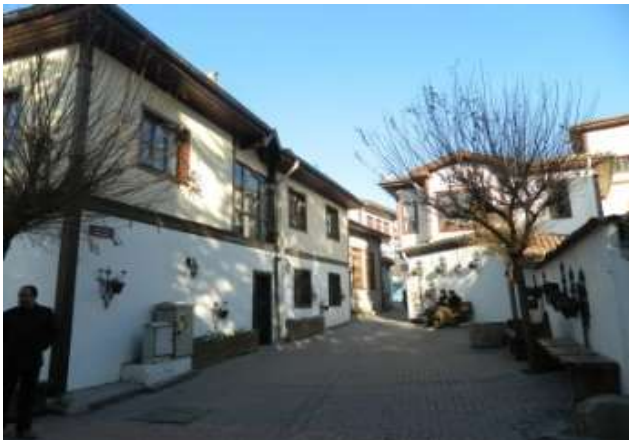
**Picture 13.** İnanlı Street, before restoration (Source: altındağ.bel.tr, 2014).

**Picture 14.** İnanlı Street, after restoration (Source: Writer, 2014).

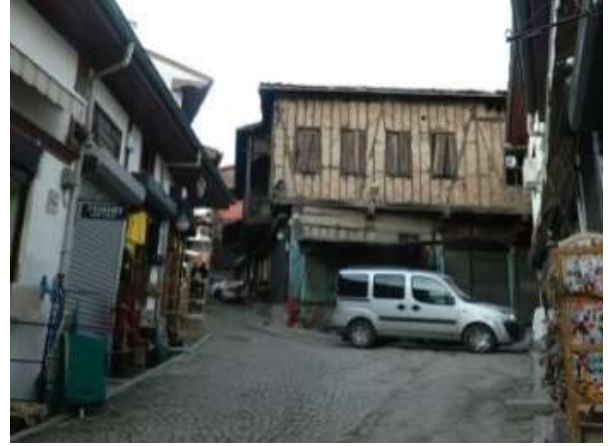
**Picture 18.** Koyunpazarı Street (Source: Writer, 2014).

At some of the commercial units wooden frame was manufactured and at some of them iron frame was preferred with different dimensions (Figure 6, Picture 17) (Altındağ Municipality, 2014). There is a non-implemented building at the centre of the street with adobe filled timber frame, need to be paid attention (Picture 18).

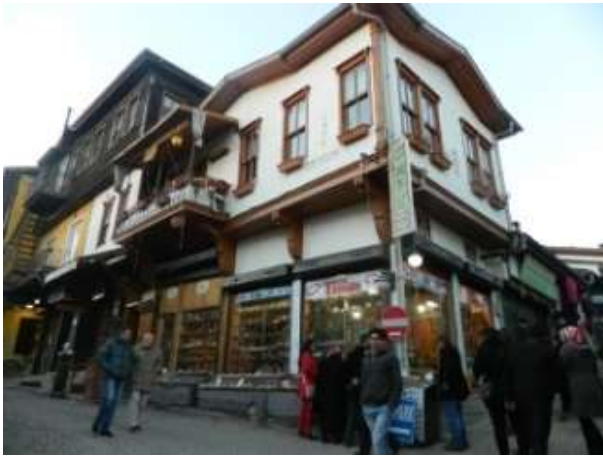
**Picture 17.** Shop windows (Source: Writer, 2014).

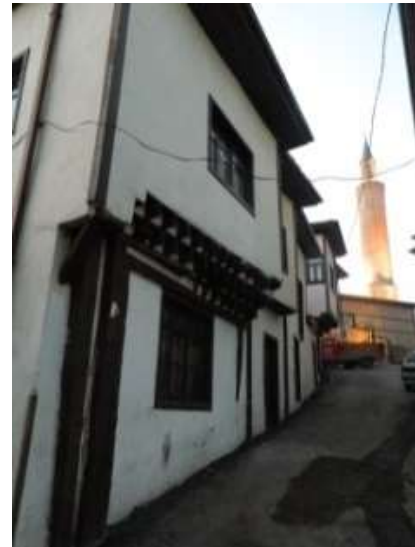
**Picture 19.** Kurnaz Street, current status (Source: Writer, 2014).

20 buildings are located on Kurnaz Street, which 9 of them registered officially, connected with Ulucanlar Street an elevation difference of approximately 10-12 m (Picture 19). At the buildings which are placed at Filiz Street, no implementations had been made (Arslan, 2012). At the

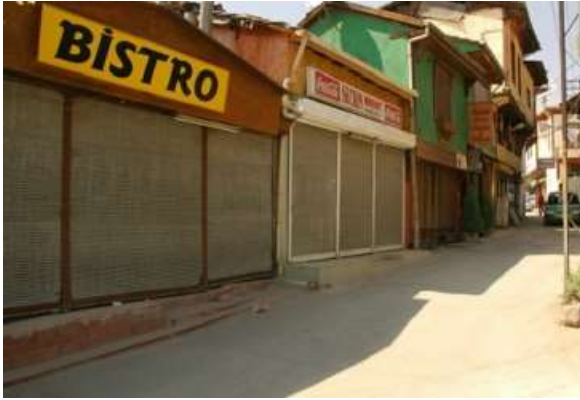
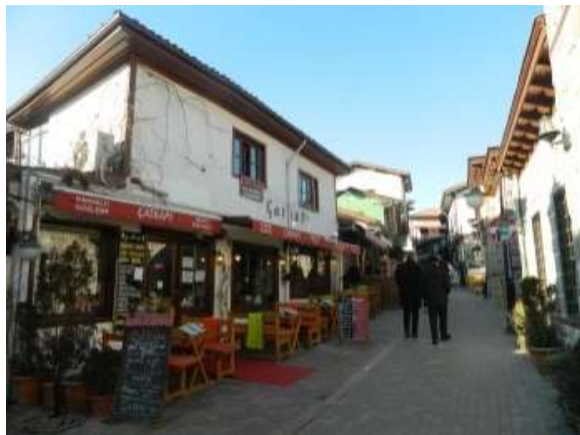
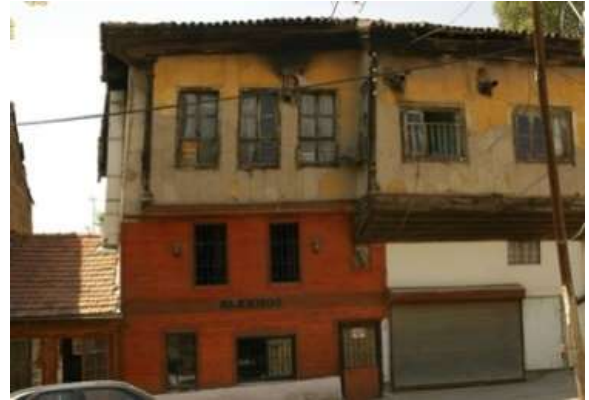
**Picture 20.** Sarıkadı Street, before restoration (Source: altındag.bel.tr, 2014).

**Picture 22.** Sarıkadı Street, before restoration (Source: altındag.bel.tr, 2014).

**Picture 21.** Sarıkadı Street, after restoration (Source: Writer, 2014).

constitutes entrance to the historical pattern (Pictures 20 and 21). In the context of the project, totally 38 buildings were handled, of which 11 of them were officially registered. The general problems detected at buildings were; moving the interior walls at commercial units, being destroyed of the facades because of the chimney need, deformation of the roof, distortion of the original windows, flaking off paints and stucco, deflection in wooden base system (Picture 22) (Altındağ Municipality, 2014). Using monotype verge boards and bonding timbers used at floor elevations, spoil the original design of the facade (Picture 23).

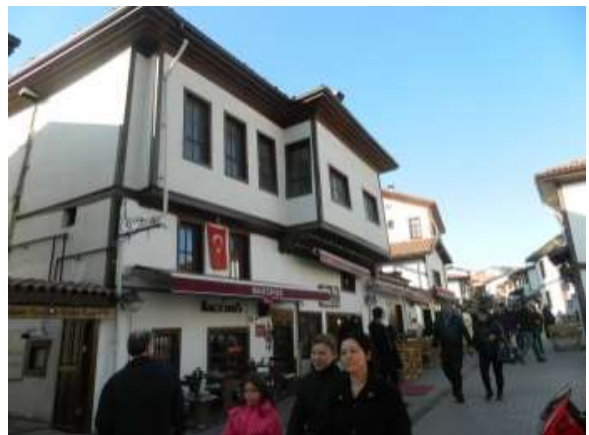
**Picture 23.** Sarıkadı Street, current status (Source: Writer, 2014).

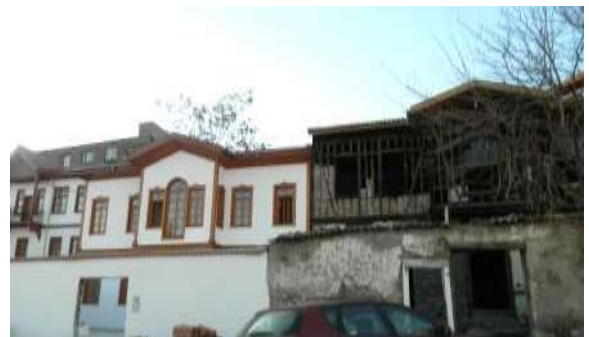
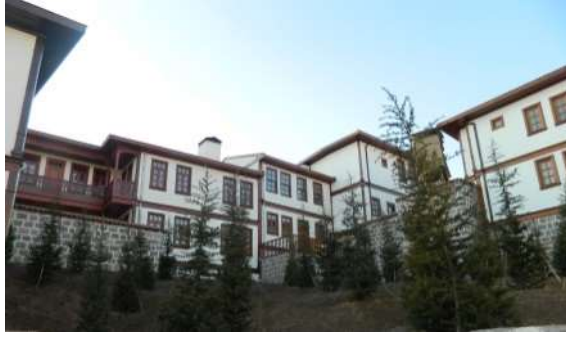
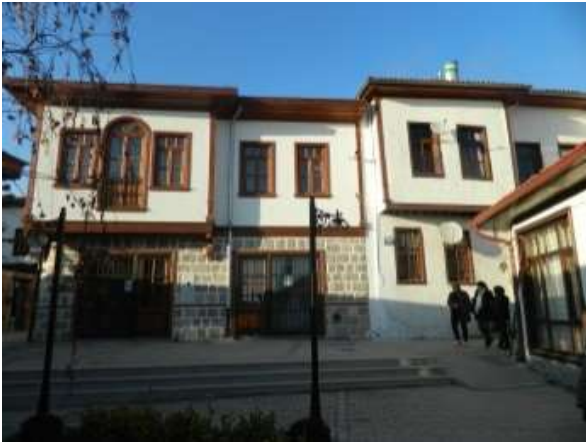
**Picture 24.** Gebze Street, before and after implementation (Source: Writer, 2014).

**Picture 25.** Gebze Street, current status (Source: Writer, 2014).

**Picture 26.** Hamamarkası Street (Source: Writer, 2014).

Gebze Streets, of which 15 of them are officially registered (Pictures 24, 25 and 26) (Arslan, 2012). The implementations in the area are being continued (Picture

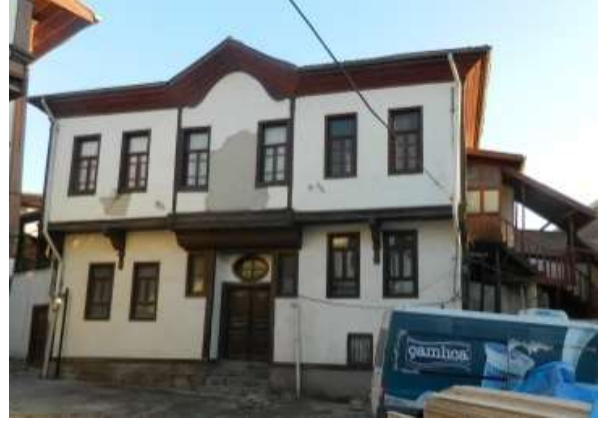
**Picture 28.** The cement stucco (Source: Writer, 2014).

27). It is observed that the facade paint flaked off and cement stucco appeared underneath, at the house which was placed at the end of Gebze Street (Picture 28).

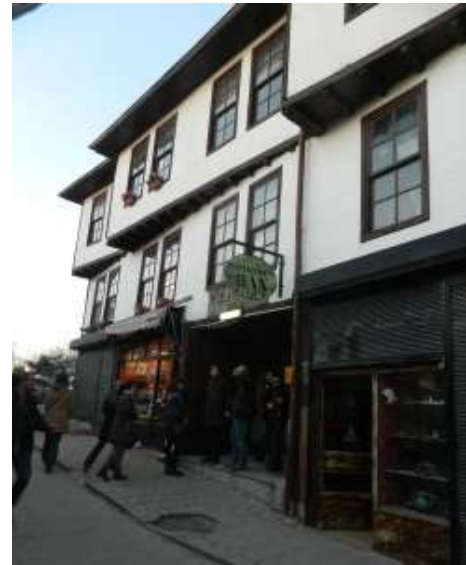
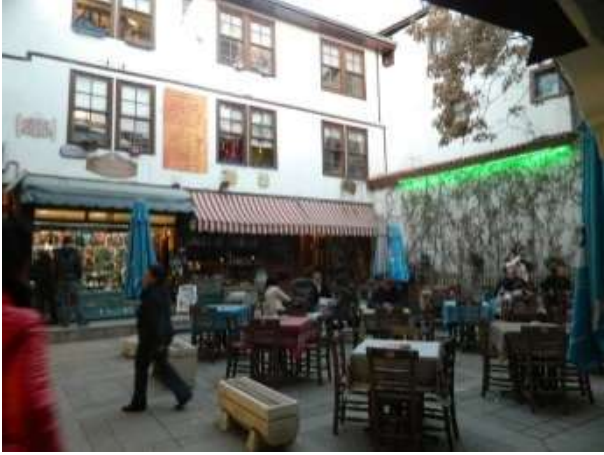
**Picture 29.** Piriç Street, current status (Source: Writer, 2014).

**Picture 30.** Piriñ Inn's courtyard (Source: Writer, 2014).

Ulus Primary School, Çengel Inn, Pilavoğlu Inn are located next to the Koyunpazarı Ramp and Piriç Inn is located near the project border (Picture 29, 30). In the area, where is the center of antique shops, cafes, restaurants, handicraft units, there are 22 buildings in the context of the Project, 3 of them are officially registered (Arslan, 2012).

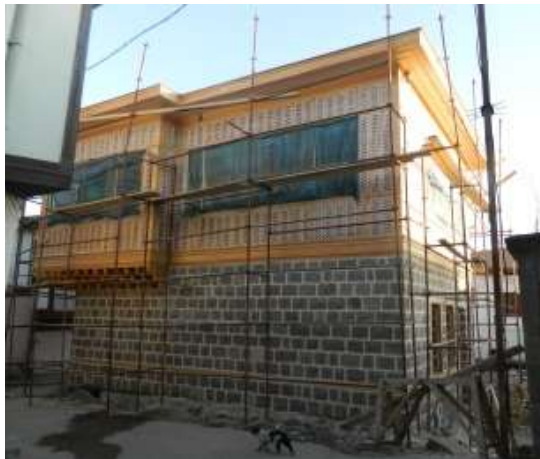
**Picture 27.** Going on studies (Source: Writer, 2014).

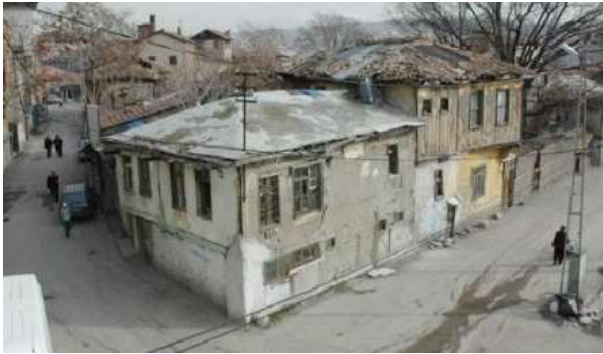
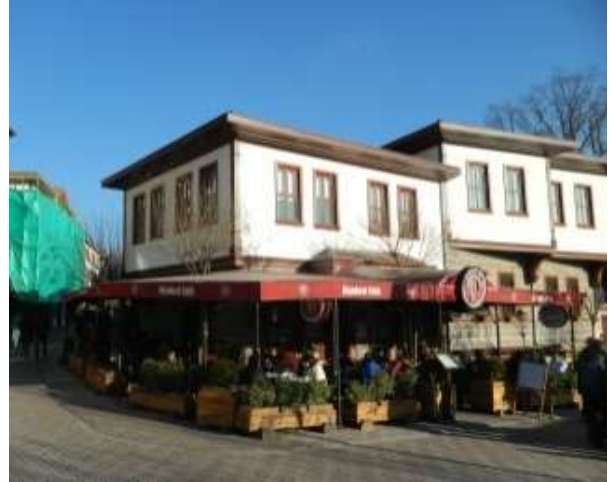
**Picture 32.** Current status of the house (Source: Writer, 2014).

**Picture 31.** The house at Mehmet Akif Ersoy Street (2004) (Source: altindag.bel.tr, 2014).

For example, to the house's facade located on M. Akif Ersoy Street, unoriginal balconies were added, the base floor was arranged to be a commercial shop and a door was opened to the facade, windows were designed monotype (Pictures 31 and 32). In some implementations, the unoriginal window openings were filled, and in some of them they have been opened which were closed previously so they have been reached to their original status (Pictures 33 and 34).

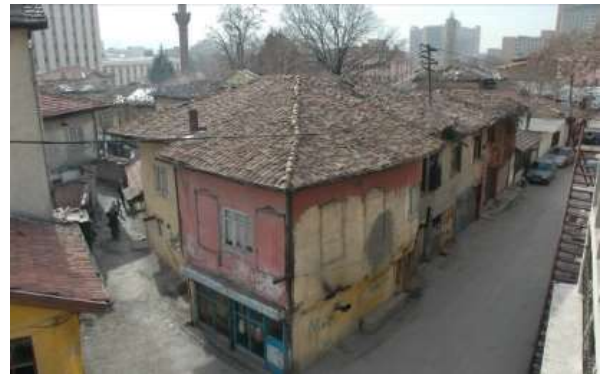
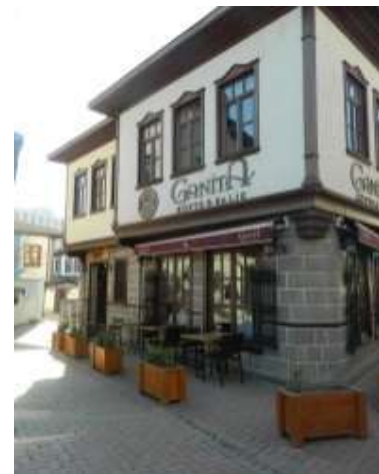
**Picture 33.** The house at Hamamönü Street, before restoration (Source: altindag.bel.tr, 2014).

**Picture 34.** The facade of the house after restoration (Source: Writer, 2014).

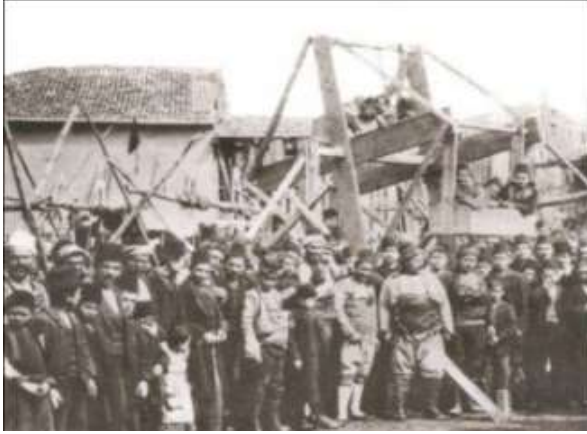
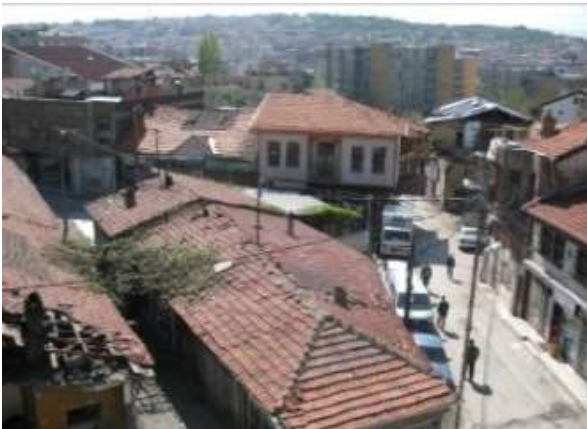
Picture 35. 1920's (Source: wowturkey.com, 2014).

Picture 36. The Shops (Source: altindag.bel.tr, 2014).

owned single floor shops, for years (Pictures 35 and 36). The shops were demolished, the area was cleaned and arranged as a square but a clock tower was put into the

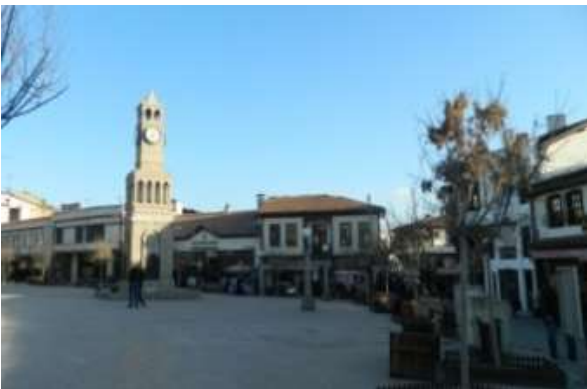
Picture 37. Current Status (Source: Writer, 2014).

middle of the square as a street furniture which didn't exist in the original form (Picture 37) (Kale, 2011; Arslan, 2012).

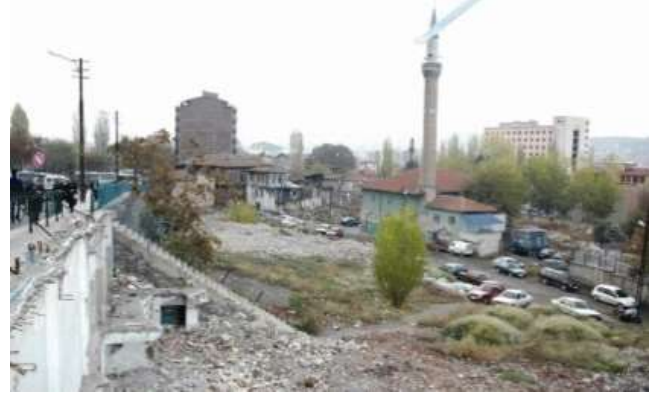
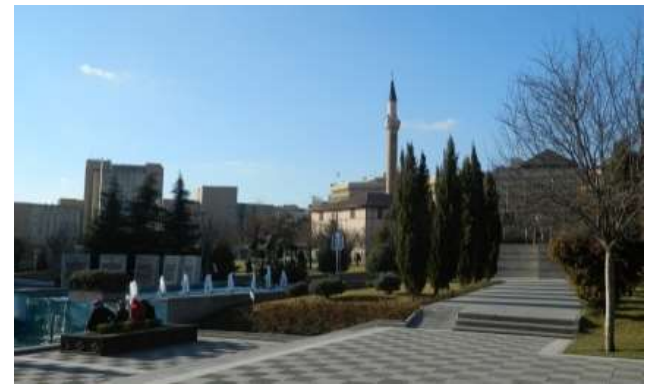
Picture 38. M. Akif Ersoy Parki, previous status (Source: altindag.bel.tr, 2014).

Picture 39. M. Akif Ersoy Parki, current status (Source: Writer, 2014).

**Mehmet Akif Ersoy Park Project** Mehmet Akif Ersoy Park, which is a reference point of the area, constitutes the main green pattern in the area. The restorations of Tacettin Sultan Mosque, Hacı Musa Mosque and Mehmet Akif Ersoy's House were completed by General Directorate of Foundations (Pictures 38 and 39) (Altındağ Municipality, 2014).

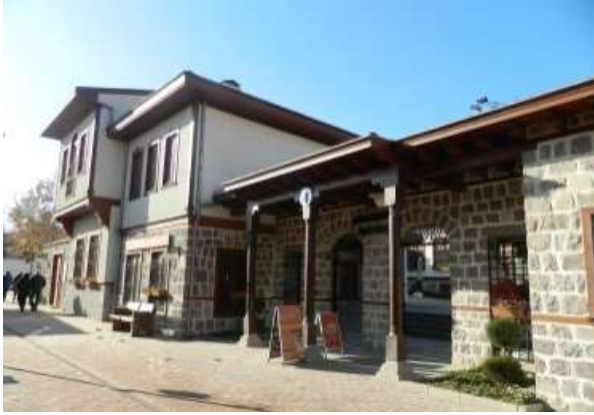
**Picture 40.** Sanat Street buildings reconstructed with infill technique (Source: Writer, 2014).

**Handicrafts Centre and Cultural Centre Projects:** Because the buildings in the area have not reached today, the buildings which function as exhibition, meeting hall, conference hall and open-air cinema were reconstructed with infill technique and have complied with existing pattern but an exact information about the original status of the buildings is not available (Pictures 40 and 41) (Kurtar, 2012).

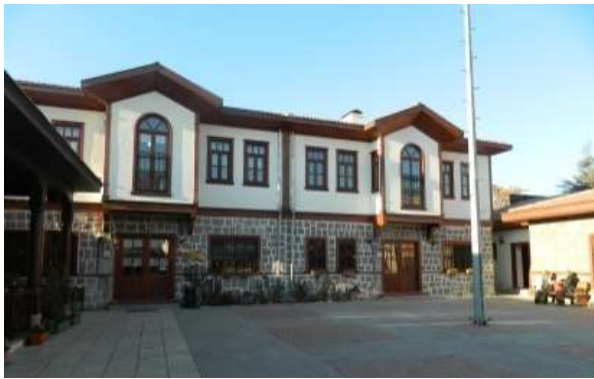
**Picture 41.** The courtyard of handicrafts workshop (Source: Writer, 2014).
