Full Length Research Paper

Investigation of premature fracture of a tail pulley in the field

An unexpected (premature) failure happened in Tail Pulley during operation in field. Consequently, a complete analysis in terms of fracture and fatigue performed. The analysis aimed to determine the failure root-cause by the analysis of the project and materials. The analysis covered the tensions undergone by the pulleys under operation and the material's mechanical strengths. The results showed the project conforms the classical mechanics calculations. The failure, on the other hand, characterized as ductile fracture – Fatigue - with crack propagating along 45° referencing the cylinder longitudinal axis. The crack initiated at a flaw found at the weldment region, which resulted a shorter lifetime (collapsing). The sharpen flaw generated a shortcut in the failure process and jumped it straight to the phase of fracture - Stage II fatigue – called crack propagation.

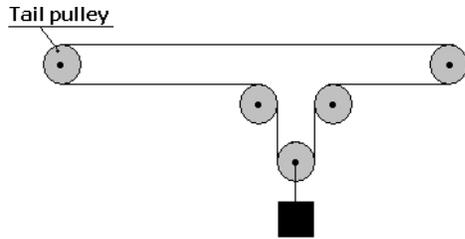
According to information's obtained in field the tail pulley collapsed abruptly and during operation (sees its positioning on the conveyor - Figure 1). The characteristics of the pulley application are; belt conveyor - belt width 762 mm, tensions T_1 and T_2 185 kN and wrapping angle of 180° on the pulley cylinder. The pulley

Figure 1. Sketch of conveyor - positioning of the tail pulley.
