Soil and foundation stability improvement by stone column: A case study in Adapazari city, Turkey

Hasan Arman^{1*}, Seyhan Fırat², İsa Vural² and Zeki Gunduz³

Key words: Marmara earthquake, alluvial deposit, ground improvement, stone column, numerical model.

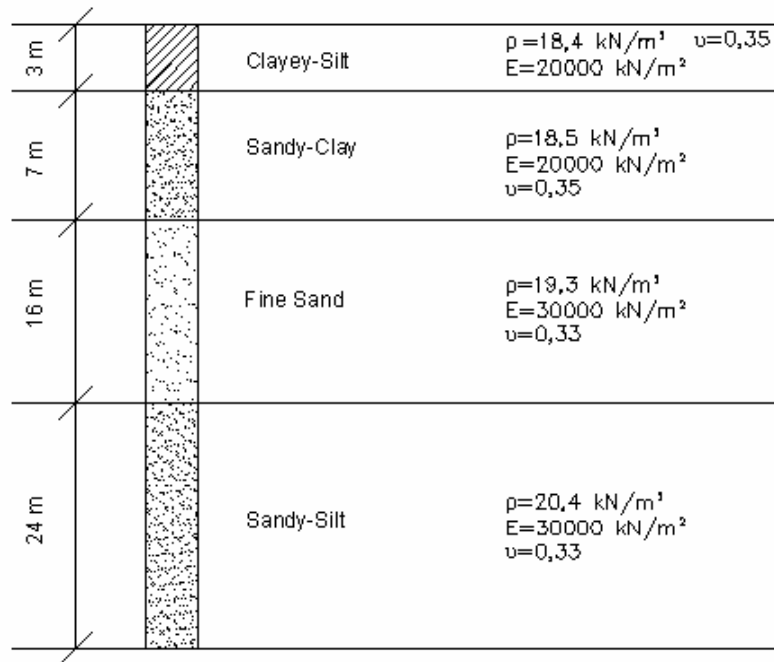
Figure 2. Typical ground cross-section of Adapazari region.

Especially after the earthquake, a number of borehole logs drilled by various governmental agencies, local public body and private consultants are available. The depth of these boreholes ranges from 10 to 200 meters. A typical borehole data obtained from the region are given

in Figure 2. In addition, some deep boreholes drilled at Adapazari Valley failed to reach bedrock. Because of its geology and local ground conditions, the valley receives a great attention for its liquefaction potential during earthquakes (Bray et al., 2004; Arman et al., 1997).

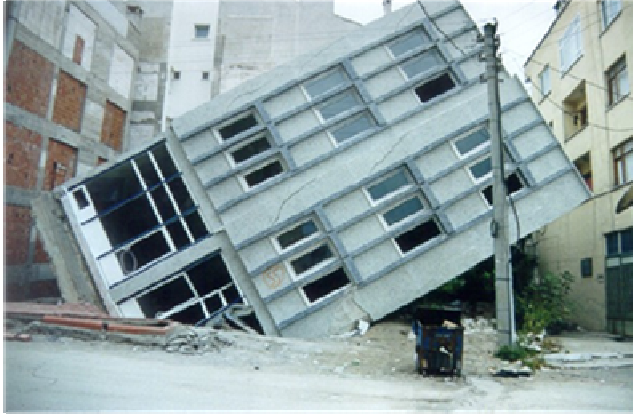
Figure 3. Totally damaged structure built on liquefiable soil.

most recent destructive event in the region. It was associated with faulting over a length of approximately 100-120 km. The maximum lateral displacement along this fault line in Adapazari region was approximately 425 cm and the maximum vertical displacement was approximately 30 cm. Most of the reinforced concrete structures, built on the liquefiable soil in the region, were severely settled or tilted besides the structural damages (Figure 3) (Bakir et al., 2002, 2005; Wasti and Ozcebe, 2003; Mollamahmutoglu et al., 2002).

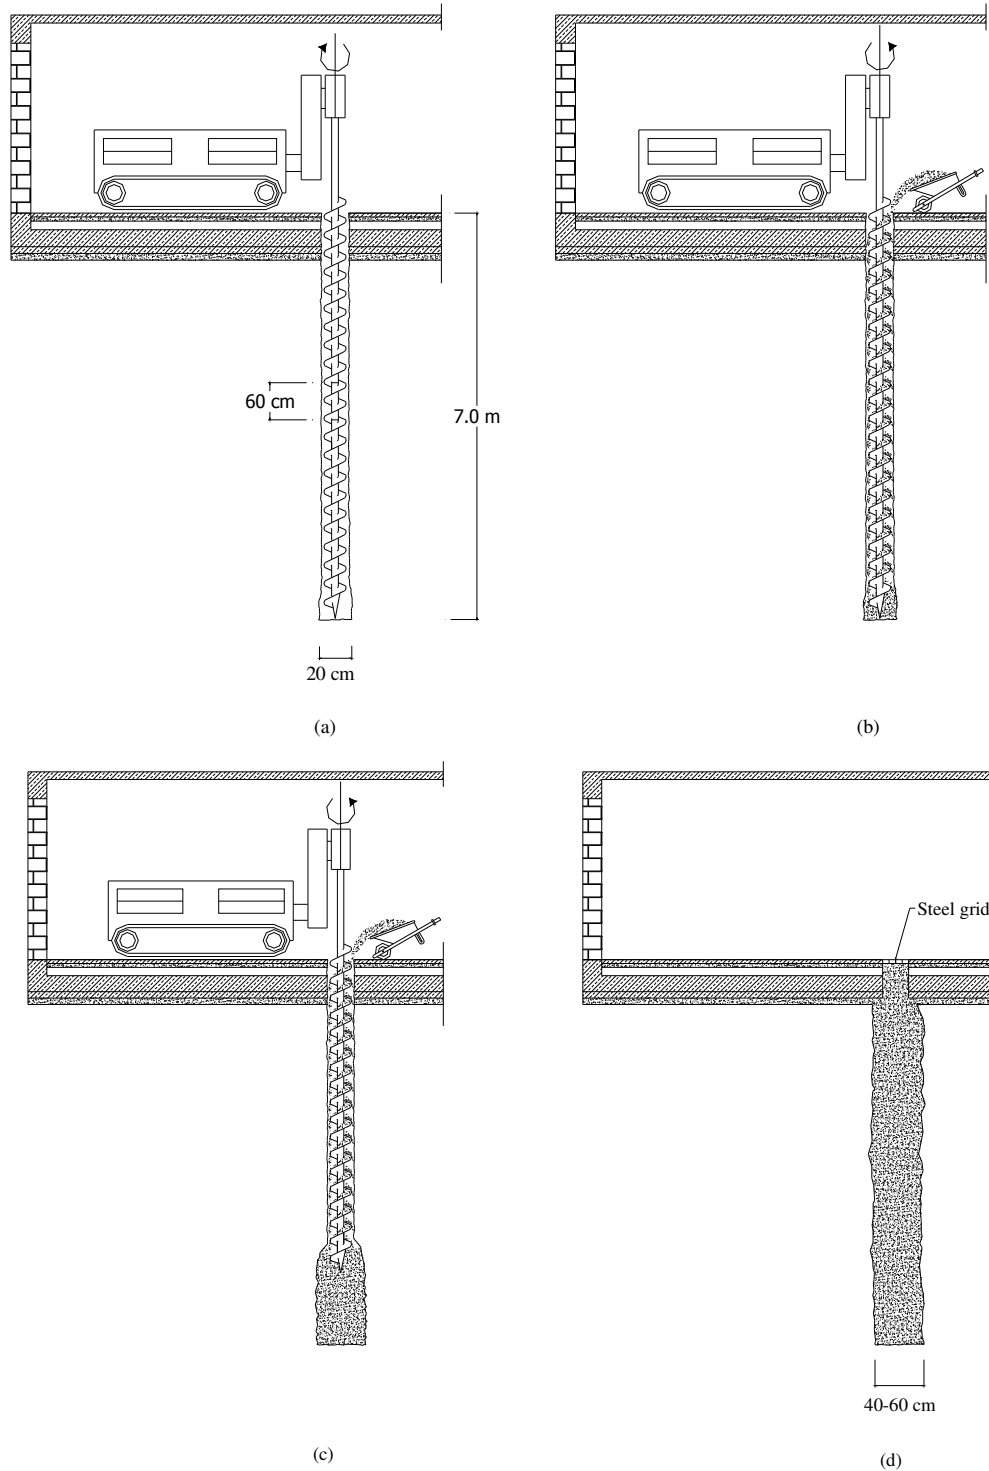
Figure 4. Sequence of stone column application (not in scale).

To apply stone columns, it requires drilling a borehole through the foundation of an existing damaged building. Boreholes must reach to the bottom of foundation. Then, continuous boring was performed using 60 cm long augers connected to each other until planned length of

boreholes for stone column was drilled (Figure 4a). A diameter of boreholes is approximately 20 cm (Figure 4a). Due to limitation of the working space, special design of pile insulation machine with strong torque and reverse auger, which was approximately 20 cm diameter and 60

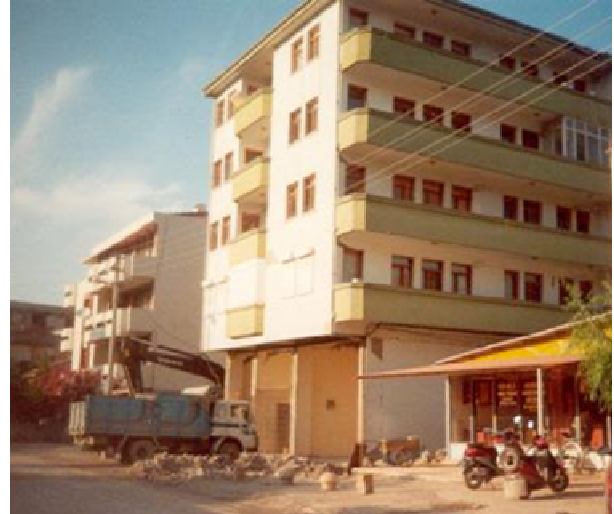
Figure 5. Structurally damaged five-story reinforced concrete building located on liquefiable soil.

Case study: A five-story reinforced concrete building, which was structurally damaged, was selected for a case study (Figure 5).

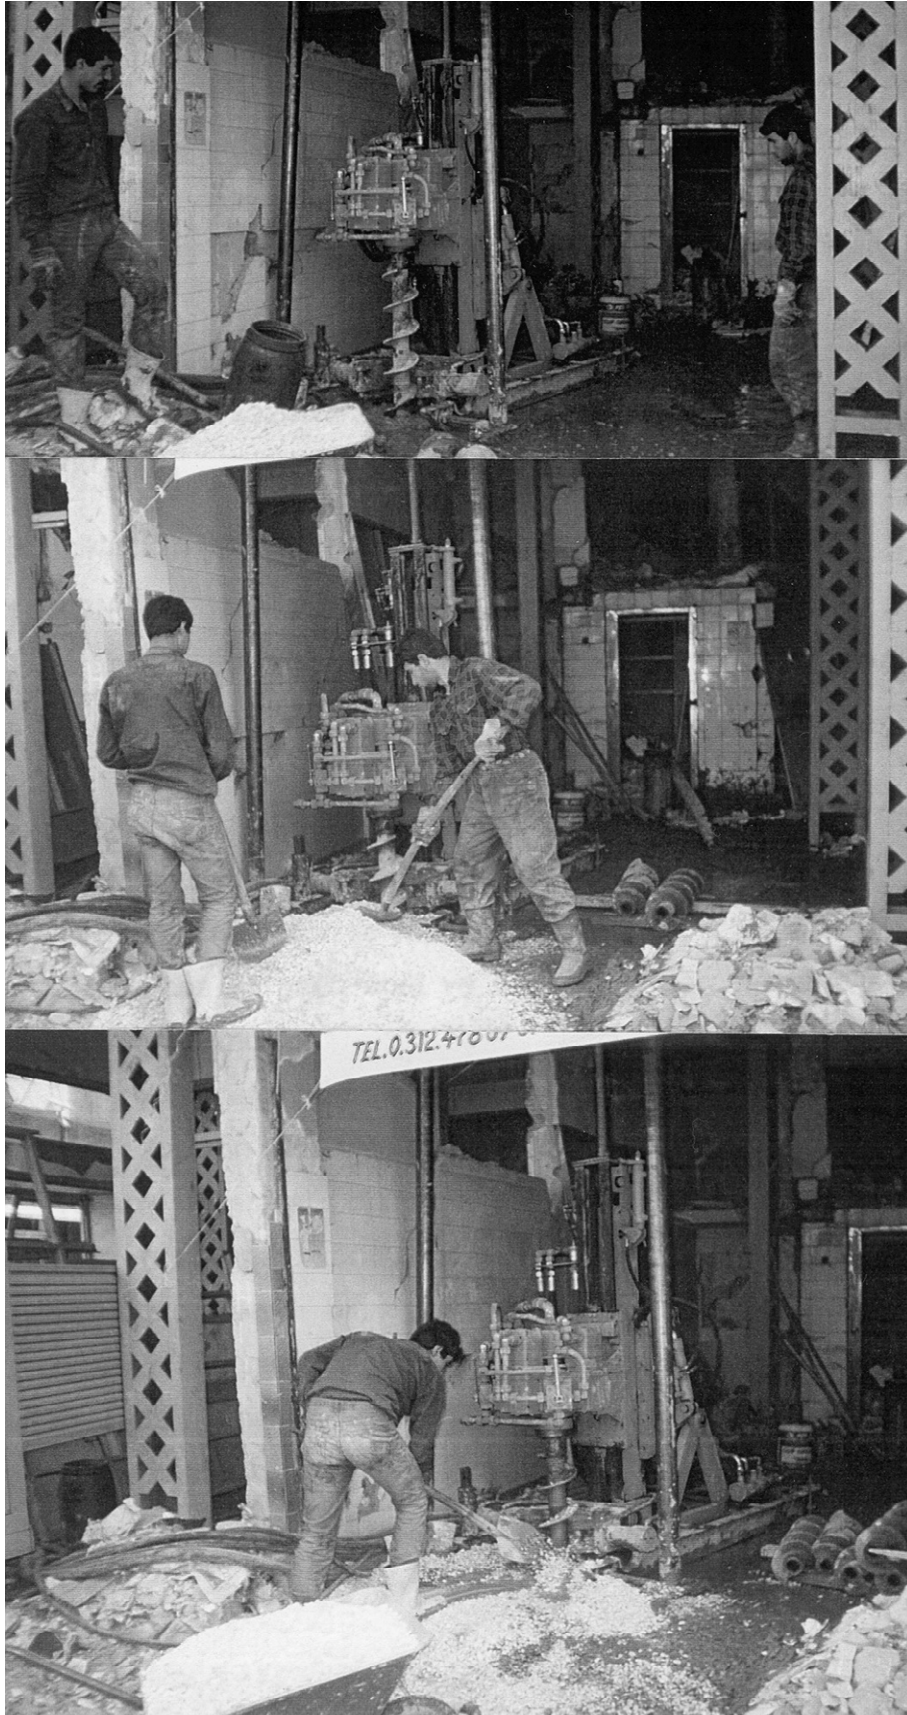
Figure 7. Typical application of stone column.

It was necessary to improve ground conditions and reinforce structural parts of the building. Based on its' geotechnical data, it was decided to use the modified dry bottom feed stone column as a ground improvement method. Figure 6 shows the plan view of the stone columns placed on the foundation and its cross-section. The length of the stone column was decided to be 7.0 m. The amount of crushed stone used for each stone column and the diameter of the stone columns are given in Table 1. The application of the modified method on the site is displayed in Figure 7.

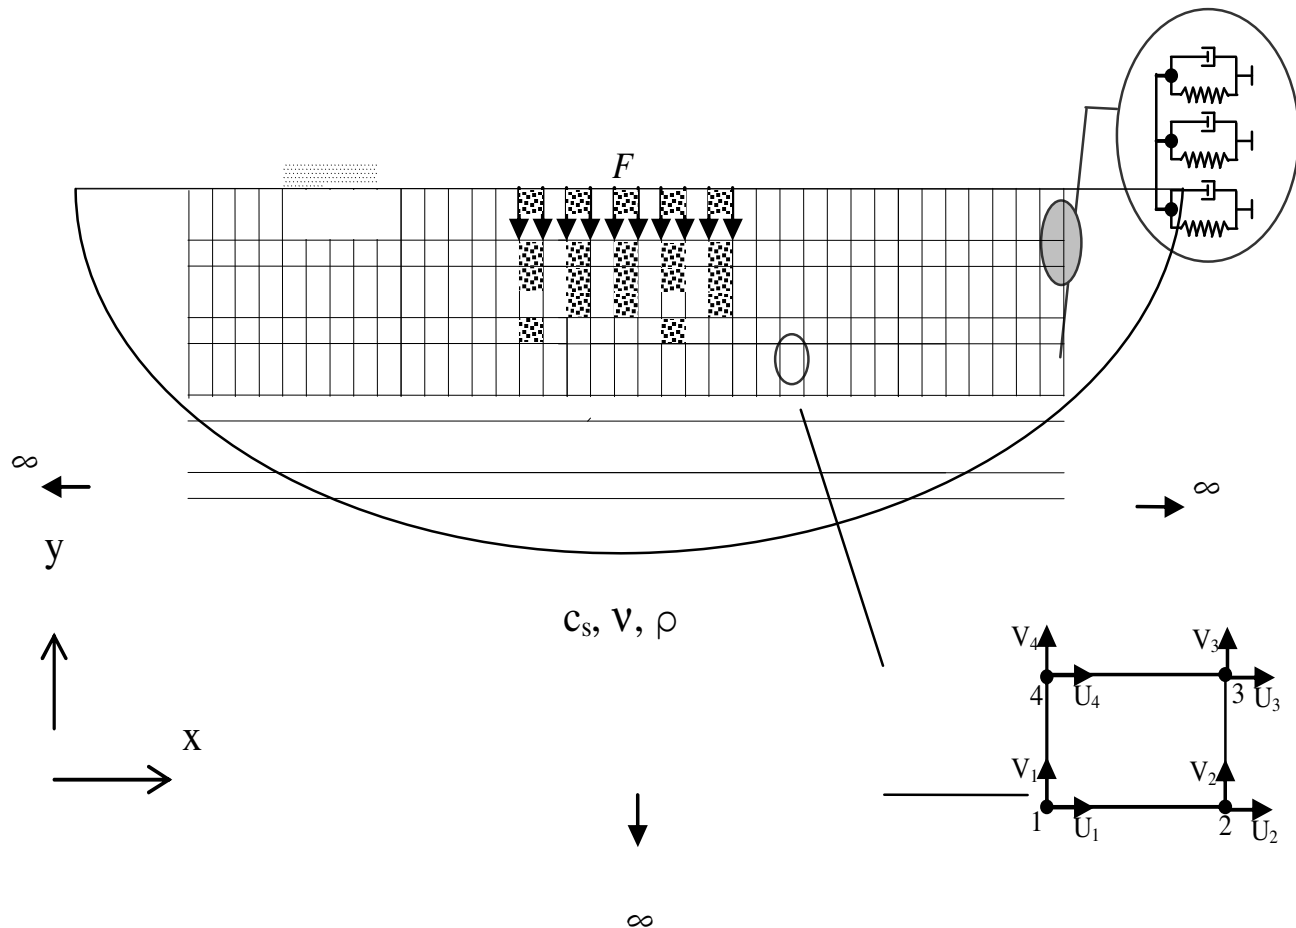
Figure 8. Mathematical model used in numerical analysis.

For the presented case study, stone columns in a layered soil were mathematically modeled in order to perform a numerical analysis (Figure 8). Plane stress condition is used in numerical modeling. To assess the effects of stone columns on the constitute model; behavior of the system in computer environment was investigated with
