Full Length Research Paper

Vehicle gearbox fault diagnosis using noise measurements

Sameh M. Metwalley*, Nabil Hammad and Shawki A. Abouel-seoud

Faculty of Engineering, Helwan University, Cairo, Egypt.

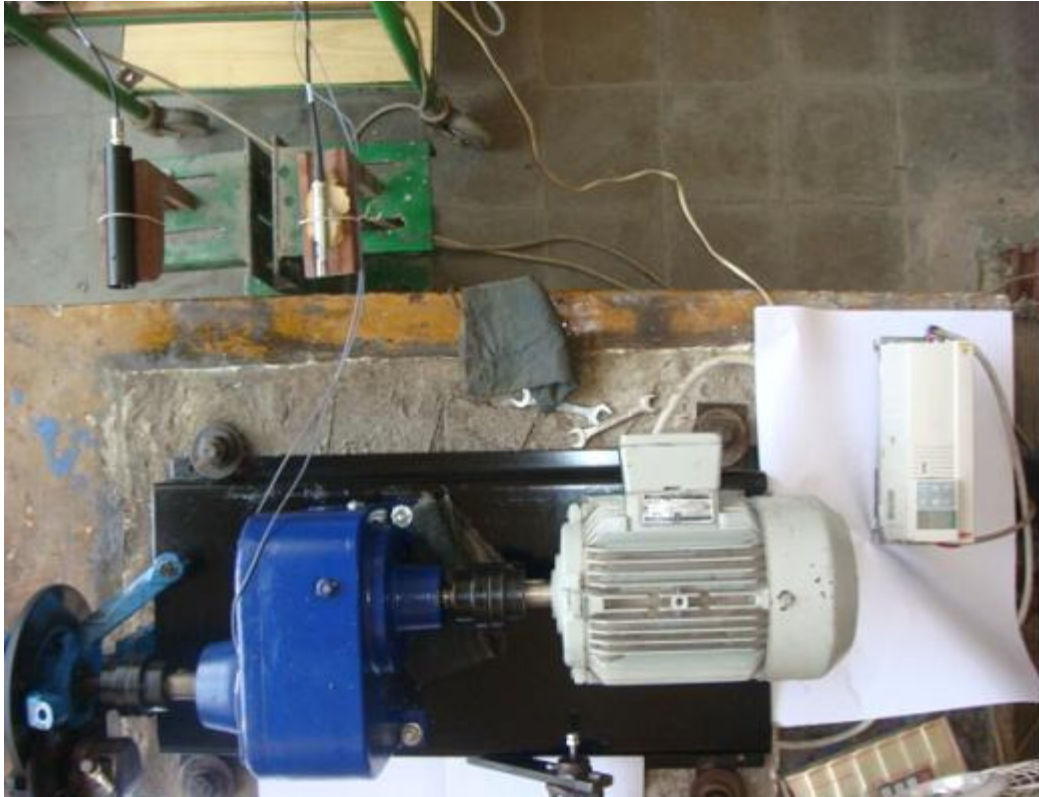
Figure 1. Experimental setup.

Figure 1 shows the experimental setup used for the gearbox testing. The gearbox consists of two helical gears with a module of 2 mm, pressure angle 20° , which have 64 and 26 teeth with 40 mm face width. The axes of the gears are supported by two ball bearings each. The entire system is settled in an oil basin in order to ensure proper lubrication. The gearbox is powered by an electric motor and consumes its power on a hydraulic disc brake, while the speed is measured by photo electric probe. Bruel and Kjaer (B and K) portable and multi-channel PULSE analyzer type 3560-B-X05 (Figure 2) with condenser 1/2- microphone and preamplifier type 4189A-021 was positioned in the center of gearbox front casing away from the casing and the ground by 1.0 and 0.50 m, respectively (Rebbechi et al., 1999). The B and K PULSE labshop is the measurement software type 7700 is used to analyse the results (Figure 3). In terms of various parameters evolution during the test – from a representative test on a gear system with a cut of root thickness to simulate the tooth crack (Figure 4) will be presented and detailed in this study. Many tests were conducted on the same configuration yield similar parameters behaviour. Small cracks were made components and this will facilitate detection of a harmonic pattern. However, the linear frequency scale equal resolution

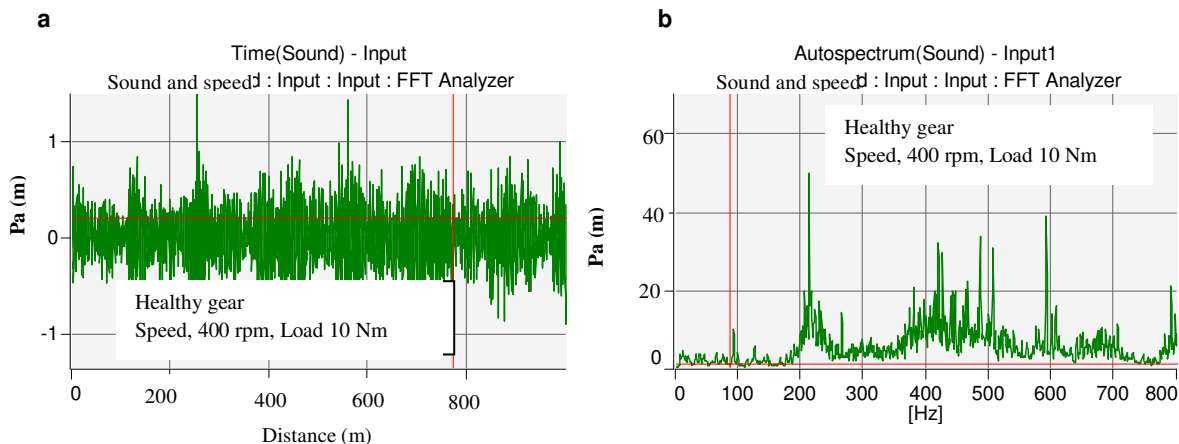
Figure 5. Sound pressure level spectra. a) Time history of sound pressure level. b) Frequency domain of sound pressure level.

In Figure 5, where the speed is 400 rpm, and load is 10 Nm for healthy gear, the sound pressure level (SPL) measured at a location of 1.0 m away from the gearbox casing front face in time domain (Figure 5a) and in frequency domain (Figure 5b). This indicates high levels in the frequency ranges of 200 to 300, 400 to 500 and 600 to 700 Hz (Figure 5b), while the levels of the remaining frequency are lower and almost constant. The influence of the load on the measured SPLs at speed of 400 rpm is presented in Figure 6, where the 1/3-octave SPL is increased with the increase of the load despite some small discrepancies existed in the 1/3-octaves up to 63

frequency domain (Figure 7b). The whole spectrum levels are higher when compared with those shown in Figure 5b, particularly towards the higher harmonics of tooth-mesh of the output gear, indicating crack. Furthermore, for healthy gears (Figure 5b), the averaged signal is normally dominated by tooth meshing harmonics modulation by the rotation of the gear shaft. When a

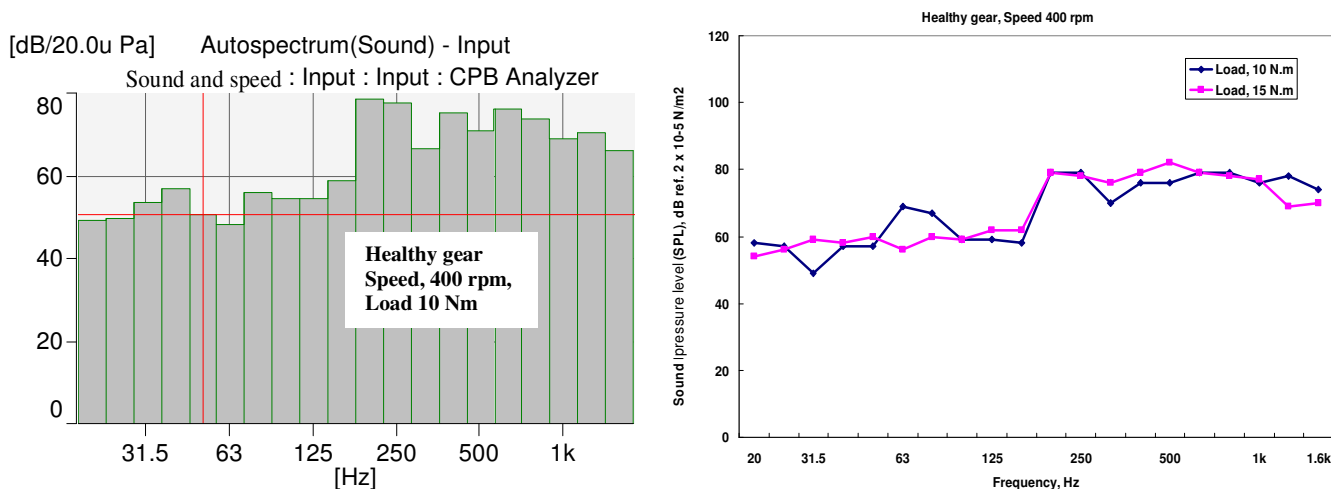
Figure 6. 1/3-Octave sound pressure level spectra. a) 1/3-octave sound pressure level. b) 1/3-octave sound pressure level.

Hz (Figure 6b). This may be attributed to the influence of gear meshing frequencies, rotating shafts frequencies and structure rigidity resonance frequencies.

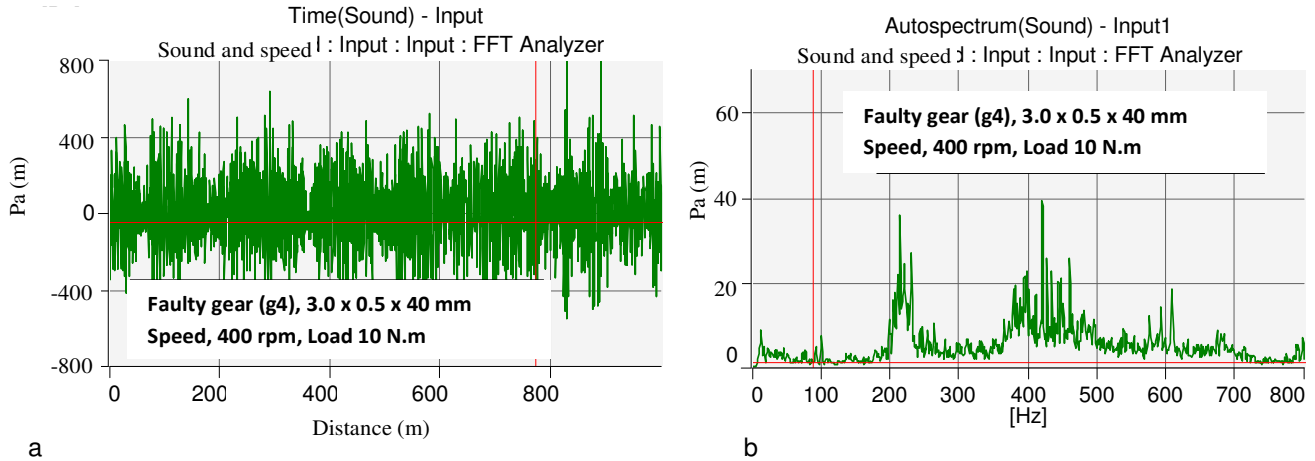
Figure 7. Sound pressure level spectra: (a) Time history of sound pressure level; b) Frequency domain of sound pressure level.

In Figure 7, where the speed is 400 rpm, and load is 10 Nm for faulty gear, the sound pressure level (SPL) measured at a location of 1.0 m away from the gearbox casing front face in time domain (Figure 7a) and in

localized tooth defect, such as tooth crack (g4) of dimension of $3.0 \times 0.5 \times 40$, the engagement of the cracked tooth will induces an impulsive change with comparatively low energy to the gear mesh signal. This can produce some higher shaft-order modulations and may excite structure resonance. The influence of the crack size on the measured SPLs at speed of 400 rpm and load 10 Nm is shown in Figure 8, where the 1/3-octave SPL is increased with the increase of the crack sizes stated in Table 2 despite some small discrepancies existed in the 1/3-octaves up to 63 Hz (Figure 8b).

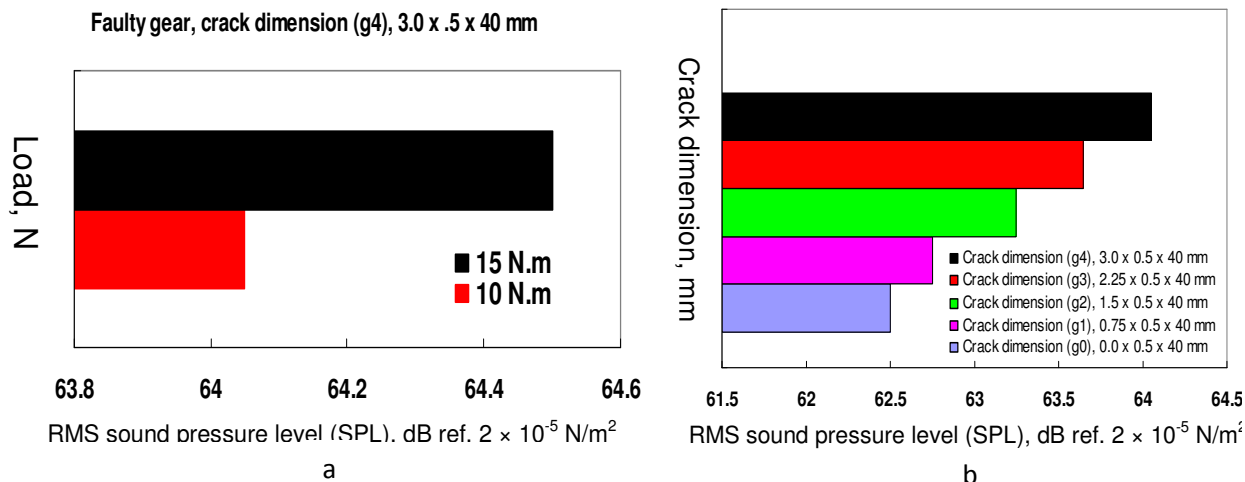
Figure 9. RMS sound pressure level: a) Influence of load; b) Influence of crack dimension.

in the gear, the obtained noise signal can be considered to be regular signals. Thus, if the sound pressure signals with 0% crack has been selected as a reference signal and remove it from each set of cracked gear SPL signals, the information contained in the remaining part is supposed to be only related to the gear crack. The aforementioned Equation (1) for RMS is applied to the residual signal, where their results are shown in Figure 9. The influence of load and crack size on the RMS SPL averages are shown in Figure 9a and 9b, respectively. It is clearly seen that the SPL in terms of RMS value increased as the increase of load output gear tooth crack size. This significant increase indicates the deterioration in condition. However, when analyzing the noise signal measured from the single-stage gearbox structure in

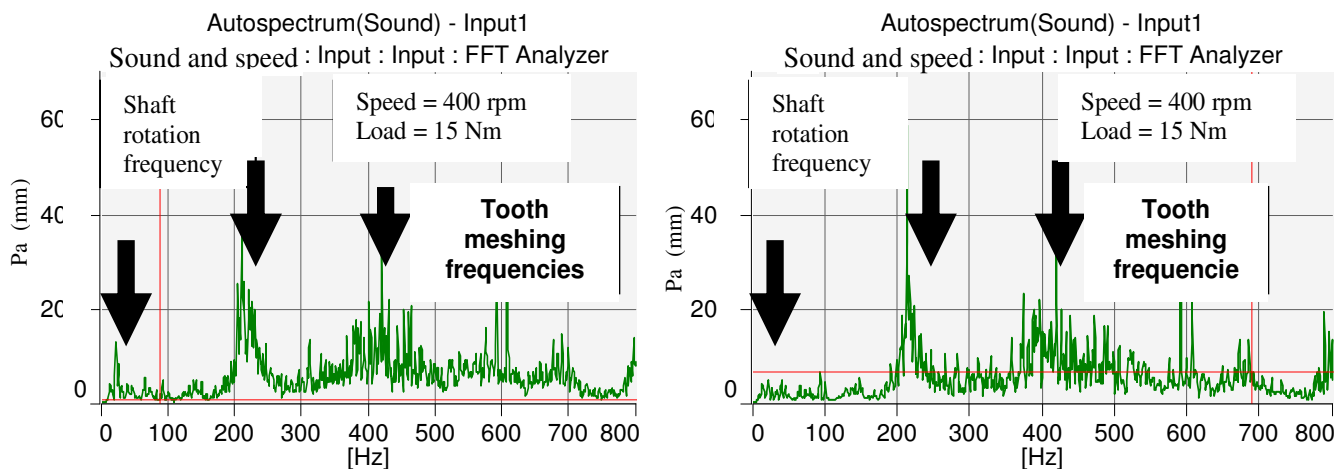
Figure 10. Locations of tooth meshing and shaft rotation frequencies: a) Healthy gear; b) Faulty gear (g4), 3.0 × 0.5 × 40 mm.

frequency-domain (Figure 10), firstly, each gear's shaft rotating frequency and meshing frequency are calculated. Table 3 tabulates them at motor speed of 400 rpm and load of 2.5 Nm, where their shaft rotating frequencies, f_{pr} and f_{gr} and meshing frequencies, f_{pm} and f_{gm} are listed. The spectrum of healthy gearbox is shown in Figure 10a which can be considered to represent the new condition, while Figure 10b represents the faulty gear at

crack size (g4) with the dimension of 3.0 × 0.5 × 40 mm. It is found that the spectra are dominated entirely by these frequencies as shown by the arrows. The other significant components in the spectra are an inter-modulation sideband with the same spacing from the first tooth-mesh harmonic as that of the ghost frequency from the fundamental tooth-meshing frequency. Some sidebands are presented, but at a relatively low SPL

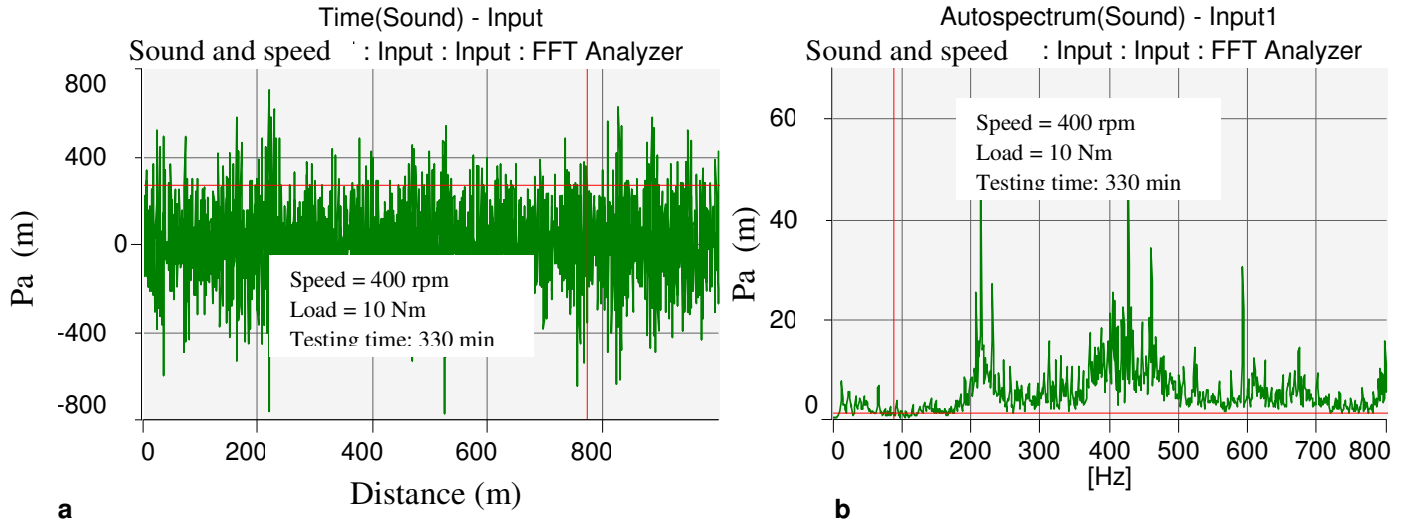
Figure 11. Sound pressure level spectra: a) Time history (g4), 3.0 × 0.5 × 40 mm; b) Frequency domain (g4), 3.0 × 0.5 × 40 mm.

Samples from SPL responses at speed of 400 rpm, load 15 and 330 min for faulty gear with crack dimension of 3.0 × 0.5 × 40 mm in terms of time history and frequency domain are shown in Figures 11a and 11b, respectively, while Figure 12a and 12b show the 1/3-octave RMS averages for different testing time up to 6.0 h. The evaluation of RMS average parameter with respect of testing time ranged from 0.0 to 360 min (6.0 h) are shown in Figure 13. To assist the more accurate observation of this parameter evaluation during the range of testing time, a magnification was shown in Figure 13, where the first transition period is obtained at the end of testing time near 135 min, while the second transition

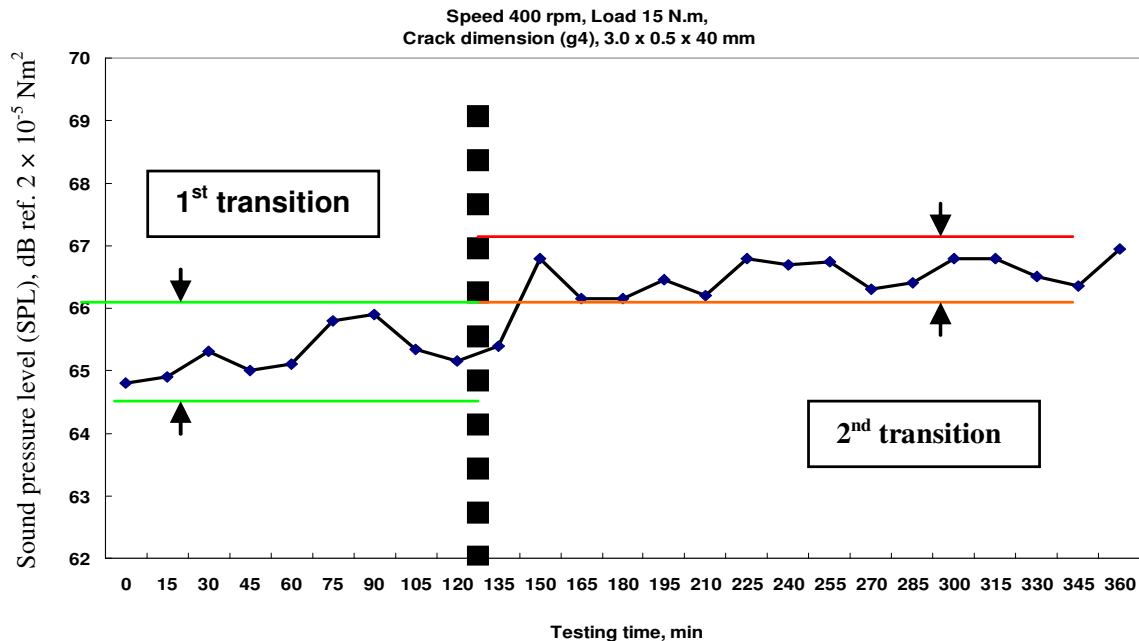
Figure 13. Relationship between RMS of SPL and testing time.

period is observed from 135 to 360 min. These transition periods are important and possess diagnostic value as they can be used to define and characterize critical changes of the gears damage accumulation and evaluation.

(4) In order to study the development of damage with artificially induced cracks in the gearbox, multi-hour tests were conducted and recordings were acquired using noise in terms of SPL monitoring, where the RMS average was calculated. In the recordings, the transitions in the RMS average values with the recording time were highlighted suggesting critical changes in the operation of the gearbox.
